Earthquake Contingency Plan for Ward 8, Rangamati Municipality: Volume 2

BUET-Japan Institute of Disaster Prevention and Urban Safety (BUET-JIDPUS)
Department of Urban and Regional Planning
Department of Civil Engineering
Bangladesh University of Engineering and Technology (BUET),
Dhaka-1000, Bangladesh.

**Earthquake Risk Assessment for Developing Contingency
Plans, Training Modules and Awareness Materials for
Rangpur City Corporation and
Tangail, Rangamati and Sunamganj Pourashavas**

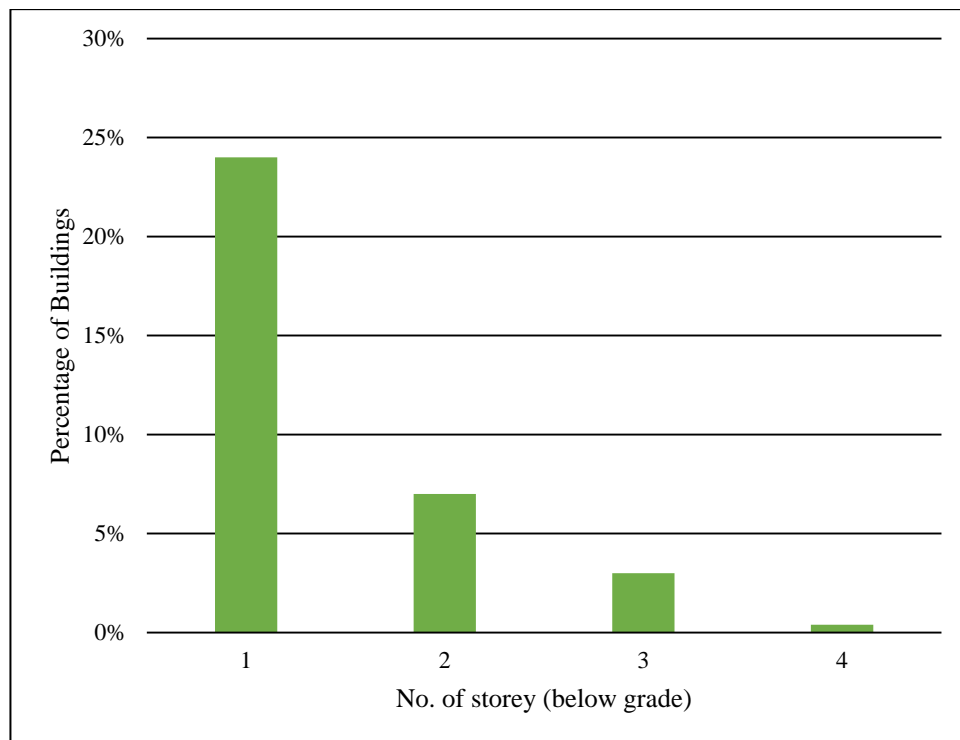
Figure 4.3: Relations between the percentage of buildings and no. of story of Ward 8 (below grade)

Among all the surveyed buildings, 34% had stories below grade. Figure 4.3 shows that 24% of such buildings have 1 story below grade. 7% of them have 2 stories and 3% of them have 3 stories below grade. Only 1 building was found which has 4 stories below grade.

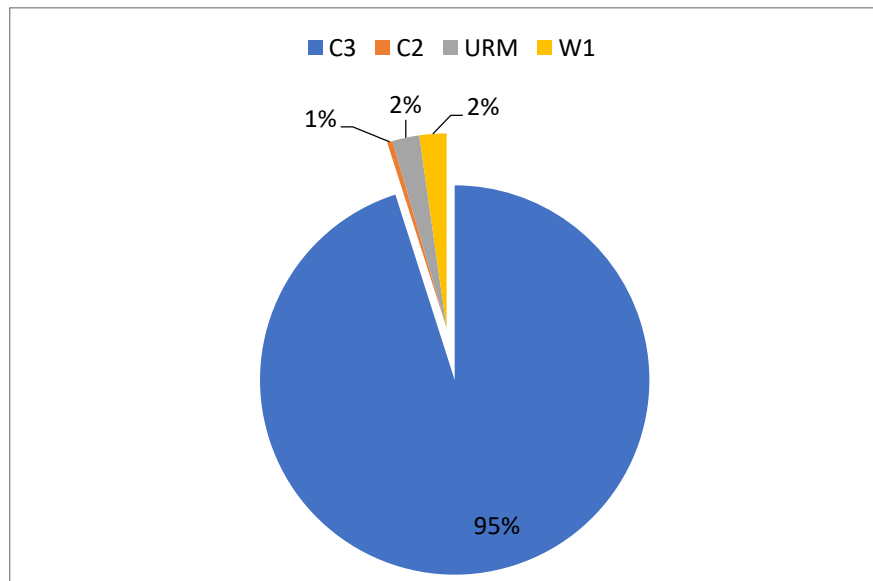
Figure 4.4: Percentage of different building types

It was found that among the 223 surveyed buildings, 95% buildings are concrete frame with unreinforced masonry infill walls (C3 as per FEMA classification). Only 1% is concrete shear wall buildings (C2 as per FEMA classification). 2% buildings are Unreinforced Masonry (URM as per FEMA classification) and 2% others are wood light frame (W1 as per FEMA classification). Figure 4.4 represents different percentages of buildings found in ward 8. Hence, the C3 type building dominates in the study area.

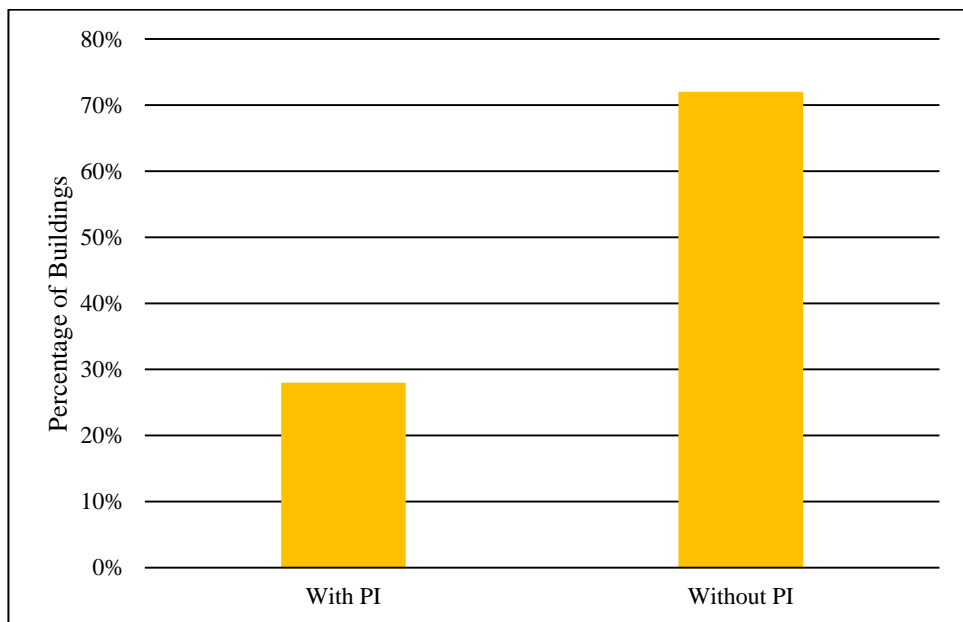
Figure 4.7: Relations between percentage of buildings and plan irregularity

Figure 4.7 represents relation between percentage of buildings and plan irregularity (e.g. torsional irregularity, non-parallel system, reentrant corner, diaphragm opening, out of plane offset). 28% of the buildings have one or more forms of plan irregularity.

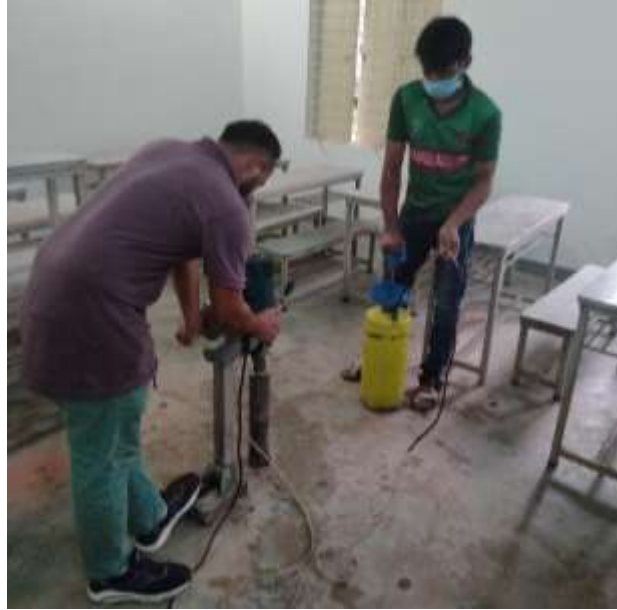
Figure 5.1: Core extraction from slab

Strength of the concrete in the existing beams, columns and slabs has been assessed by extracting concrete core samples. Figure 5.1 shows the extraction of core from the slab. Location of core cutting and their respective strength has been provided in Appendix C. Variations have been observed in the concrete strength derived from tests of the core samples. This may have resulted due to the quality control issue and other uncertainties associated with the core collection and testing (Ahsan et al., 2018). Hence, by applying judgment, concrete strength has judiciously been considered between the lowest and mean value. From these results, concrete compressive strength of 1.5 ksi for slab, column and beam of the building has been used for the structural analysis on finite element software.

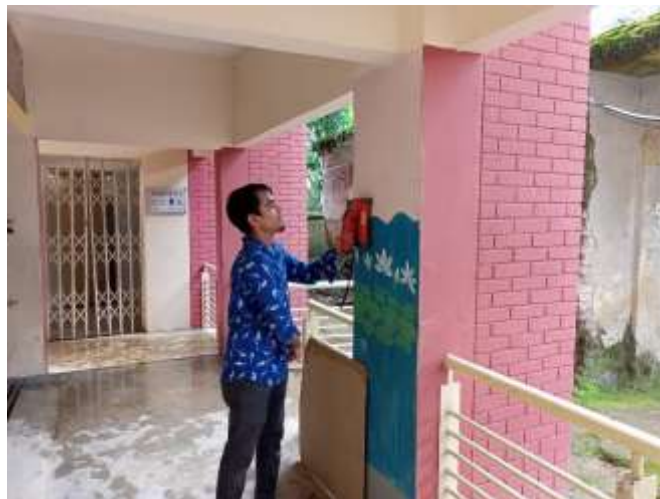
Figure 5.2: Ferro-scanning of a column

Ferro-scan tests of the building have been done to know the number and size of reinforcement in column, slab and beam. All scanned images of the Ferro-scan results are attached in Appendix C. Figure 5.2 shows ferro-scanning from a column.

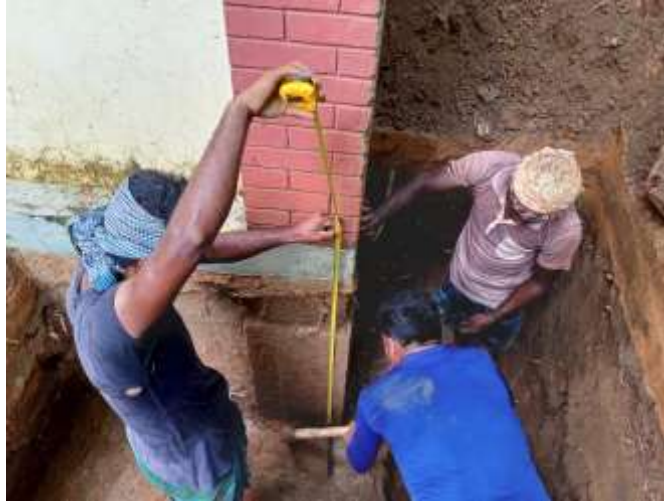
Figure 5.3: Footing excavation

Foundations of the building were checked by excavating the soil. The size, thickness and depth were measured. Figure 5.3 shows the excavation of footing. Footing details have been attached to the drawing as Appendix C.

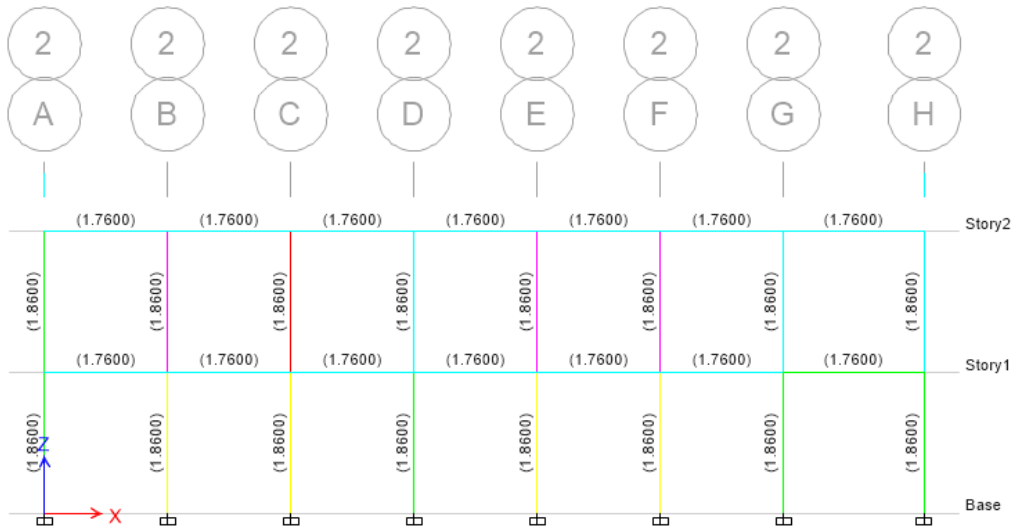
Figure 5.6: Elevation view to identify overstressed columns along (a) 2-ABCDEF GH (b) 4-ABCDEF GH frames

Figure 5.6 identifies the overstressed columns (shown in “Red”) along Frame 2-ABCDEF GH and 4-ABCDEF GH in elevation view. Figure 5.7 identifies the failed beams (shown in “Red”) along the frame E-1234. Thus to use this building in future as a the ward coordination center, retrofitting will inadequate columns and beams will be required.
