Earthquake Contingency Plan for Ward 9, Rangamati Municipality: Volume 2

BUET-Japan Institute of Disaster Prevention and Urban Safety (BUET-JIDPUS)
Department of Urban and Regional Planning
Department of Civil Engineering
Bangladesh University of Engineering and Technology (BUET),
Dhaka-1000, Bangladesh.

**Earthquake Risk Assessment for Developing Contingency
Plans, Training Modules and Awareness Materials for
Rangpur City Corporation and
Tangail, Rangamati and Sunamganj Pourashavas**

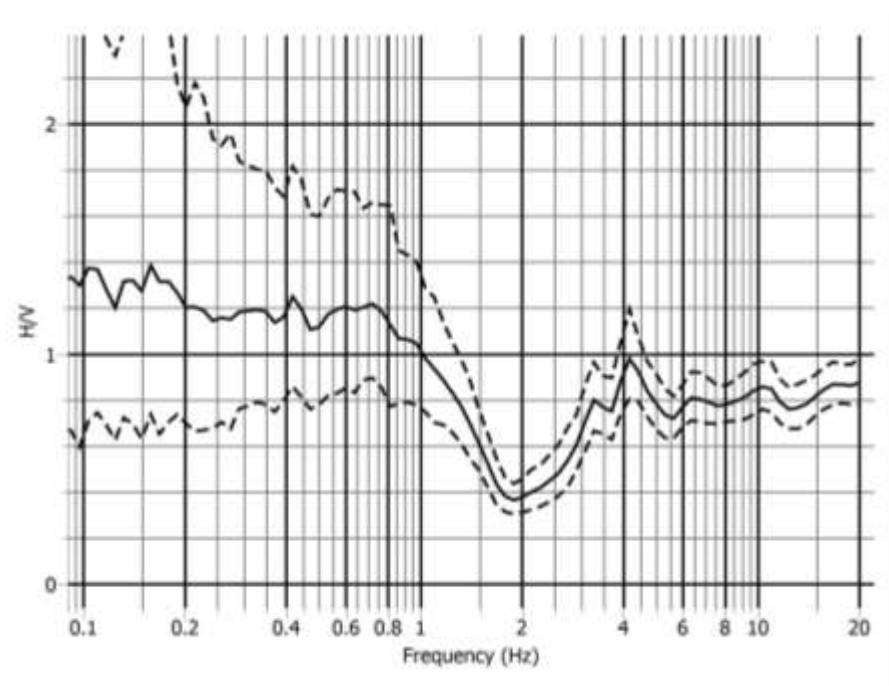
Figure 3.3: Amplitude Ratio vs Frequency graph of Ward no. 9 of Rangamati Paurashava

By dividing the horizontal component (vibrations recorded in N-S and E-W directions) by the vertical component (vibrations recorded in Up-Down direction) we obtained the amplitude. All the graphs have been smoothed by averaging 20 data points and considering it as a single point in the graph. This was repeated for 25 sections and the geometric average of the amplitude ratios was taken to finally plot the Amplitude ratio vs Frequency (Hz) graph.

Figure 3.3 shows the Amplitude ratio vs Frequency graph for Ward 9 of Rangamati Paurashava. From the graph we can observe that the amplitude ratio is maximum at around 4.0 Hz. The frequency at which the amplitude ratio shows a prominent peak is considered to be the predominant/natural frequency of the soil at that location. So, the predominant frequency is around 4.0 Hz. The predominant period is 0.25s. Using empirical equations along with the soil profile obtained from the bore holes, the shear wave velocity of the 30 meter 1-D soil column was found to be around 149.48 m/s (Bore hole-1) and 140.02 m/s (Bore hole-2).

According to the soil classification (FEMA 2017), the soil class is D. From the microtremor analysis, the natural frequency of the soil is found to be around 4.0 Hz, and the shear wave velocity is around 149.48 m/s (Bore hole-1) and 140.02 m/s (Bore hole-2). These data will be used further to determine index and engineering properties of soil along with the determination of liquefaction potential.

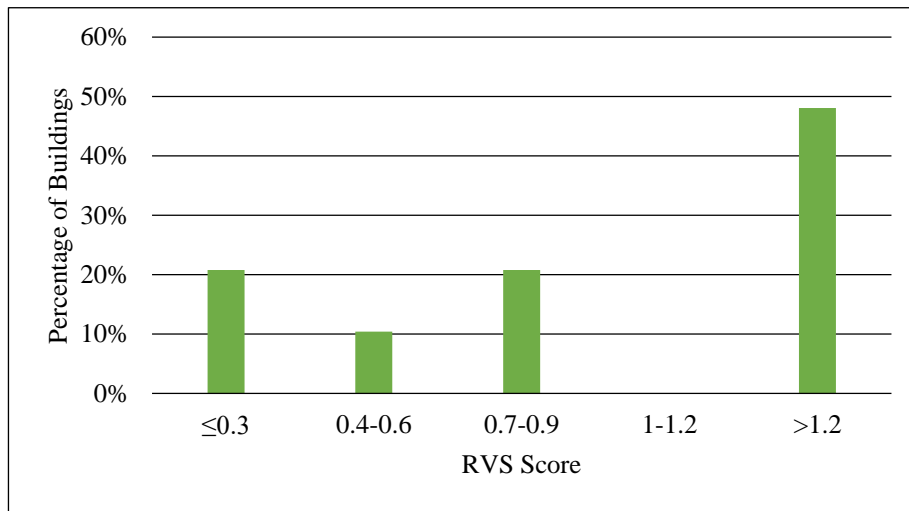
Figure 4.1: Relations between percentage of buildings and RVS score of ward no. 9

between 0.7 to 0.9, and finally 48% buildings have a score greater than 1.2. Thus, 48% of buildings can be marked as safe during an earthquake.

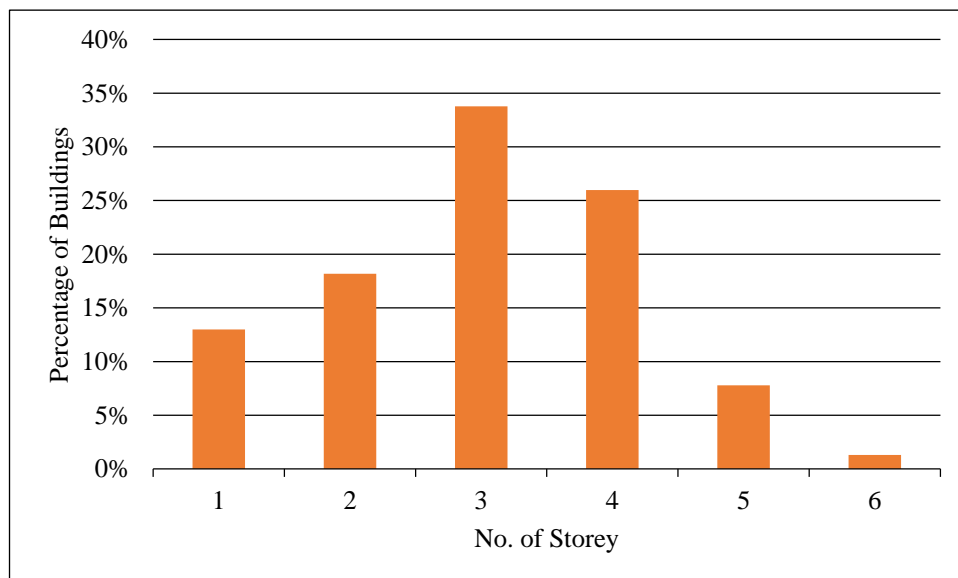
Figure 4.2: Relations between the percentage of buildings and total no. of story of Ward no. 9

Figure 4.2 shows the percentage of buildings against the total number of stories. It was observed that 3 story buildings (including above and below grade) are dominating in this ward and it is 34% of the total sample size. 4 story and 2 story buildings comprise 26% and 18% of the total surveyed buildings, respectively. 13% of the buildings are 1 storied and 8% are 5 storied. Only 1% of buildings are above 5 story.

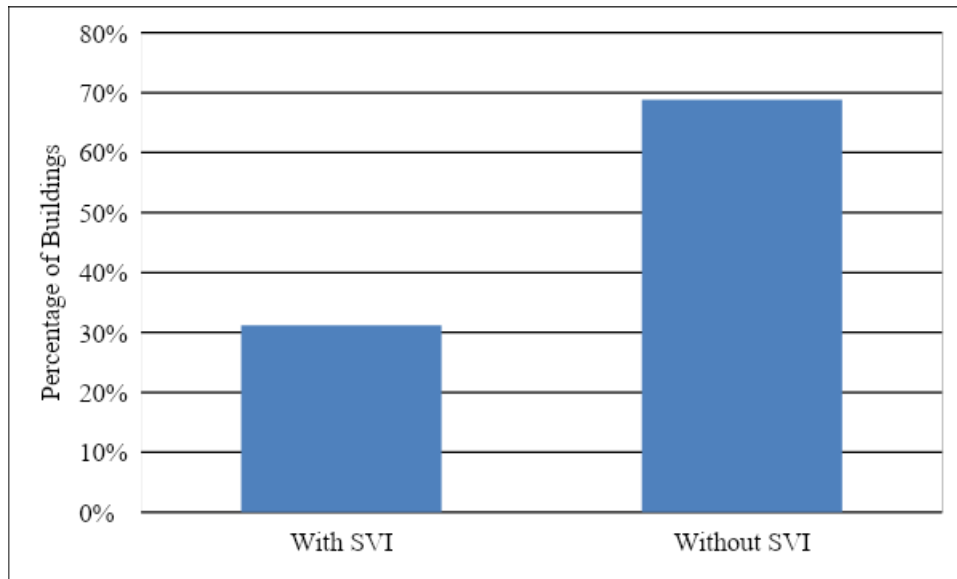
Figure 4.4: Relations between percentage of buildings and severe vertical irregularity

Figure 4.4 represents relation between percentage of buildings and severe vertical irregularity which include any or a combination of the following: short column, soft story/weak story and out of plane setback. It has been observed that 31% of the buildings that were surveyed have severe vertical irregularity.

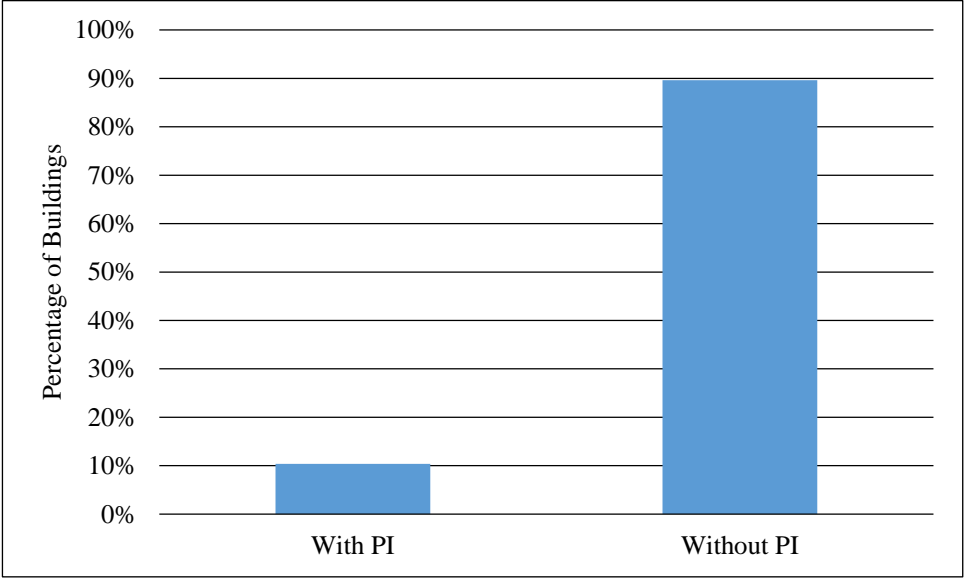
Figure 4.6: Relations between percentage of buildings and plan irregularity

Figure 4.6 shows the percentage of buildings against plan irregularity (e.g. torsional irregularity, non-parallel system, reentrant corner, diaphragm opening, out of plane offset). 10% of the buildings have one or more forms of plan irregularity.

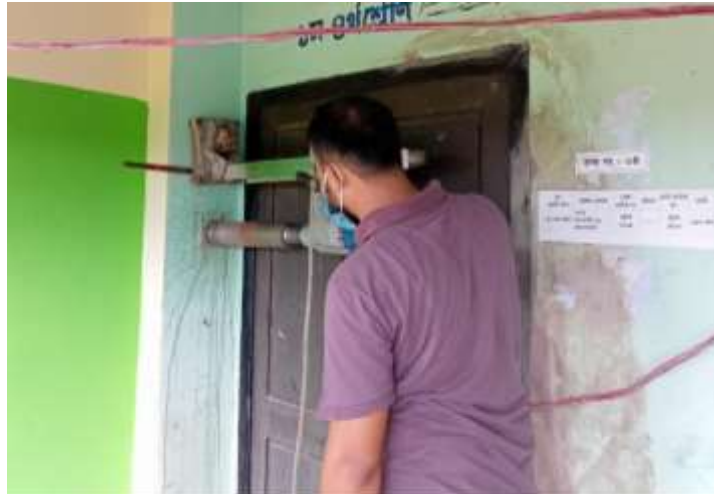
Figure 5.1: Core extraction from a column

Strength of the concrete in the existing beams, columns and slabs has been assessed by extracting concrete core samples. Figure 5.1 shows the extraction of core from a column. Location of core cutting and their respective strength has been provided in Appendix C. Variations have been observed in the concrete strength derived from tests of the core samples. This may have resulted due to the quality control issue and other uncertainties associated with the core collection and testing (Ahsan et al., 2018). Hence, by applying judgment, concrete strength has judiciously been considered between the lowest and mean value. From these results, concrete compressive strength of 1.2 ksi for slab, column and beam of the building has been used for structural analysis.

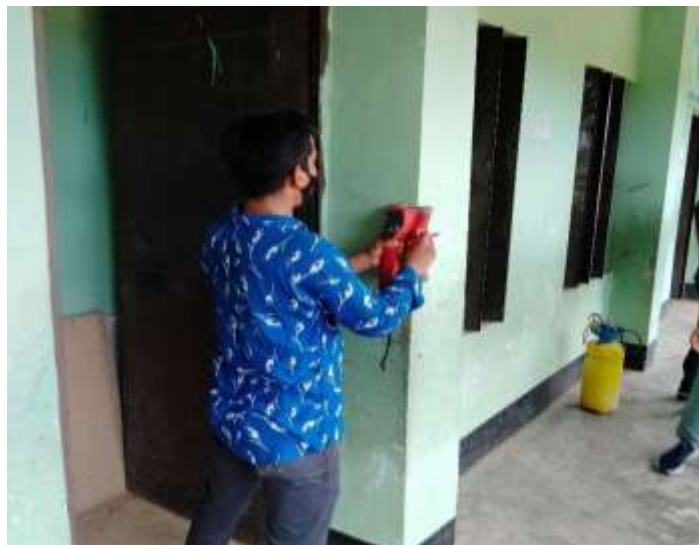
Figure 5.2: Ferro-scanning of a column

Ferro-scan tests of the building have been done to know the number and size of reinforcement in column, slab and beam. All scanned images of the Ferro-scan results are attached in Appendix C. Figure 5.2 shows ferro-scanning from a column.

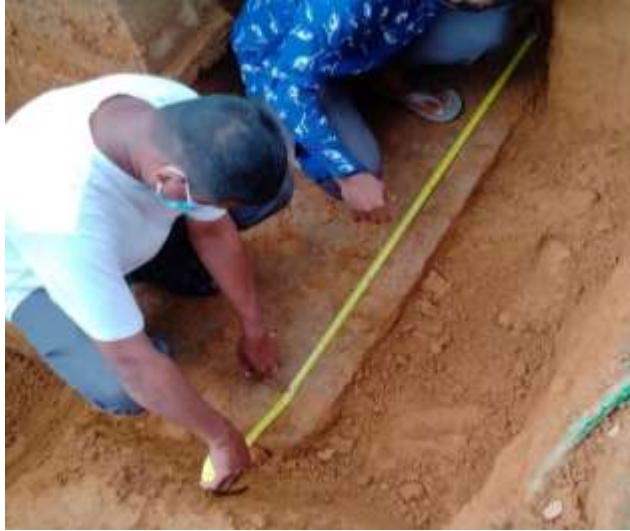
Figure 5.3: Footing excavation

Foundations of the building were checked by excavating the soil. The size, thickness and depth were measured. Figure 5.3 shows the excavation of footing. Footing details have been attached to the drawing as Appendix C.

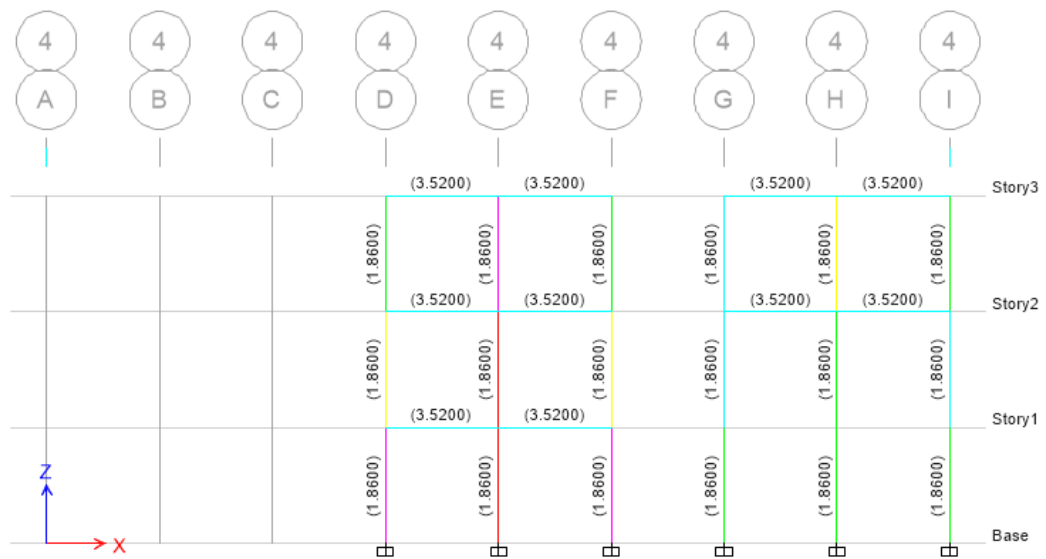
Figure 5.6 (a-d) depicts the failed columns along different frames in elevation view. Thus to use this building in future as a temporary shelter, retrofitting of inadequate columns will be required.

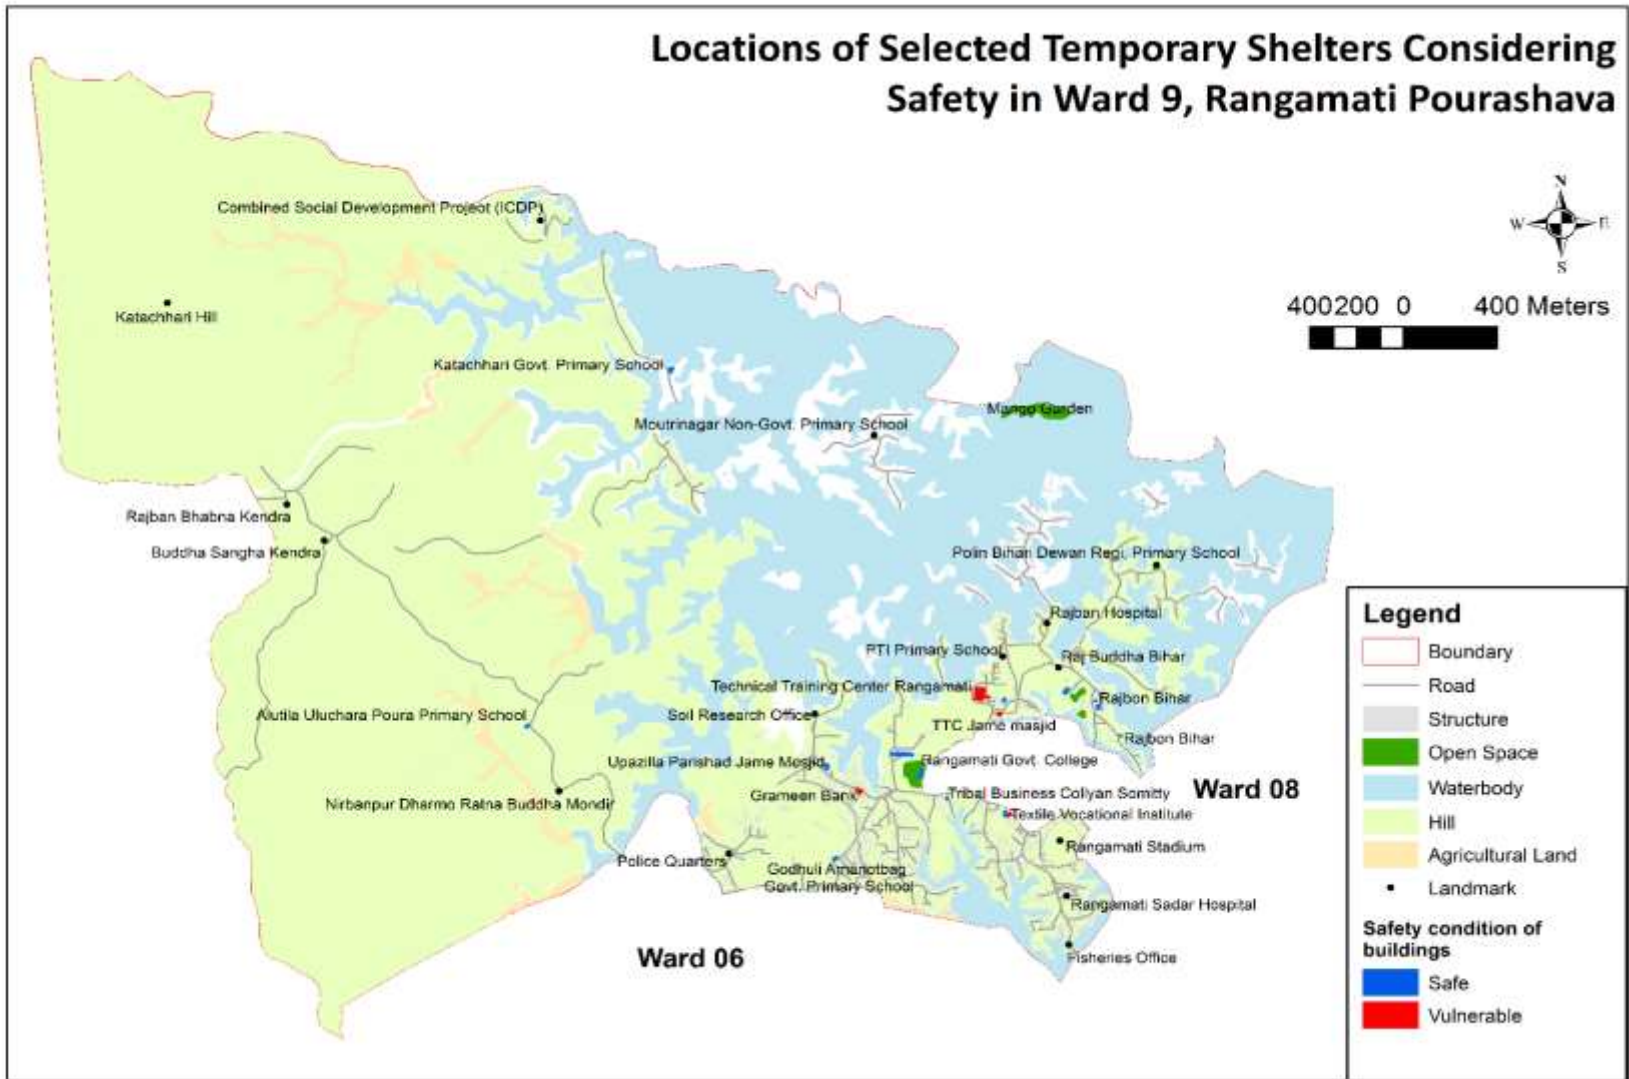
Figure 7.2: Location of possible temporary shelter in the study area considering safety

(Source: Field Survey, 2021)

Among the facility buildings identified to be used for temporary shelter, some are structurally vulnerable (with RVS score less than 1.2) which cannot be utilized as temporary shelter. Figure 7.2 shows the locations of possible temporary shelters in the study area considering safety of public buildings. Table 7.1 shows the supply scenario
