# Earthquake Contingency Plan for Ward 16, Rangpur City Corporation: Volume 2

BUET-Japan Institute of Disaster Prevention and Urban Safety (BUET-JIDPUS)  
Department of Urban and Regional Planning  
Department of Civil Engineering  
Bangladesh University of Engineering and Technology (BUET),  
Dhaka-1000, Bangladesh.

**Earthquake Risk Assessment for Developing Contingency  
Plans, Training Modules and Awareness Materials for  
Rangpur City Corporation and  
Tangail, Rangamati and Sunamganj Pourashavas**

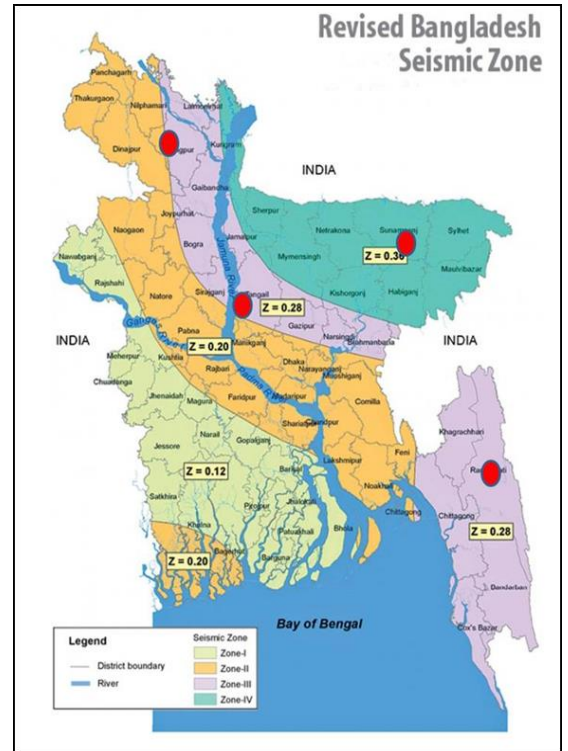
Figure 1.1: Proximity of study area to major fault lines (Source: Akhter, 2010)      Figure 1.2: Revised Seismic Zoning of Bangladesh (Source: HBRI, 2015)

According to Revised Seismic Zoning Map of BNBC Rangpur belongs to Seismic Zone 3 (Figure 1.2). The geotechnical and geophysical investigation under CDMP II shows that almost total city corporation area is consist of soil which is dense or stiff which has a high liquefaction susceptibility as Peak Ground Acceleration value ranges between 0.3-0.38 which has been illustrated in Figure 1.3 (CDMP, 2015).

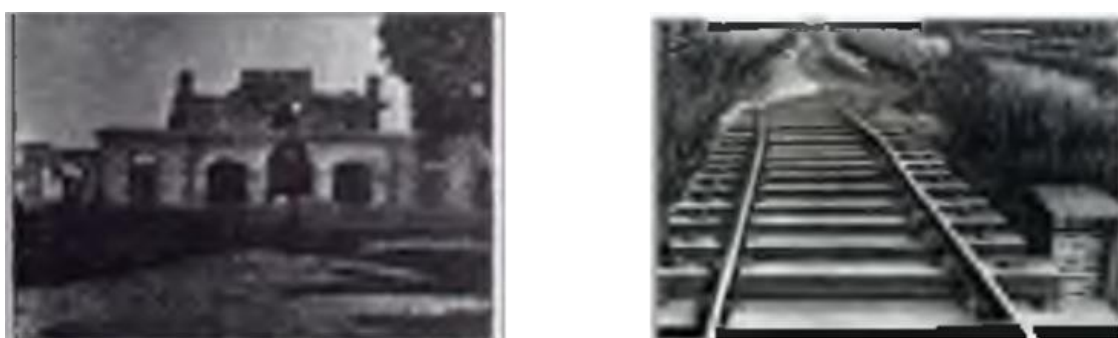
Figure 1.4: Damage of building in 1897 earthquake and damage of rail track in 1997 earthquake

It is evident that Rangpur faced a huge damage in the Great Indian Earthquake in 1897. Some old and historical building got collapsed (Figure: 1.4). Dhubri Earthquake (1930) with a magnitude of 7.1 and the epicenter at Dhubri, Assam caused major damage in the eastern parts of Rangpur district. Some rail track at Rangpur got damaged as the effect of 1997 earthquake (Figure: 1.4).

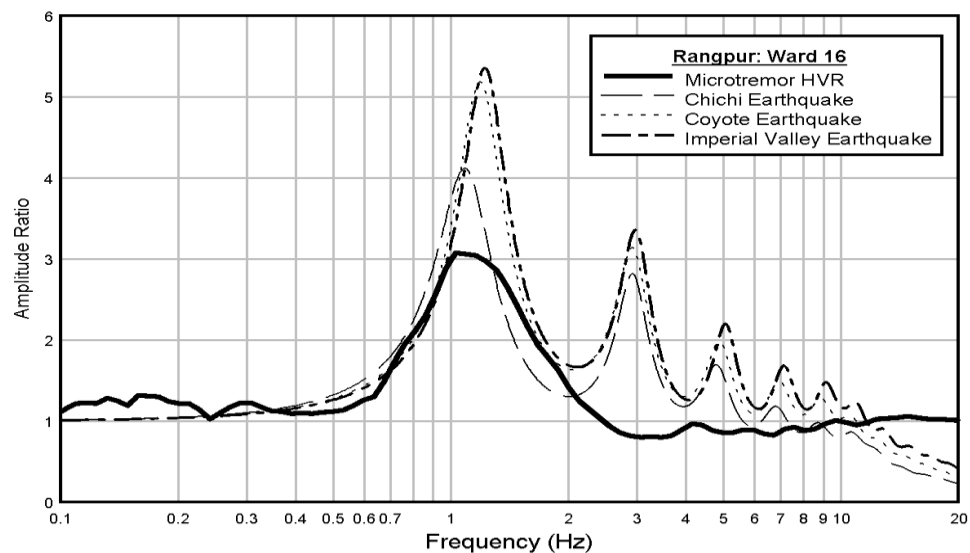
Figure 3.3: Amplitude Ratio vs Frequency graph of Ward no. 16 of Rangpur City Corporation

By dividing the horizontal component (vibrations recorded in N-S and E-W directions) by the vertical component (vibrations recorded in Up-Down direction) we obtained the amplitude ratio. All the graphs have been smoothed by averaging 20 data points and considering it as a single point in the graph. This was repeated for 25 sections and the geometric average of the amplitude ratios was taken to finally plot the Amplitude ratio vs Frequency (Hz) graph.

From the graph we can observe that the amplitude ratio is maximum at around 1 Hz. The frequency at which the amplitude ratio shows a prominent peak is considered to be the predominant/natural frequency of the soil at that location. So, the predominant frequency is around 1 Hz. The predominant period is 1s. The Peak Ground Acceleration (PGA) at the surface for Ward no. 16 was obtained as 0.35g. Using an empirical equation, the shear wave velocity of the 30 meter 1-D soil column was found to be around 130 m/s.

analysis, the natural frequency of the soil is found to be around 1.09 Hz, and the shear wave velocity is around 130 m/s. These data will be used further to determine index and engineering properties of soil along with the determination of liquefaction potential.

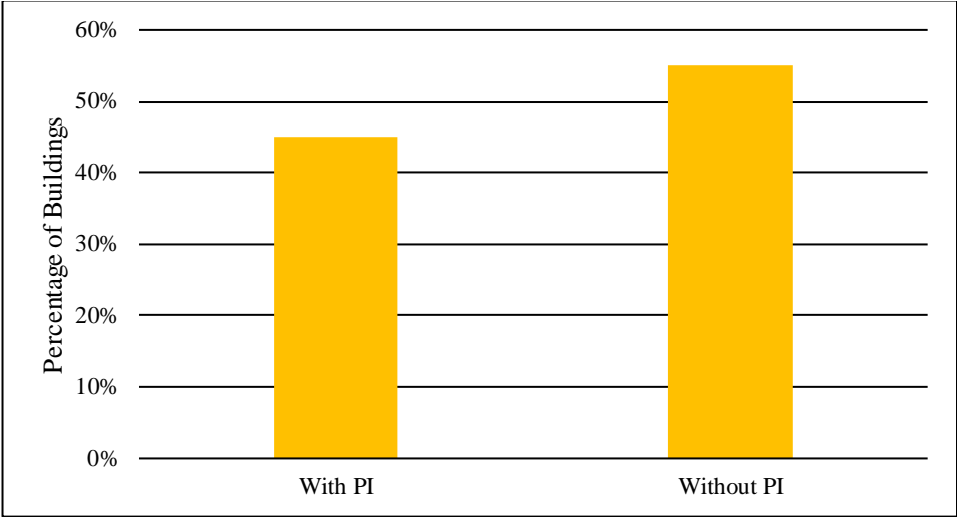
Figure 4.6: Relations between percentage of buildings and Plan Irregularity

Figure 4.6 represents the relation between percentage of buildings and plan irregularity (e.g. torsional irregularity, non-parallel system, reentrant corner, diaphragm opening, out of plane offset). 45% of the buildings have plan irregularities.

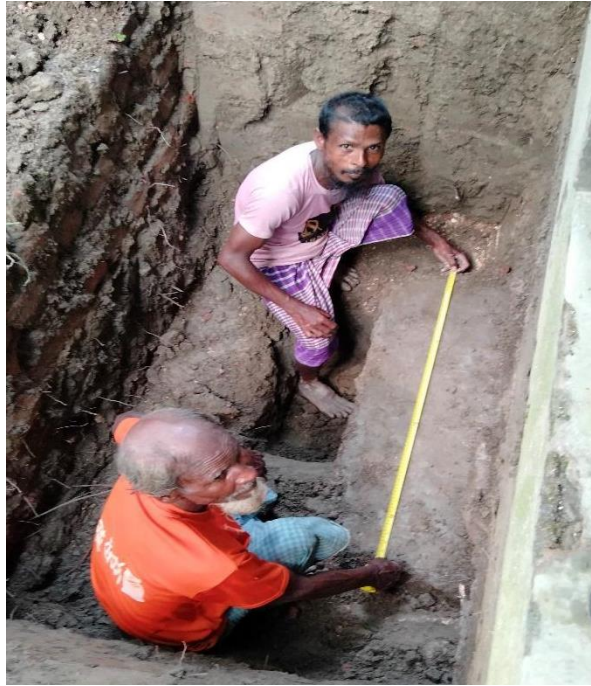
Figure 5.1: Footing excavation

Foundation of the building was checked by excavating the soil. The size, thickness and depth were measured. Figure 5.1 shows the excavation of footing. Footing details have been attached in Appendix C.

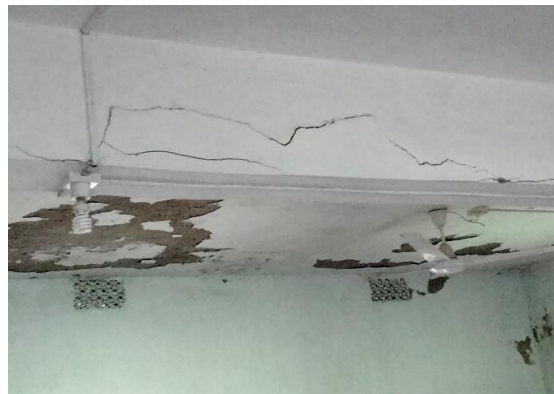
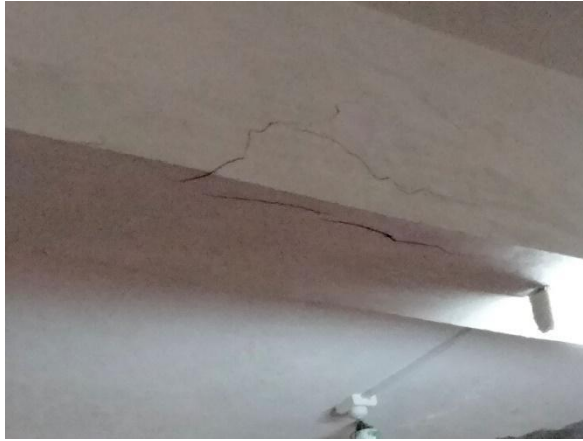
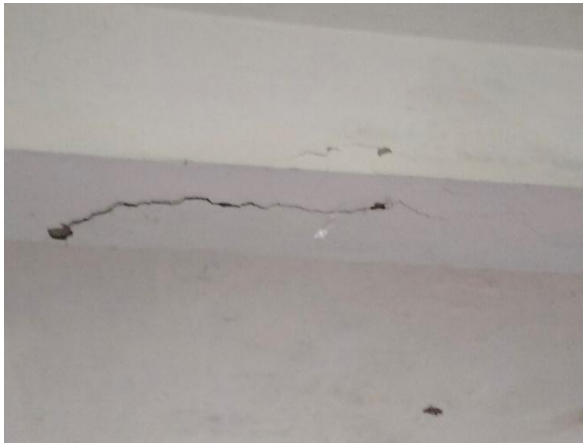
Figure 5.5: Cracks found from the visual assessment of the building

Cracks were also visible along the beam during the inspection of the building. This also supports the results of FEM analysis. Figure 5.5 shows the cracks found on the beam during the inspection.

These cracks may also arise due to the corrosion of reinforcement which eventually resulted in the spalling. However, from the analysis it is concluded that corner columns and beams are overstressed due to the considered loading conditions; hence the building will be vulnerable during earthquakes. To use this structure as a ward coordination center adequate retrofitting needs to be performed.
