Earthquake Contingency Plan for Ward 18, Rangpur City Corporation: Volume 2

BUET-Japan Institute of Disaster Prevention and Urban Safety (BUET-JIDPUS)
Department of Urban and Regional Planning
Department of Civil Engineering
Bangladesh University of Engineering and Technology (BUET),
Dhaka-1000, Bangladesh.

**Earthquake Risk Assessment for Developing Contingency
Plans, Training Modules and Awareness Materials for
Rangpur City Corporation and
Tangail, Rangamati and Sunamganj Pourashavas**

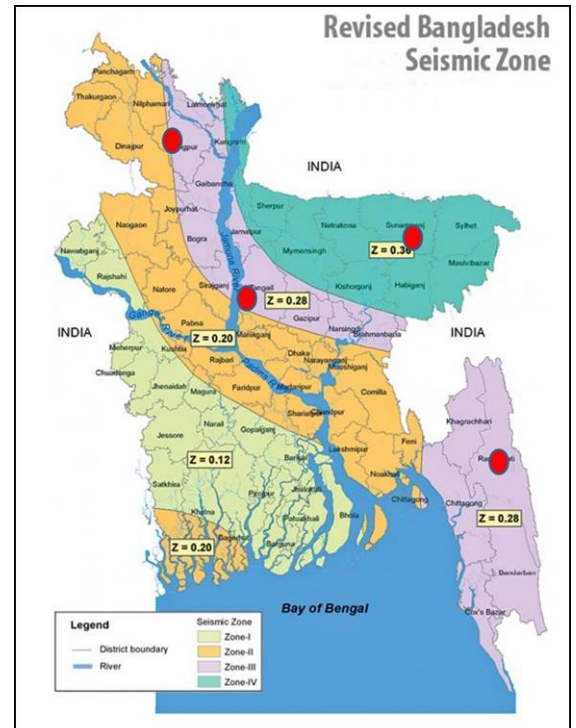
Figure 1.2: Revised Seismic Zoning of Bangladesh

According to Revised Seismic Zoning Map of BNBC Rangpur belongs to Seismic Zone 3 (Figure 1.2). The geotechnical and geophysical investigation under CDMF II shows that almost total city corporation area is consist of soil which is dense or stiff which has a high liquefaction susceptibility as Peak Ground Acceleration value ranges between 0.3-0.38 which has been illustrated in Figure 1.3 (CDMP, 2015).

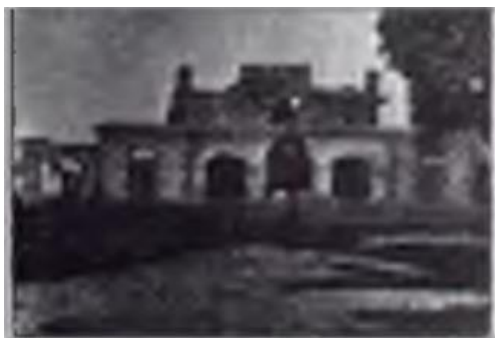
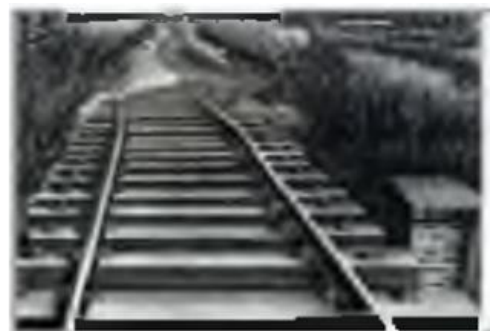
Figure 1.4: Damage of building in 1897 earthquake and damage of rail track in 1997 earthquake

It is evident that Rangpur faced a huge damage in the Great Indian Earthquake in 1897. Some old and historical building got collapsed (Figure: 1.4). Dhubri Earthquake (1930) with a magnitude of 7.1 and the epicenter at Dhubri, Assam caused major damage in the eastern parts of Rangpur district. Some rail track at Rangpur got damaged as the effect of 1997 earthquake (Figure: 1.4).

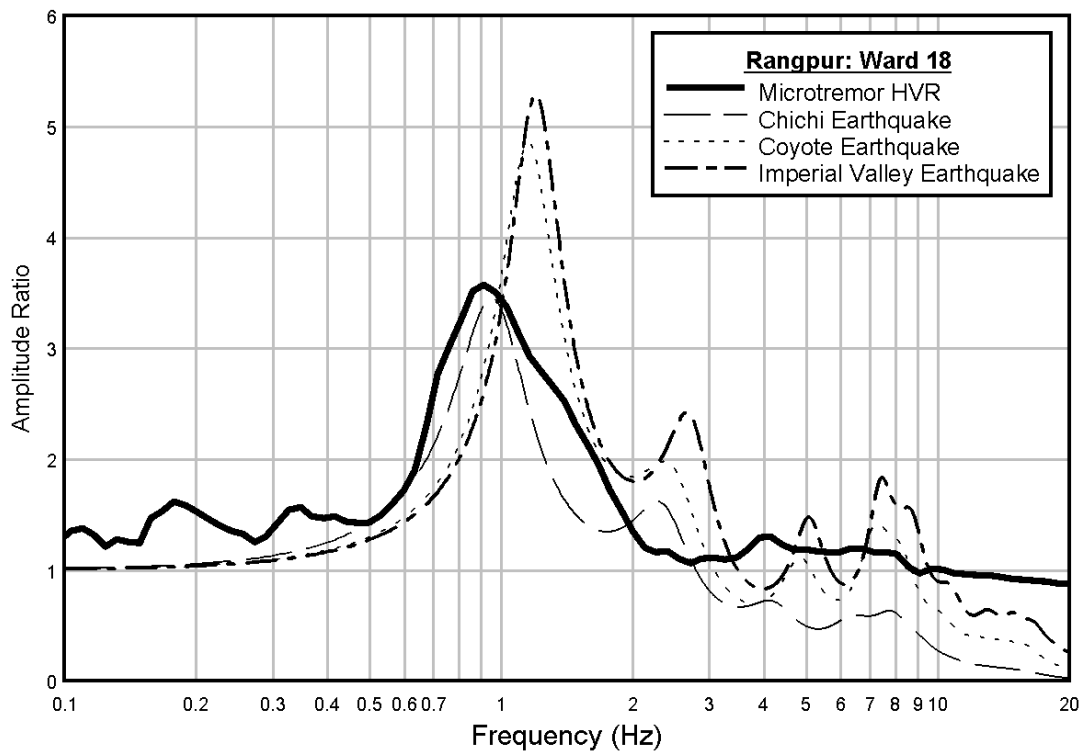
Figure 3.3: Amplitude vs Frequency graph of Ward no. 18 of Rangpur City Corporation

By dividing the horizontal component (vibrations recorded in N-S and E-W directions) by the vertical component (vibrations recorded in Up-Down direction) we obtained the amplitude ratio. All the graphs have been smoothed by averaging 20 data points and considering it as a single point in the graph. This was repeated for 25 sections and the geometric average of the amplitude ratios was taken to finally plot the Amplitude Ratio vs Frequency (Hz) graph.

From the graph we can observe that the amplitude ratio is maximum at around 0.90 Hz. The frequency at which the amplitude ratio shows a prominent peak is considered to be the predominant/natural frequency of the soil at that location. So, the predominant frequency is around 0.9 Hz. The predominant period is 1.12 second. The Peak Ground Acceleration (PGA) at the surface for Ward no. 18 was obtained as 0.33g. Using an empirical equation, the shear wave velocity of the 30 meter 1-D soil column was found to be around 120 m/s.

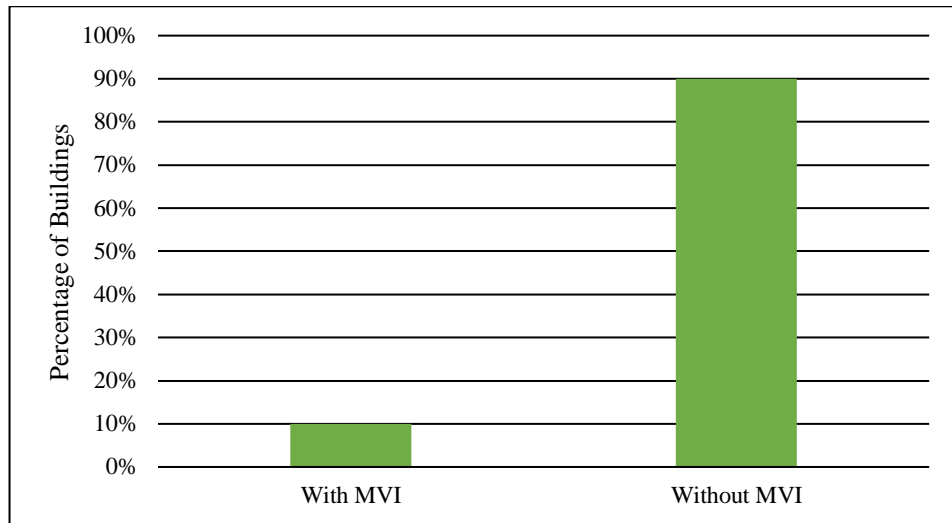
Figure 4.5: Relations between percentage of buildings and Moderate Vertical Irregularity

Figure 4.5 represents relation between percentage of buildings and moderate vertical irregularity (e.g. in plane setback, sloping site, split level). It is found that only 10% of the buildings have moderate vertical irregularity.

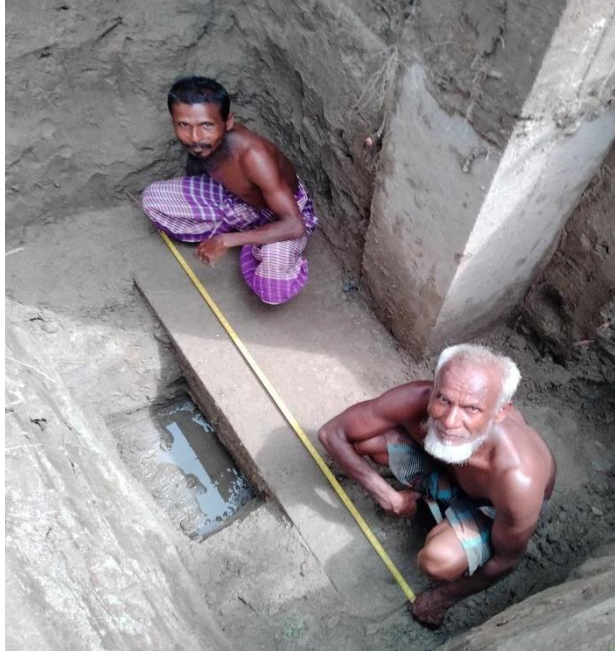
Figure 5.1: Excavation of footing

Foundation of the building was checked by excavating the soil. The size, thickness and depth were measured. Figure 5.1 shows the excavation of footing. Footing details have been attached to the drawing as Appendix C.

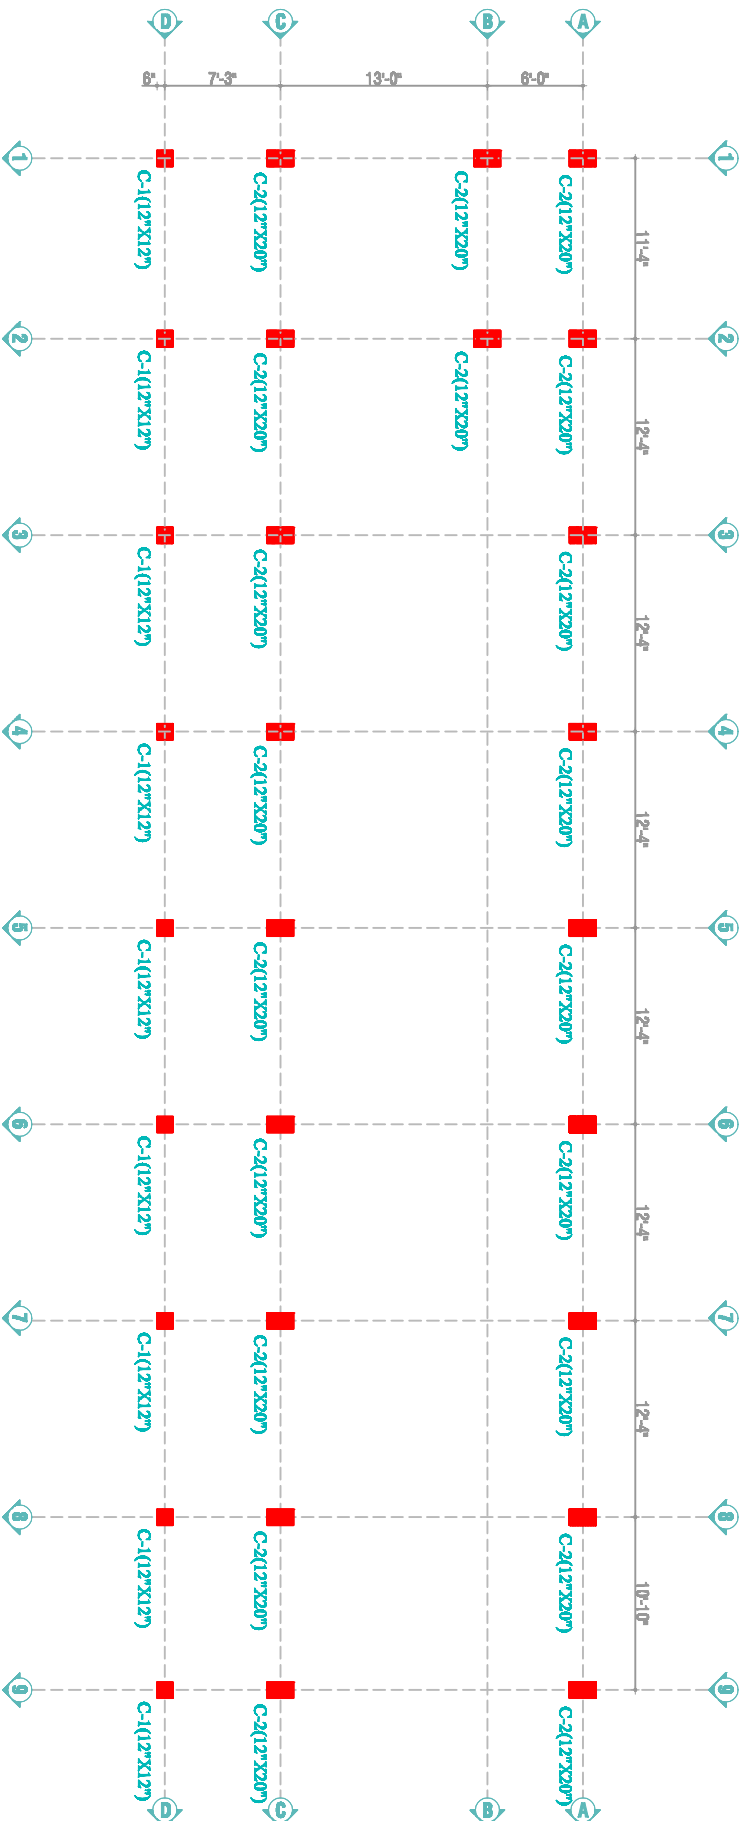
COLUMN LAYOUT (TYPICAL)
SCALE: N T S

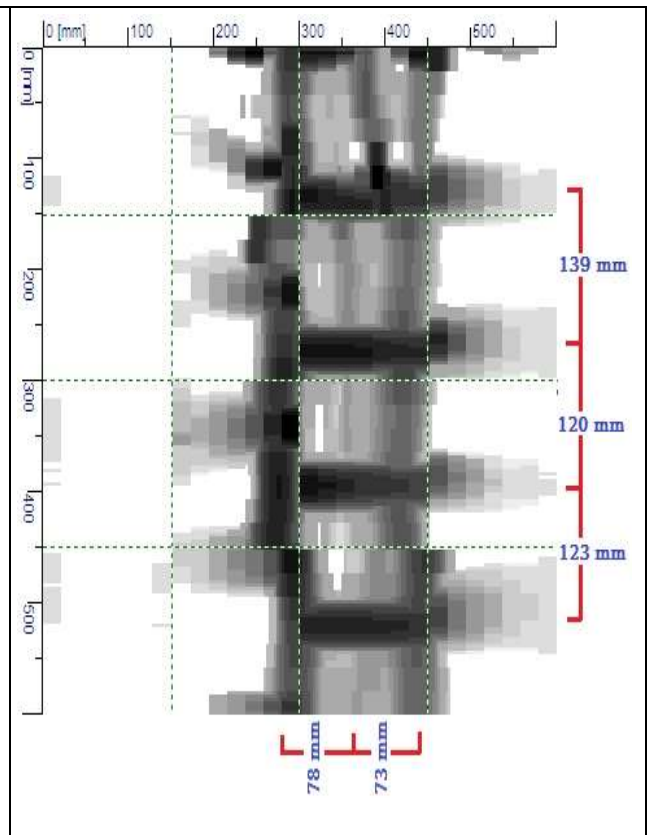
Figure E-14: Image scan of beam GF-B1 (bottom)
