Earthquake Contingency Plan for Ward 19, Rangpur City Corporation: Volume 2

BUET-Japan Institute of Disaster Prevention and Urban Safety (BUET-JIDPUS)
Department of Urban and Regional Planning
Department of Civil Engineering
Bangladesh University of Engineering and Technology (BUET),
Dhaka-1000, Bangladesh.

**Earthquake Risk Assessment for Developing Contingency
Plans, Training Modules and Awareness Materials for
Rangpur City Corporation and
Tangail, Rangamati and Sunamganj Pourashavas**

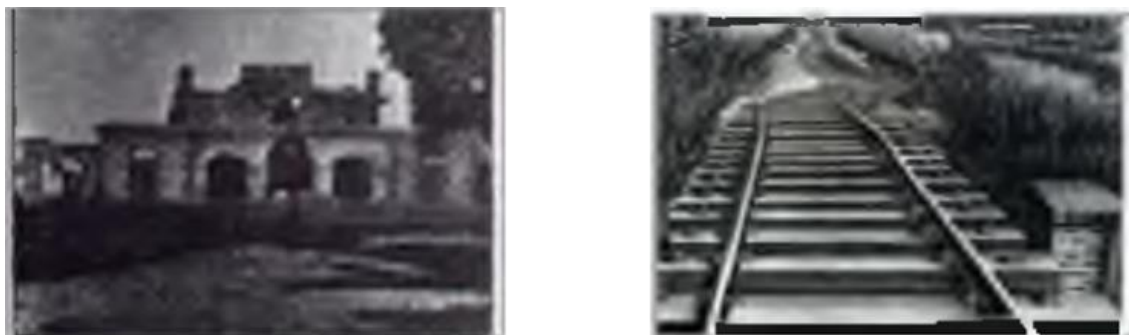
Figure 1.4: Damage of building in 1897 earthquake and damage of rail track in 1997 earthquake

It is evident that Rangpur faced a huge damage in the Great Indian Earthquake in 1897. Some old and historical building got collapsed (Figure: 1.4). Dhubri Earthquake (1930) with a magnitude of 7.1 and the epicenter at Dhubri, Assam caused major damage in the eastern parts of Rangpur district. Some rail track at Rangpur got damaged as the effect of 1997 earthquake (Figure: 1.4).

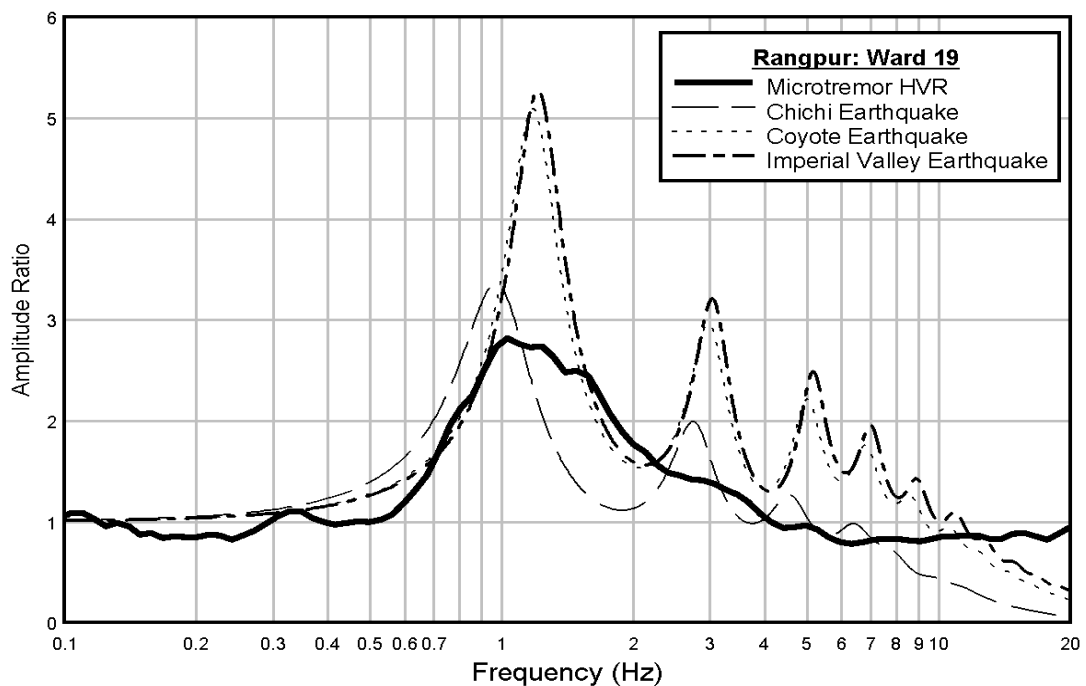
Figure 3.3: Amplitude vs Frequency graph of Ward no. 19 of Rangpur City Corporation

By dividing the horizontal component (vibrations recorded in N-S and E-W directions) by the vertical component (vibrations recorded in Up-Down direction) we obtained the amplitude ratio. All the graphs have been smoothed by averaging 20 data points and considering it as a single point in the graph. This was repeated for 25 sections and the geometric average of the amplitude ratios was taken to finally plot the Amplitude Ratio vs Frequency (Hz) graph.

From the graph we can observe that the amplitude ratio is maximum at around 1.0 Hz. The frequency at which the amplitude ratio shows a prominent peak is considered to be the predominant/natural frequency of the soil at that location. So, the predominant frequency is around 1.0 Hz. The predominant period is also 1.0 second. The Peak Ground Acceleration (PGA) at the surface for Ward no. 19 was obtained as 0.36g. Using an empirical equation, the shear wave velocity of the 30 meter 1-D soil column was found to be around 144 m/s.

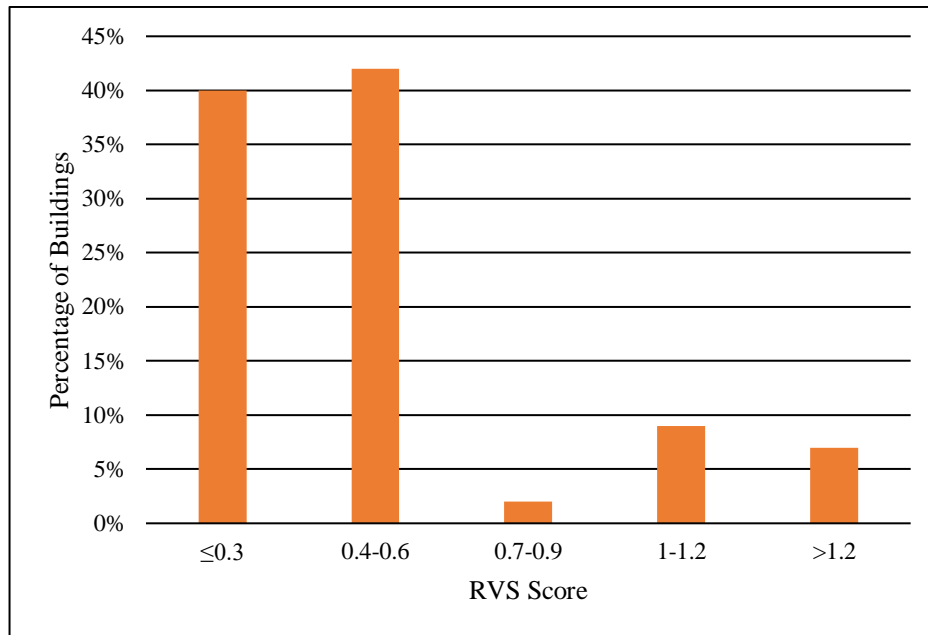
Figure 4.1: Relations between percentage of buildings and RVS Score of Ward no 19

Figure 4.1 represents relations between percentage of buildings and the RVS score. This figure indicates that 40% of the buildings has a score less than or equal 0.3, 42% of the buildings has a score between 0.4 to 0.6, 2% of the buildings score in between 0.7 to 0.9, 9% of the buildings has a score in between 1 to 1.2 and finally 7% of the buildings has score greater than 1.2. These 7% can be marked safe during earthquakes.

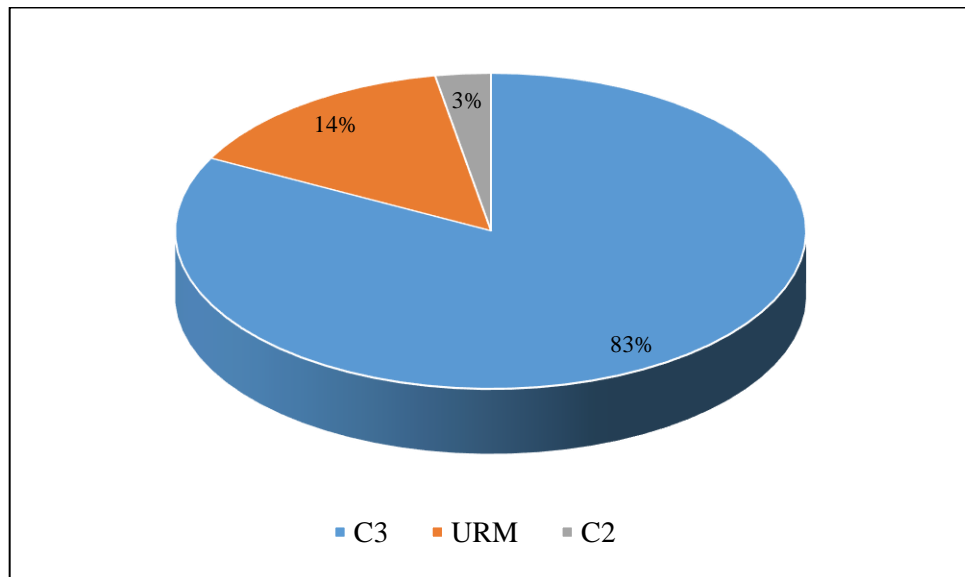
Figure 4.3: Building Classification percentage of Ward 19

It was found that among the 284 surveyed buildings, 235 buildings are Concrete frame with unreinforced masonry infill walls (C3 as per FEMA classification). 40 of the buildings are Unreinforced masonry (URM as per FEMA classification) and only 9 of them are Concrete shear wall buildings (C2 as per FEMA classification). Figure 4.3 shows the percentages of the different building types.

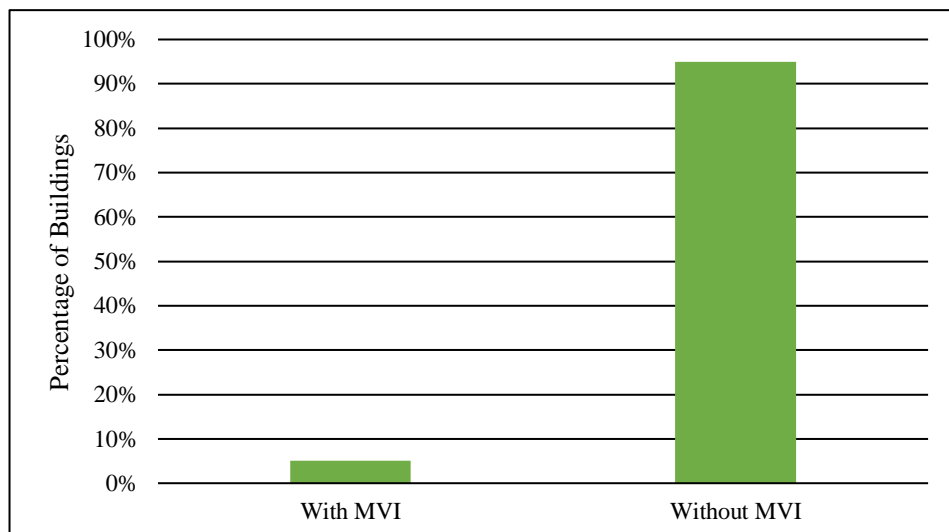
Figure 4.5: Relations between percentage of buildings and Moderate Vertical Irregularity

Figure 4.5 represents relation between percentage of buildings and moderate vertical irregularity (e.g. in plane setback, sloping site, split level). It is found that only 5% of the buildings have moderate vertical irregularity.

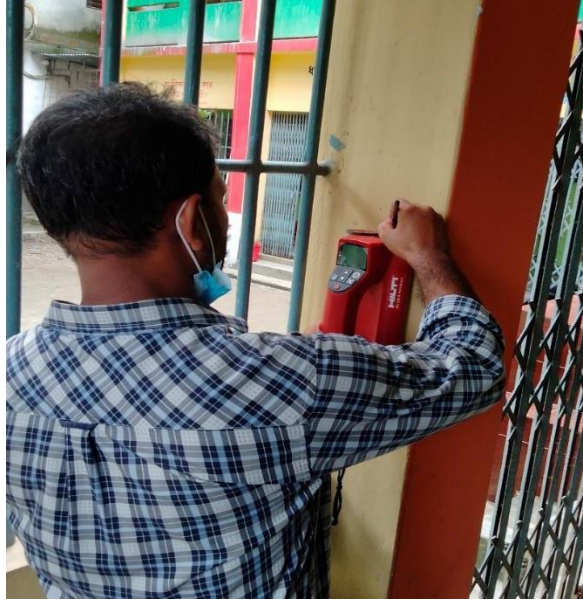
Figure 5.1: Ferro-scanning of a column

Ferro-scan tests on the different structural members of the building have been done to know the number and size of reinforcement in those. All scanned images of reinforcement layout are attached in Appendix C. Figure 5.1 shows ferro-scanning of a column.
