Earthquake Contingency Plan for Ward 4, Sunamganj Municipality: Volume 2

BUET-Japan Institute of Disaster Prevention and Urban Safety (BUET-JIDPUS)
Department of Urban and Regional Planning
Department of Civil Engineering
Bangladesh University of Engineering and Technology (BUET),
Dhaka-1000, Bangladesh.

Earthquake Risk Assessment for Developing Contingency Plans, Training Modules and Awareness Materials for Rangpur City Corporation and Tangail, Rangamati and Sunamganj Pourashavas

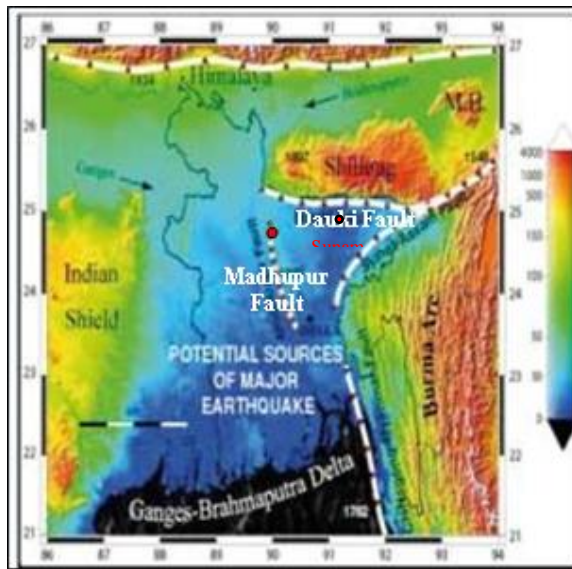
Figure 1.1: Proximity of study area to major fault lines
(Source: Akhter, 2010)

Sunamganj is located at a vulnerable seismic zone near the Dauki fault (Figure 1.1). According to the Revised Seismic Zoning Map of BNBC, Sunamganj belongs to Seismic Zone 3 (Figure 1.2).

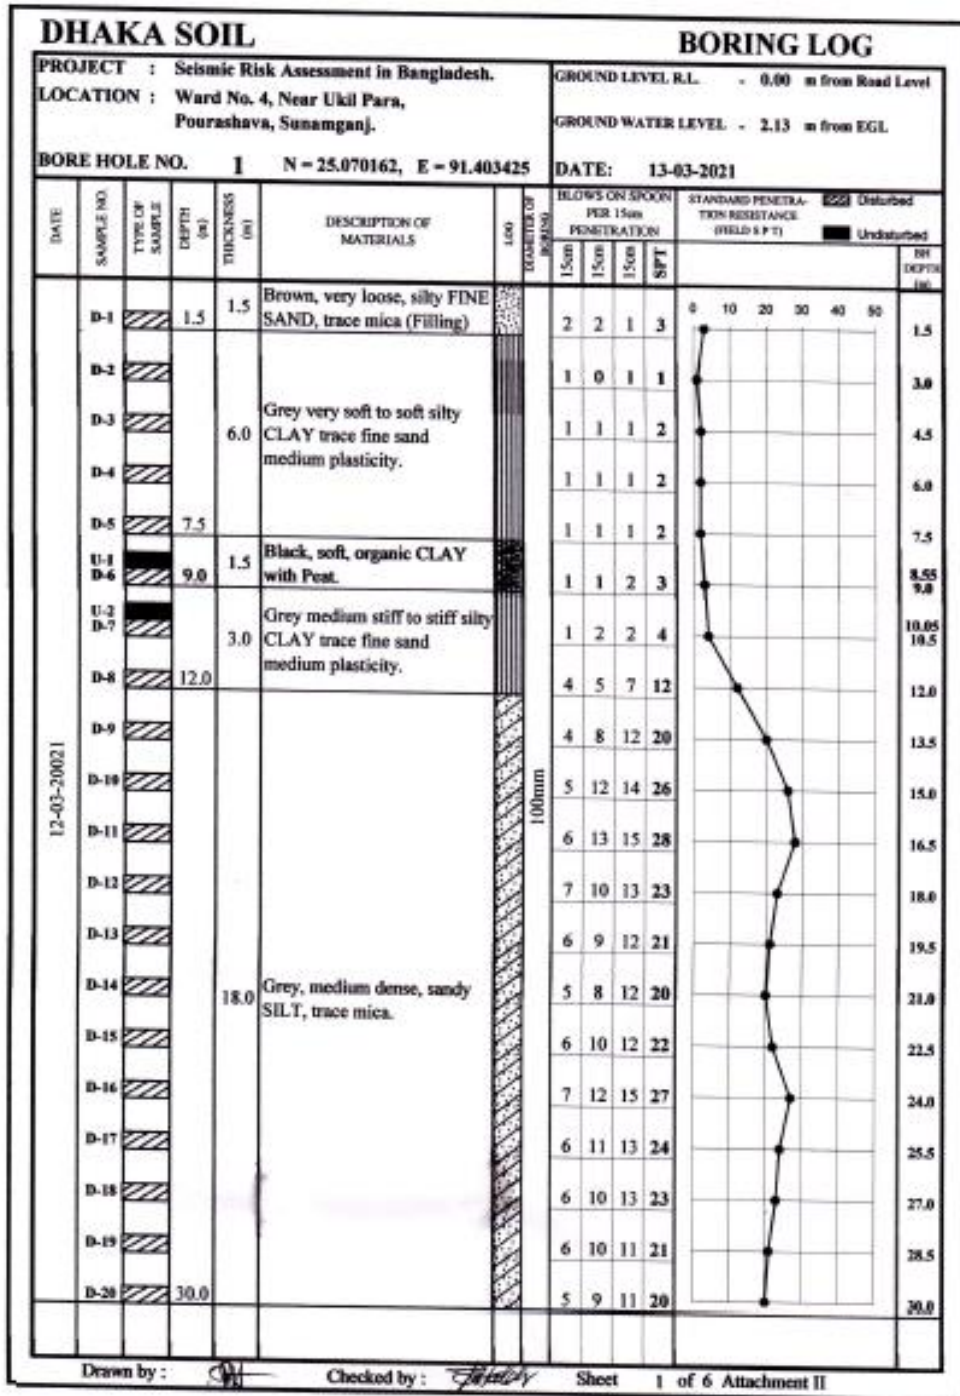
Figure 3.1: SPT data of Bore Hole 1 of Ward 4

In order to determine the seismic hazard of ward no. 4, two Standard Penetration Tests have been done. From these, it has been observed the soil profile of borehole 1 shows five different layers of soil where the N value up to 10.5m is less than 5. Moreover, a layer of organic clay with peat was located from 7.5m to 9m. The SPT-N value increases beyond 10.5 and reaches a maximum of 28 at 16.5m. As the depth increases further, the N value remains within 20 to 24, with an exception at 24m where the value becomes 27. On the other hand, the soil profile of bore hole 2 also shows five layers of soil. However, no organic soil was detected in this borehole. Up to 7.5m, the SPT-N value remains below 5 resulting in low soil strength. The SPT-N value increases beyond this depth with occasional fluctuation and reaches at a value higher than 20 (N=24) at 18m. At the last layer of medium dense sandy silt, the N values stay mostly steady among 18-24. However, the maximum value of 26 is obtained at 27 m. According to the soil classification (FEMA 2017), the soil class is D. From the microtremor analysis, the natural frequency of the soil is found to be around 4.5 Hz, and the shear wave velocity is around 129.05 m/s (Bore hole-1) and 130.78 m/s (Bore hole-2). These data will be used further to determine index and engineering properties of soil along with the determination of liquefaction potential.

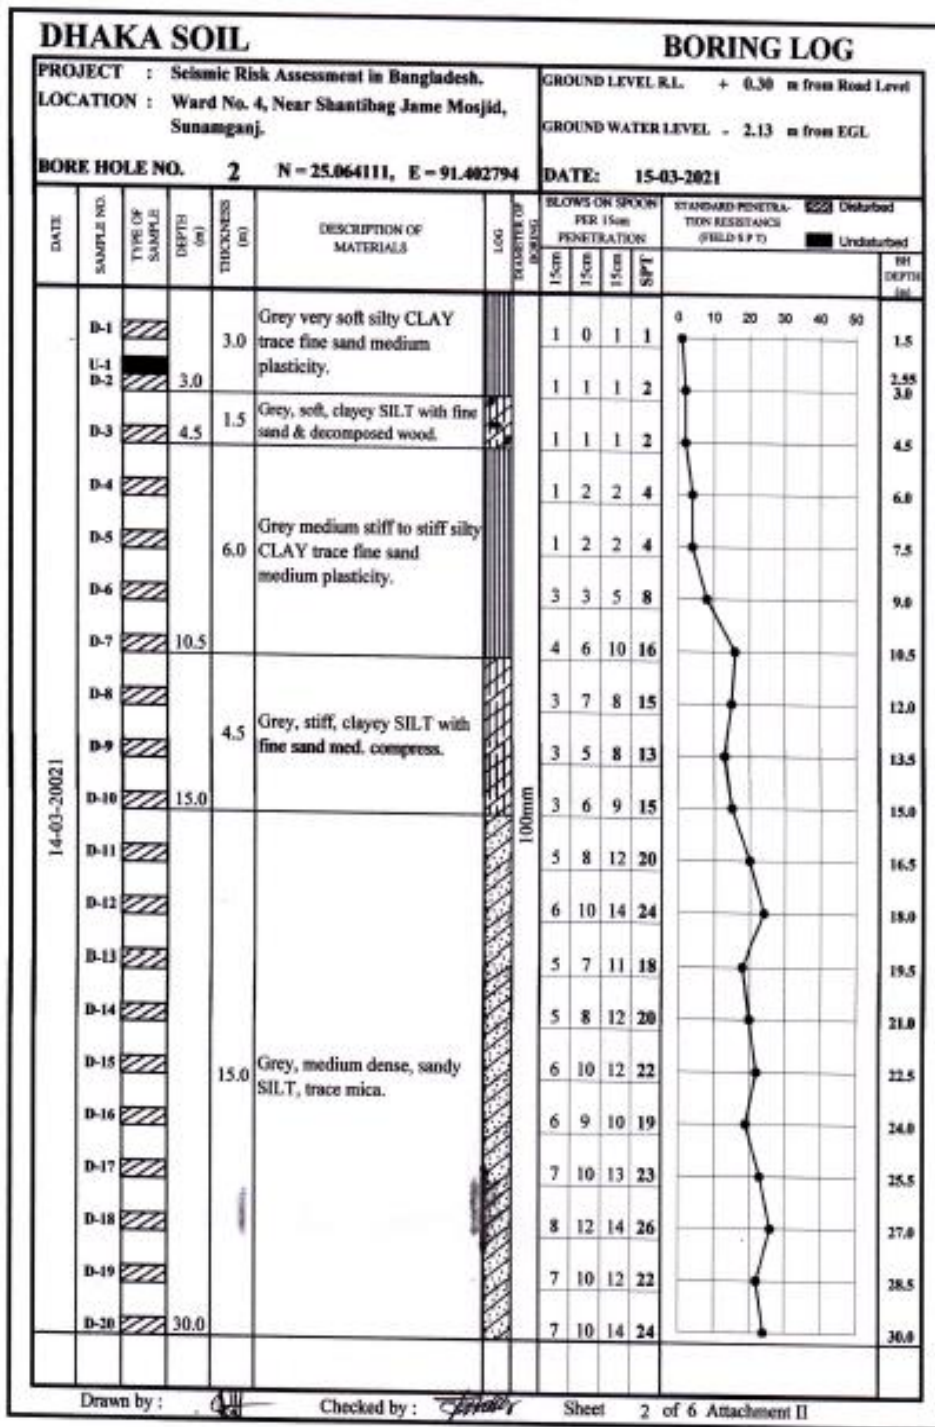
Figure 3.2: SPT data of Bore Hole 2 of Ward 4

The soil profile of bore hole 2 in Figure 3.2 also shows five different layers of soil. However, no organic soil was detected in this borehole. Up to 7.5m, the SPT-N value remains below 5 resulting in low soil strength. The SPT-N value increases beyond this depth with occasional fluctuation and reaches at a value higher than 20 (N=24) at 18m. At the last layer of medium dense sandy silt, the N values stay mostly steady among 18-24. However, the maximum value of 26 is obtained at 27 m. Though from the comparison of both the boreholes it can be observed that their strength characteristics

are quite similar, the presence of organic soil in borehole 1 shall be carefully considered during construction.

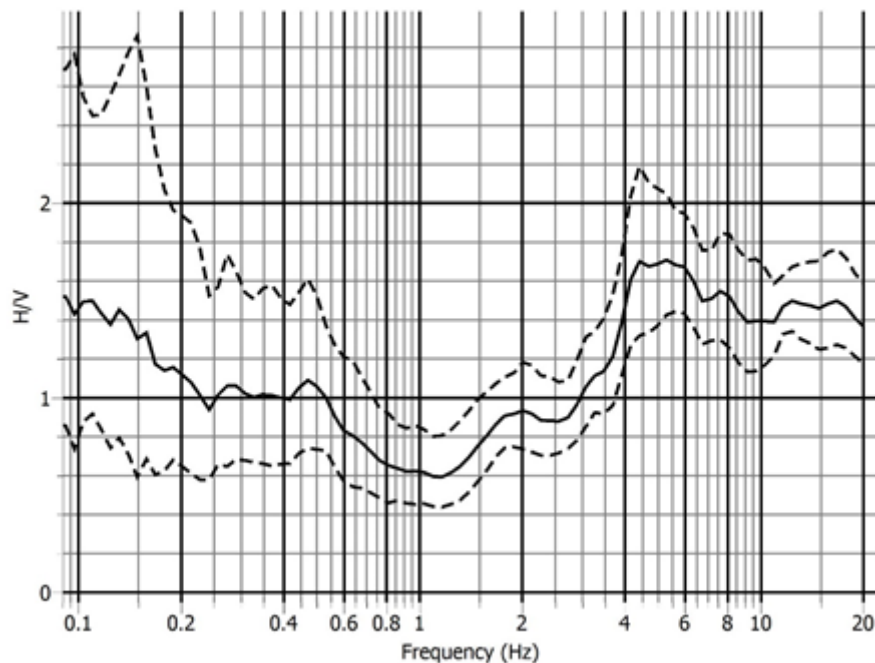
Figure 3.3: Amplitude Ratio vs Frequency graph of Ward no. 4 of Sunamganj Pourashava

By dividing the horizontal component (vibrations recorded in N-S and E-W directions) by the vertical component (vibrations recorded in Up-Down direction) we obtained the amplitude. All the graphs have been smoothed by averaging 20 data points and considering it as a single point in the graph. This was repeated for 25 sections and the geometric average of the amplitude ratios was taken to finally plot the Amplitude ratio vs Frequency (Hz) graph.

Figure 3.3 shows the Amplitude ratio vs Frequency graph for Ward 4 of Sunamganj Pourashava. From the graph we can observe that the amplitude ratio is maximum at around 4.5 Hz. The frequency at which the amplitude ratio shows a prominent peak is considered to be the predominant/natural frequency of the soil at that location. So, the predominant frequency is around 4.5 Hz. The predominant period is 0.22s. Using empirical equations along with the soil profile obtained from the bore holes, the shear wave velocity of the 30 meter 1-D soil column was found to be around 129.05 m/s (Bore hole-1) and 130.78 m/s (Bore hole-2).

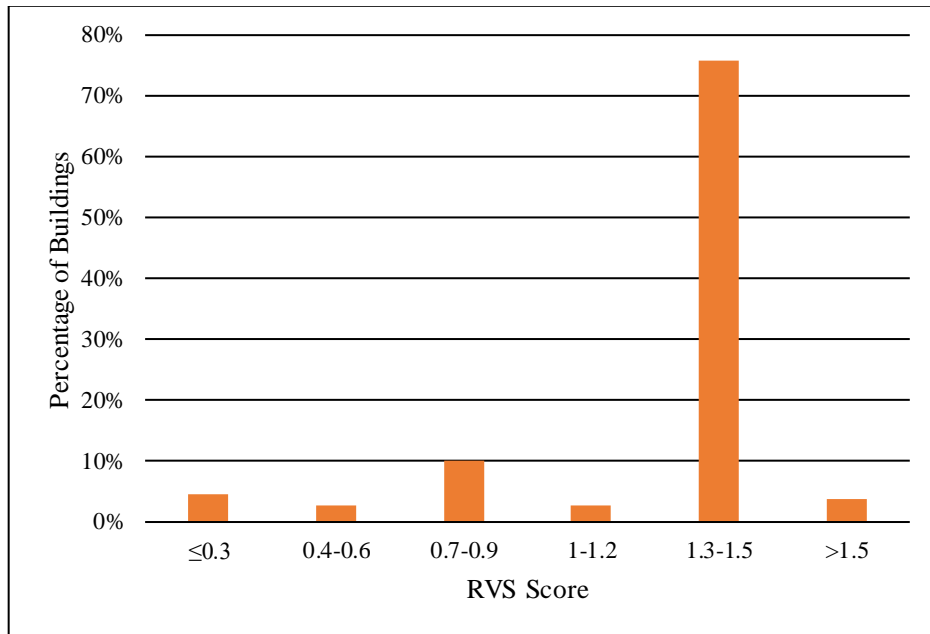
Figure 4.1 (a) indicates that 5% of the buildings has a score less than or equal 0.3, 3% of the buildings has a score in between 0.4 to 0.6, 10% of the buildings score in between 0.7 to 0.9, 3% of the building has score in between 1-1.2, 76% of the building score in between 1.3-1.5 and finally 3% building has a score greater than 1.5. Thus, 79% of buildings can be marked as safe during an earthquake of lower magnitude.

Figure 4.1 (a): Relations between percentage of buildings and RVS score of Ward 4 for moderately high seismicity

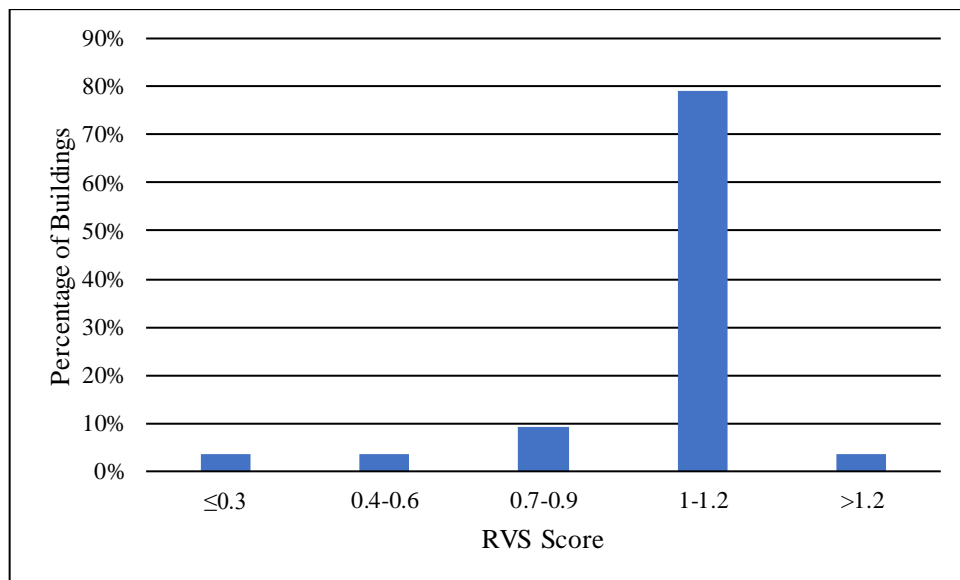
Figure 4.1 (b): Relations between percentage of buildings and RVS score of ward no 4 for high seismicity

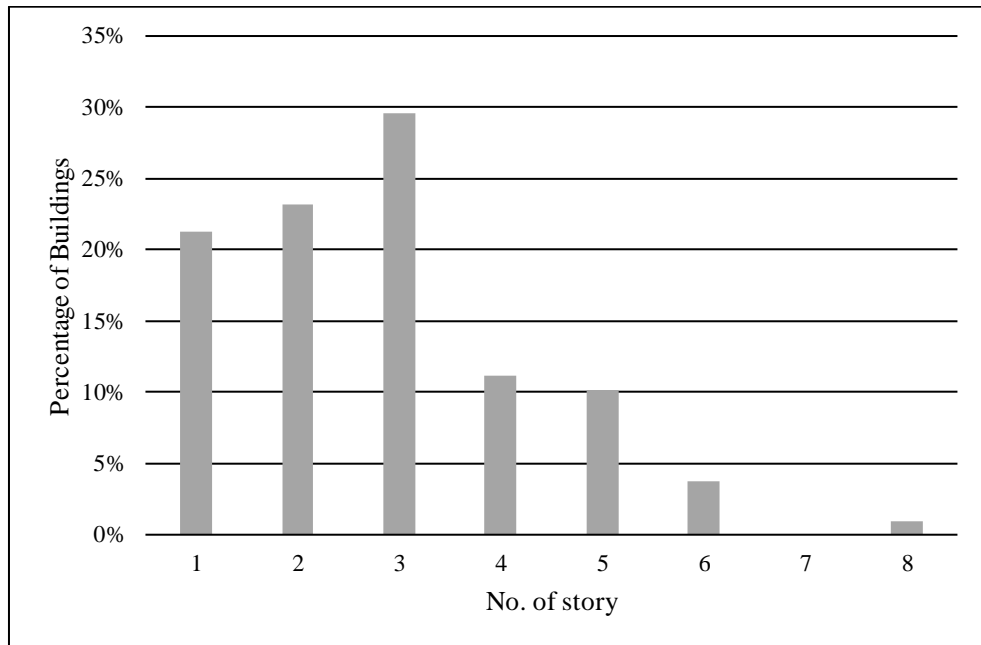
Figure 4.2 shows the percentage of buildings against the total number of stories. It was observed that 3 story buildings are dominating in this ward and it is 30% of the total sample size. Then 2 story buildings comprised 23%, followed by 1 story building which is 21% of the sample size. 4 story and 5 story buildings comprise 11% and 10% of the total surveyed buildings, respectively. 4% of the buildings are 6 stories. Only 1% of the building is above 6 stories.

Figure 4.2: Relations between the percentage of buildings and no. of story of Ward 4

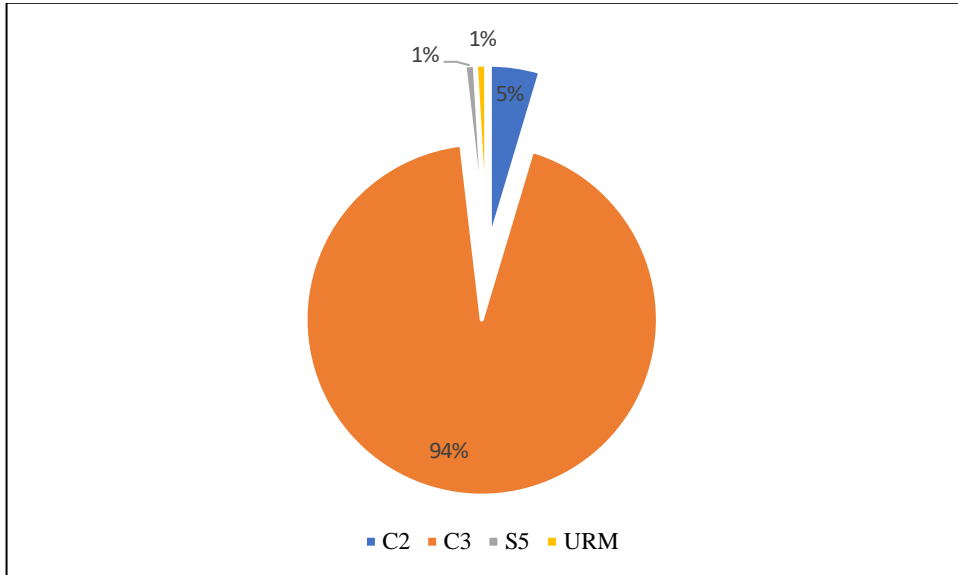
It was found that among the 108 surveyed buildings, 101 buildings are Concrete Frame with Unreinforced Masonry Infill Walls (C3 as per FEMA classification), 5 buildings are Concrete Shear Wall Building (C2 as per FEMA classification), 1 building is Unreinforced Masonry building (URM as per FEMA classification), and 1 building is Steel Frame Building with Unreinforced Masonry Infill Walls (S5 as per FEMA classification). Figure 4.3 represents different percentages of buildings found in ward 4. Hence, the C3 type building dominates in the study area.

Figure 4.3: Percentage of Different Building Types

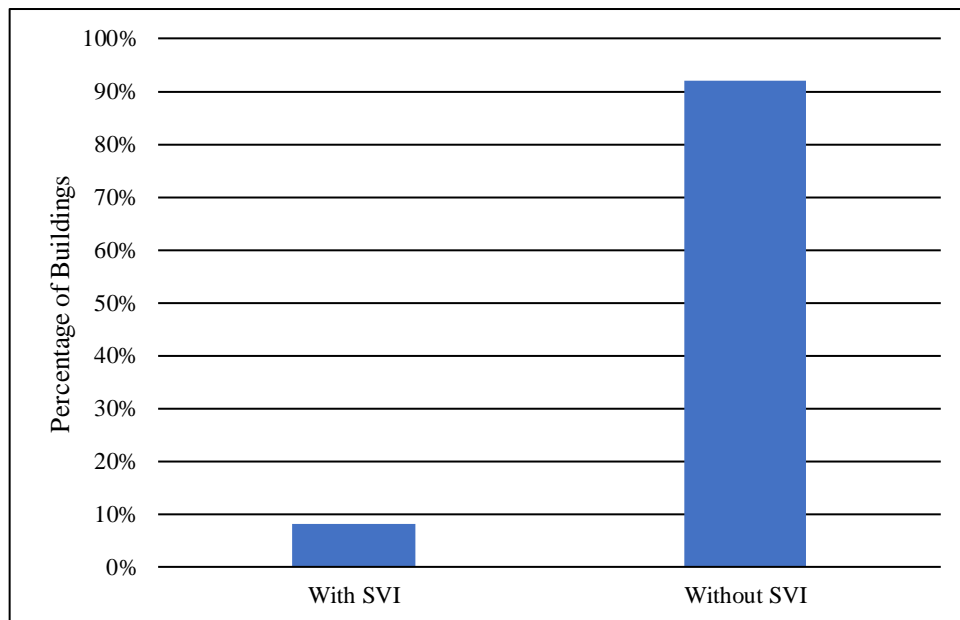
Figure 4.4 represents relation between percentage of buildings and severe vertical irregularity which include any or a combination of the following: short column, soft story/weak story and out of plane setback. It has been observed that 8% of the buildings that were surveyed have severe vertical irregularity.

Figure 4.4: Relations between percentage of buildings and severe vertical irregularity

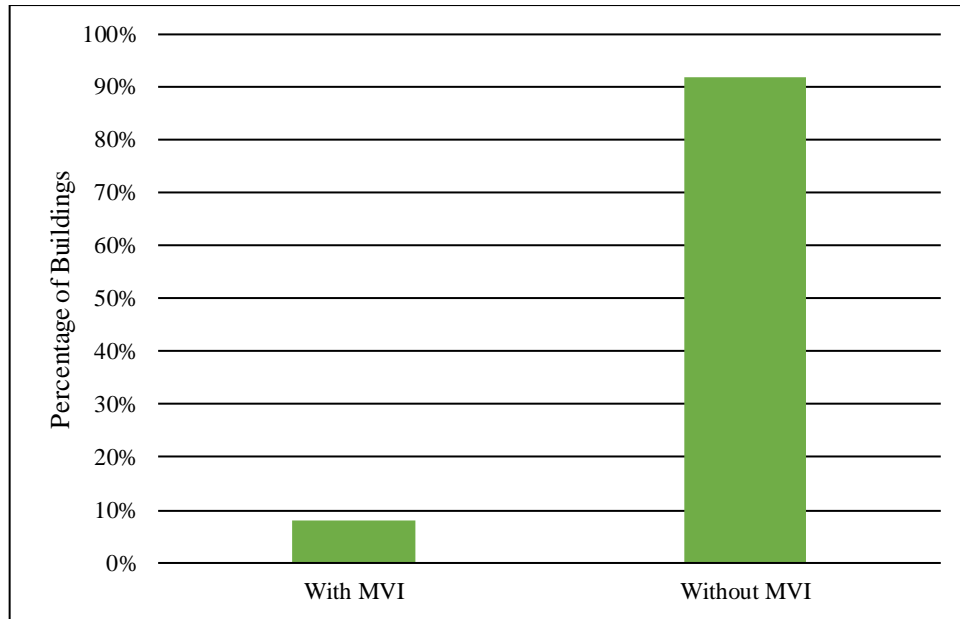
Figure 4.5 represents relation between percentage of buildings and moderate vertical irregularity (e.g. in plane setback, sloping site, split level). It is found that 8% of the buildings have moderate vertical irregularity.

Figure 4.5: Relations between percentage of buildings and moderate vertical irregularity

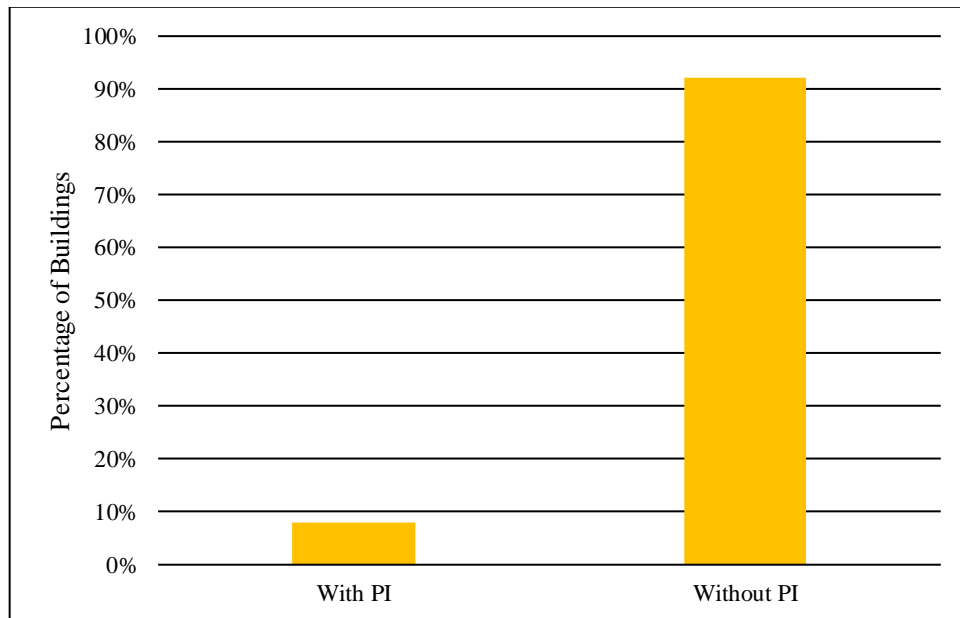
Figure 4.6 represents relation between percentage of buildings and plan irregularity (e.g. torsional irregularity, non-parallel system, reentrant corner, diaphragm opening, out of plane offset). 8% of the buildings have one or more forms of plan irregularity.

Figure 4.6: Relations between percentage of buildings and plan irregularity

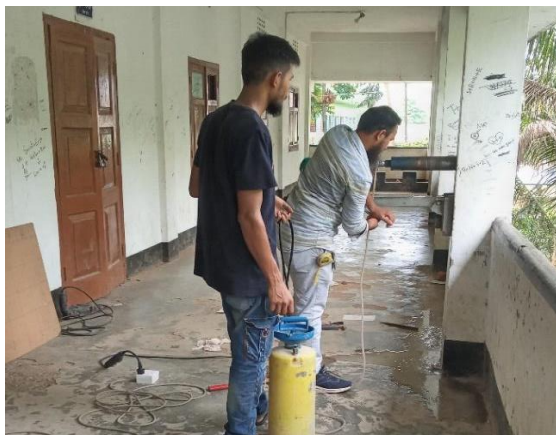
Strength of the concrete in the existing beams, columns and slabs has been assessed by extracting concrete core samples. Figure 5.1 shows the extraction of core from a column. Location of core cutting and their respective strength has been provided in Appendix C. Variations have been observed in the concrete strength derived from tests of the core samples. This may have resulted due to the quality control issue and other uncertainties associated with the core collection and testing (Ahsan et al., 2018). Hence, by applying judgment, concrete strength has judiciously been considered between the lowest and mean value. From these results, concrete compressive strength of 1.8 ksi for slab, column and beam of the building has been used for the structural analysis on finite element software.

Figure 5.1: Core extraction from a column

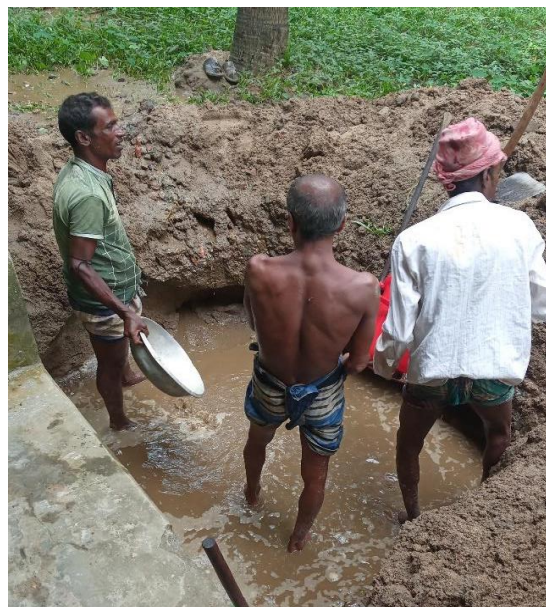
Foundations of the building were checked by excavating the soil. The size, thickness and depth were measured. Figure 5.2 shows the excavation of footing. Footing details have been attached in Appendix C.

Figure 5.2: Footing excavation

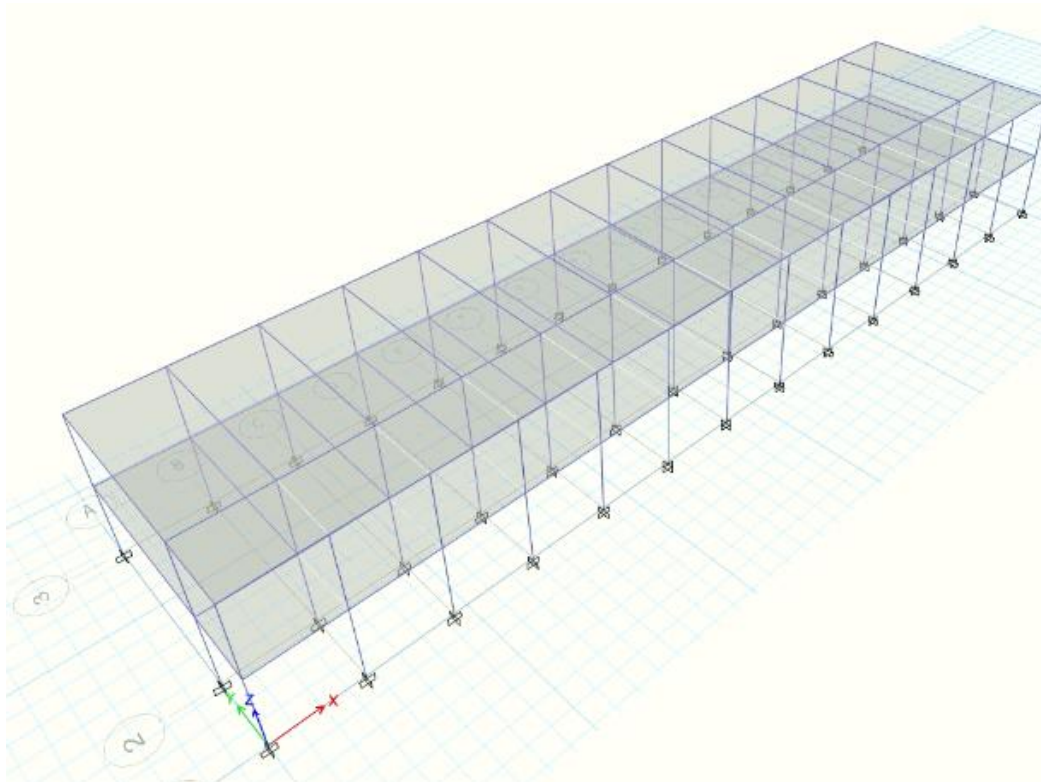
It is a two-storied school building. As-built drawings of this building are shown in Appendix C. Figure 5.3 depicts the 3-D view of the finite element model. Figure 5.4 shows the 3-D view of the structure after analysis with the required amount of reinforcement. The red marked columns indicate that they are overstressed and failed due to the applied loading condition. Similarly, the red marked beams indicate that the beams failed in flexure. But for this particular analysis, no red marked beam was identified (see figure 5.4); hence the beams of this building did not fail in flexure due to considered loading conditions.

Figure 5.3: 3-D view of the finite element model before analysis

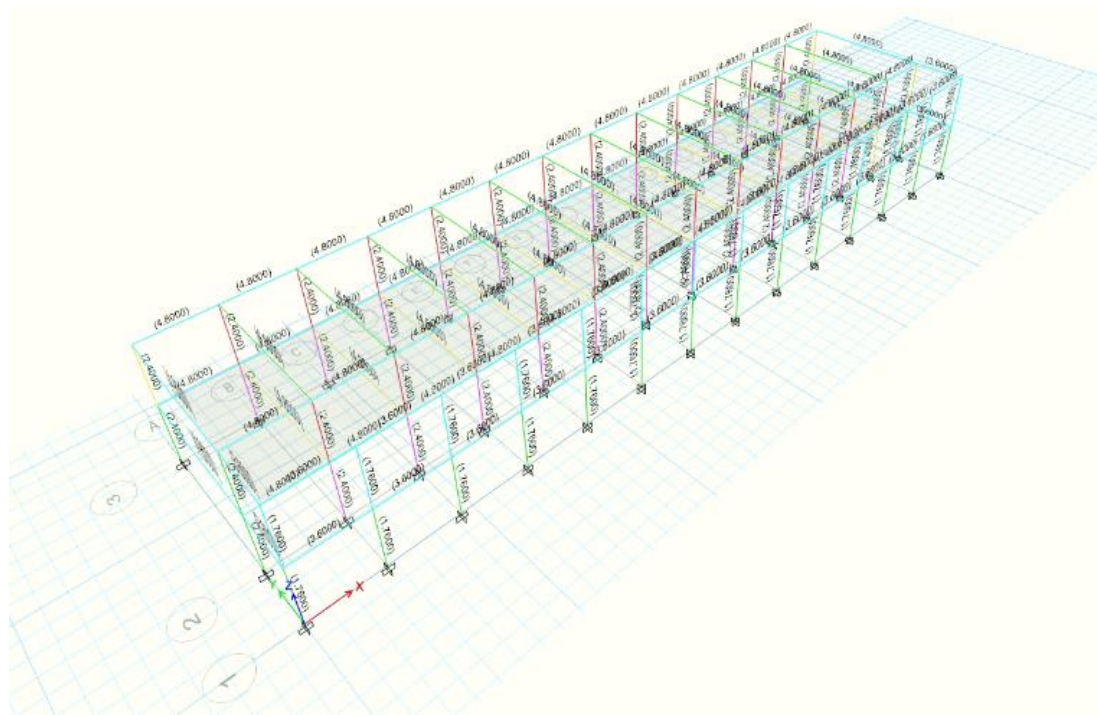
Figure 5.4: 3-D view of the building in FEM after analysis with reinforcement details

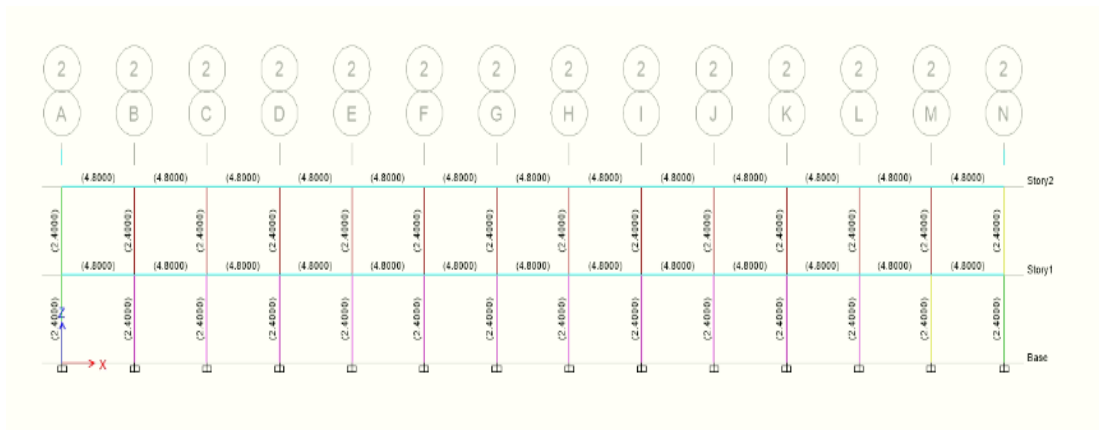
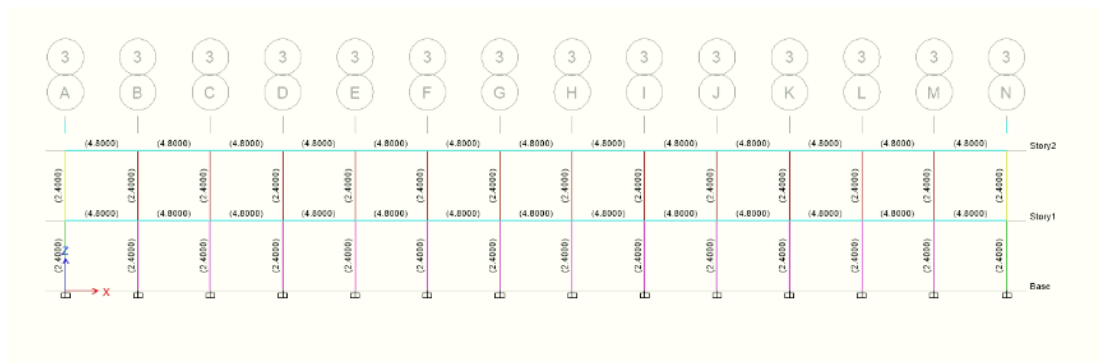
Figure 5.5 identifies the overstressed columns (shown in “Red”) along Frame 2-ABCDEFGHIJKLMN and 3-ABCDEFGHIJKLMN in elevation view. Hence to use the structure in the future as a ward coordination center, necessary retrofitting of the inadequate columns need to be done.

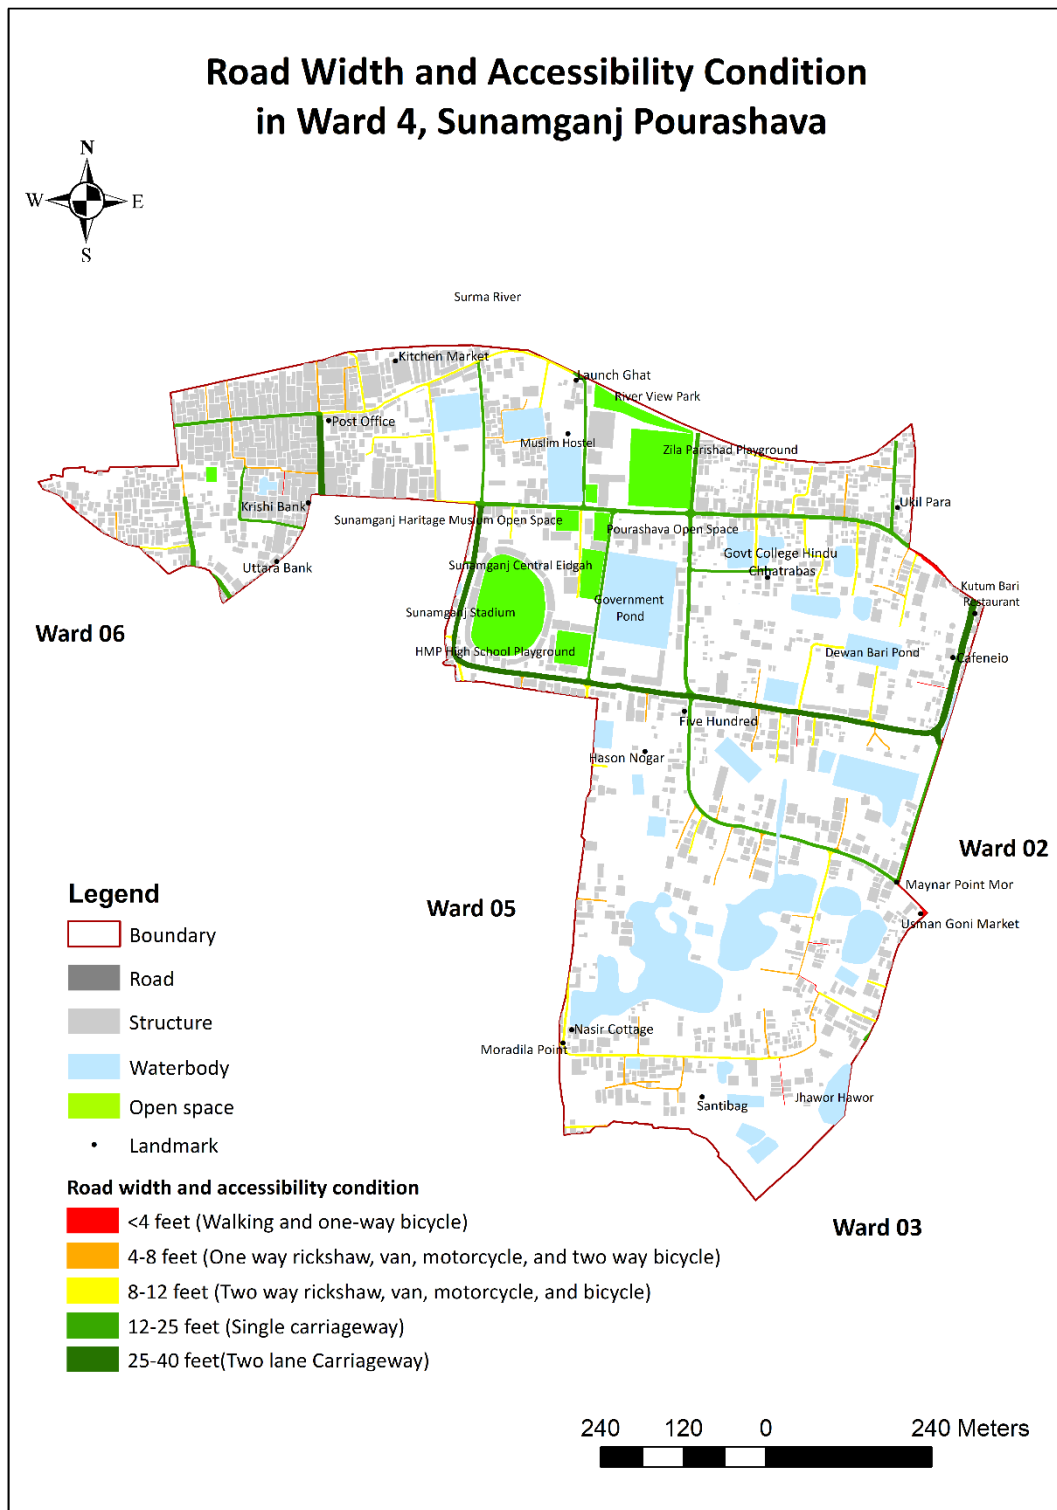
From the maps (Figure: 7.5, 7.6, and 7.8) it can be observed that roads less than 8 feet are mainly prone to blockage. It indicates that rescuing from residential building and access to temporary shelter and emergency health facility and will be quite challenging. The single-lane carriageway, which connects this ward with the surrounding wards, will be fully blocked in at least two locations if a >8 magnitude earthquake strikes. These blockages are crucial, as they will trap other roads which will be unable to use for any kind of movements and which will possibly prohibit entrance of any large emergency vehicle or rescuing equipment in the southern portion of the ward. Figure-7.7 and 7.9 provide the evacuation route maps which will be usable for the evacuees to move to designated locations after an earthquake.

Figure 7.5: Road width and accessibility condition
(Source: Field Survey, 2021)

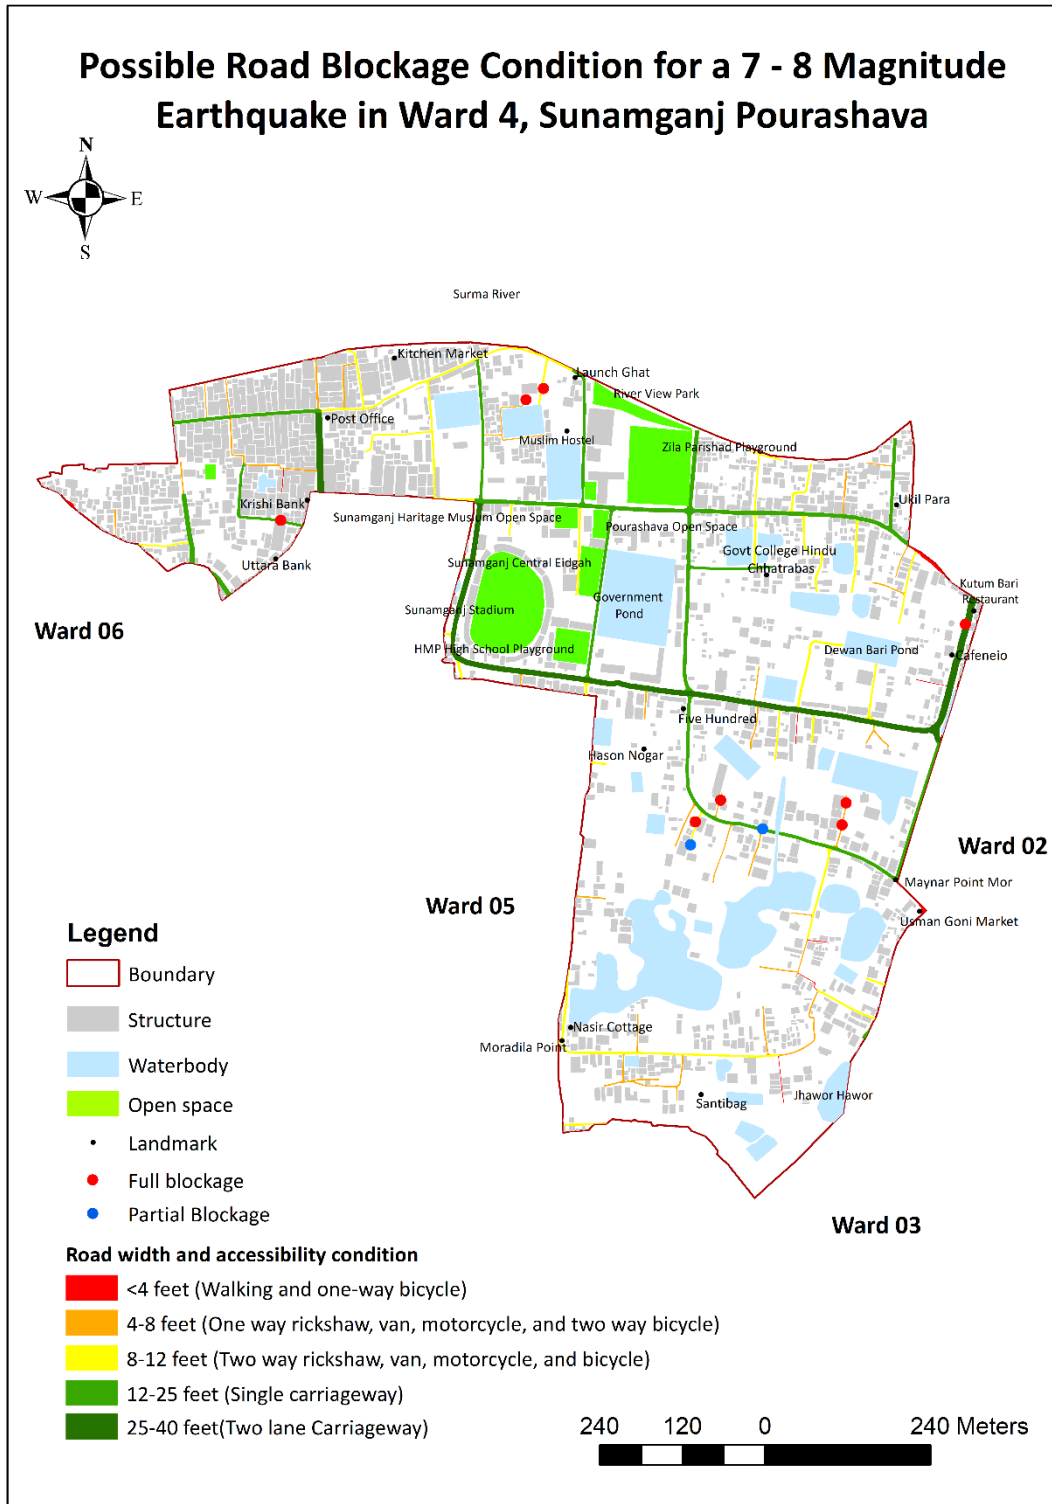
Figure 7.6: Possible road blockage condition for Scenario 01
(Source: Field Survey, 2021)

Accessibility of the roads for rescue and rehabilitation were identified considering the road width and blockage size after an earthquake. It was observed that roads less than 8 feet are mainly prone to blockage. It indicates that rescuing from residential buildings, and access to temporary shelters and emergency health facilities will be quite challenging. The single-lane carriageway, which connects this ward with the surrounding wards, will be blocked in at least four locations.

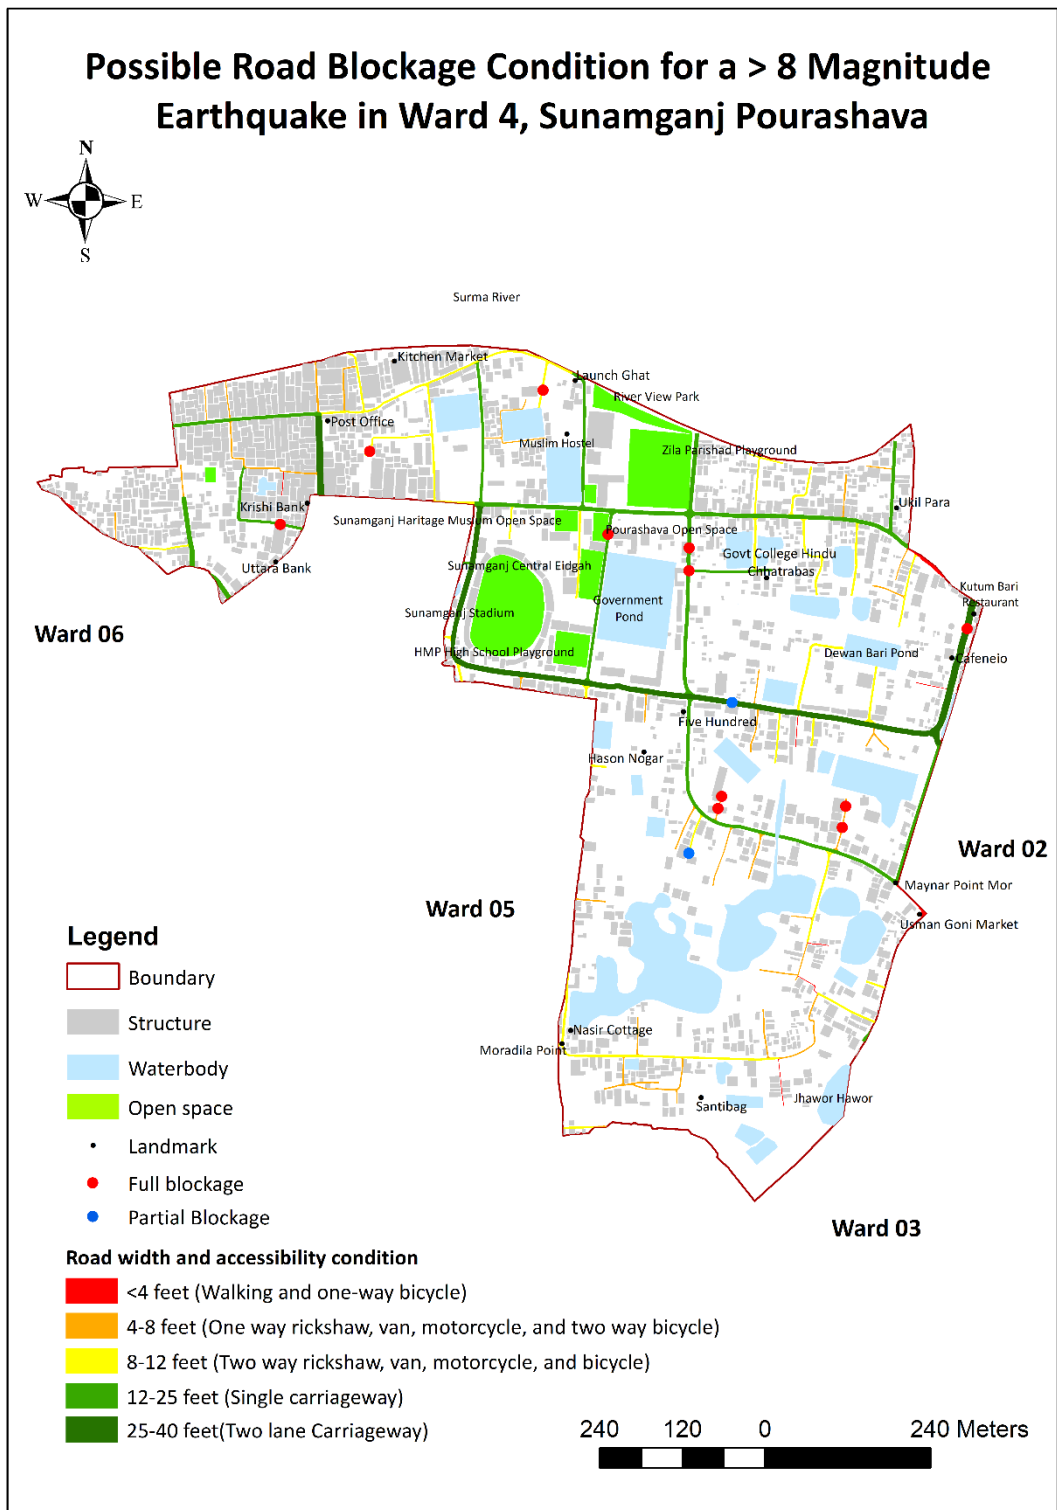
Figure 7.8: Possible road blockage condition for Scenario 02
(Source: Field Survey, 2021)

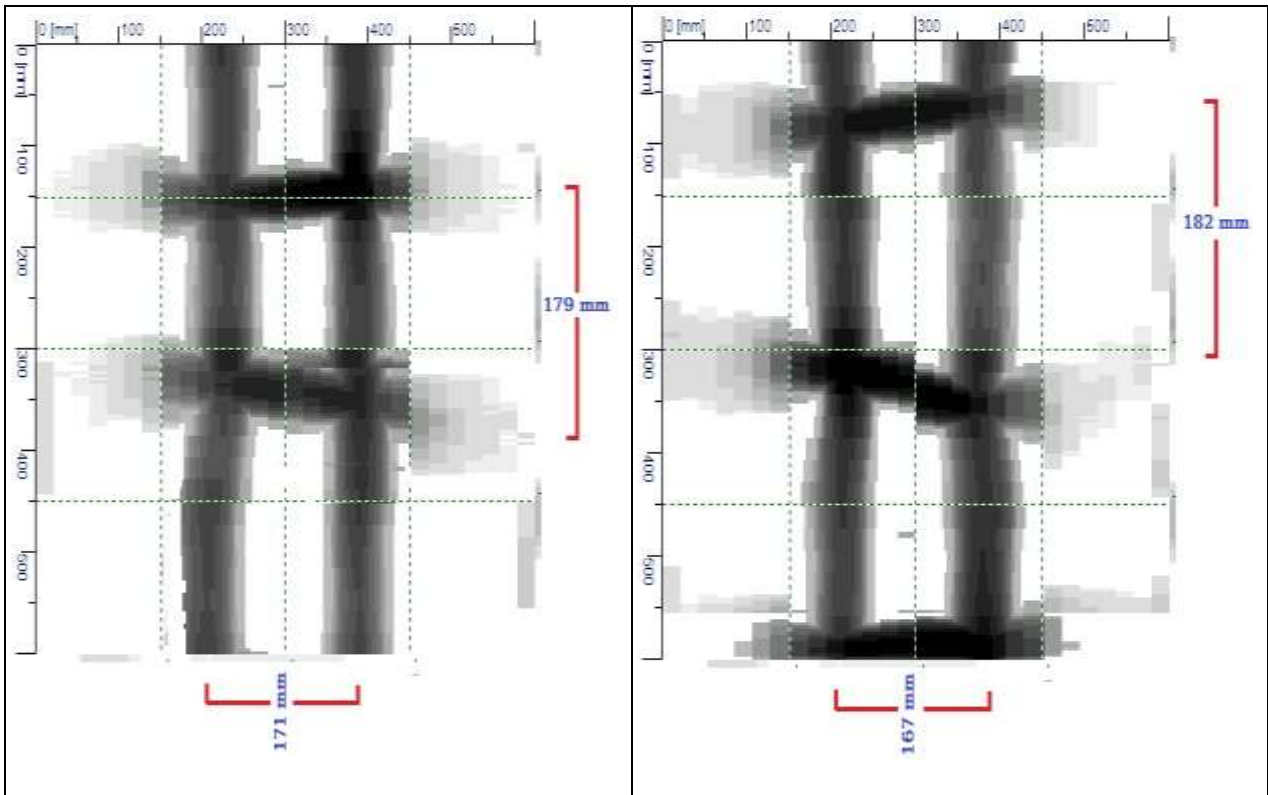
Figure E-08: Image scan of column GF-C1 (Long Side)

Figure E-09: Image scan of column GF-C1 (Short Side)

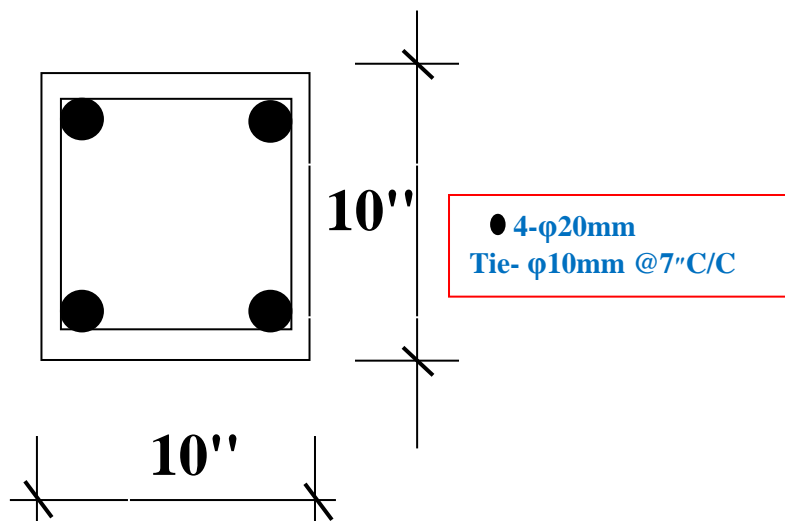
Figure E-10: Cross section of column GF-C1

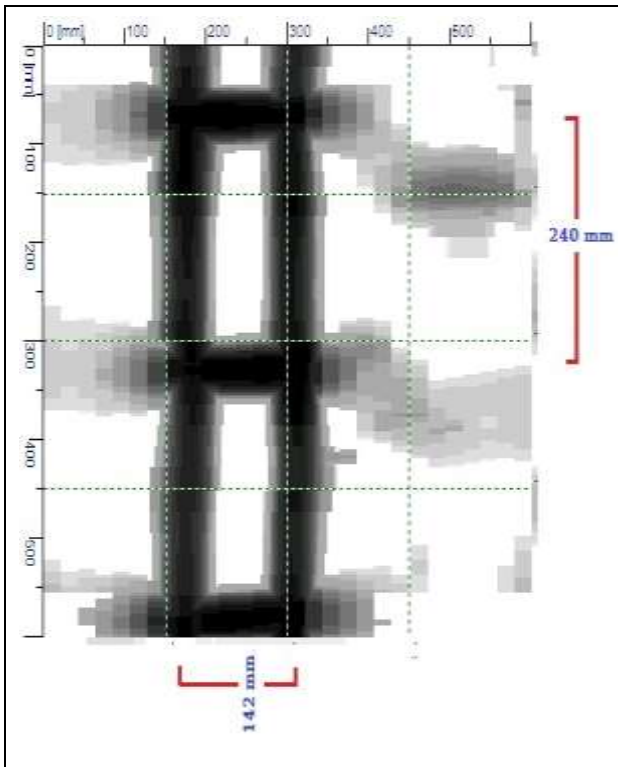
Figure E-11: Image scan of column GF-B2 (Long Side)

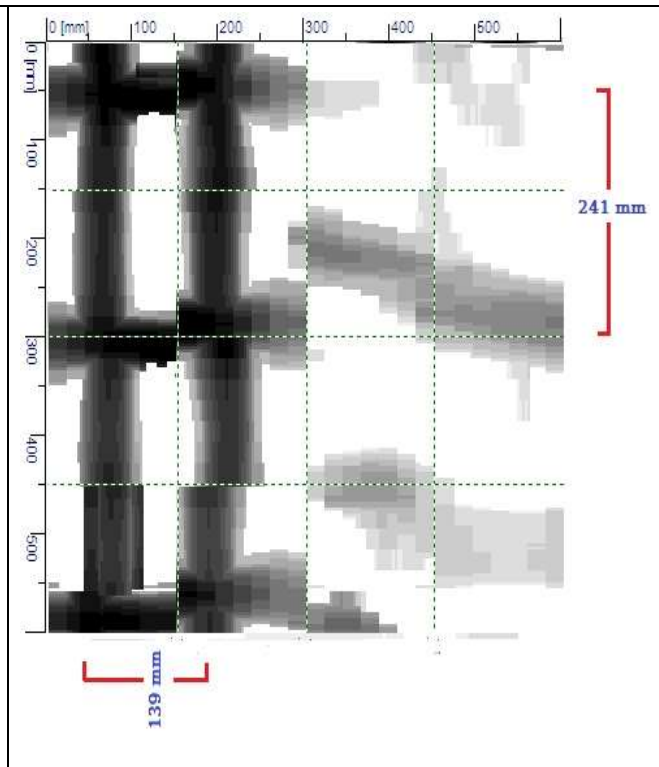
Figure E-12: Image scan of column GF-B2 (Short Side)

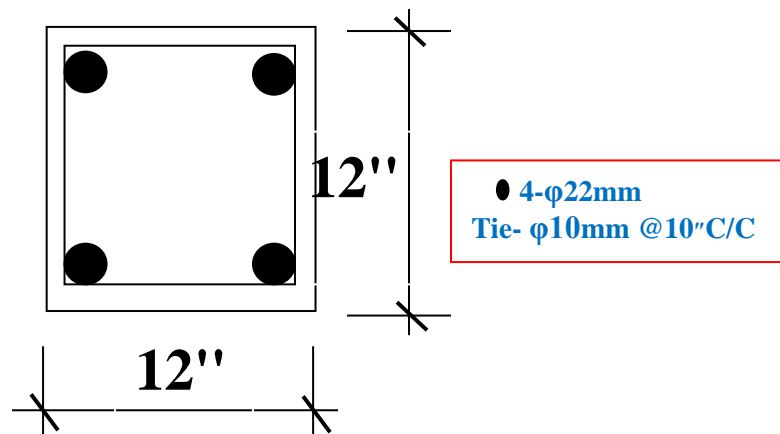
Figure E-13: Cross section of column GF-B2

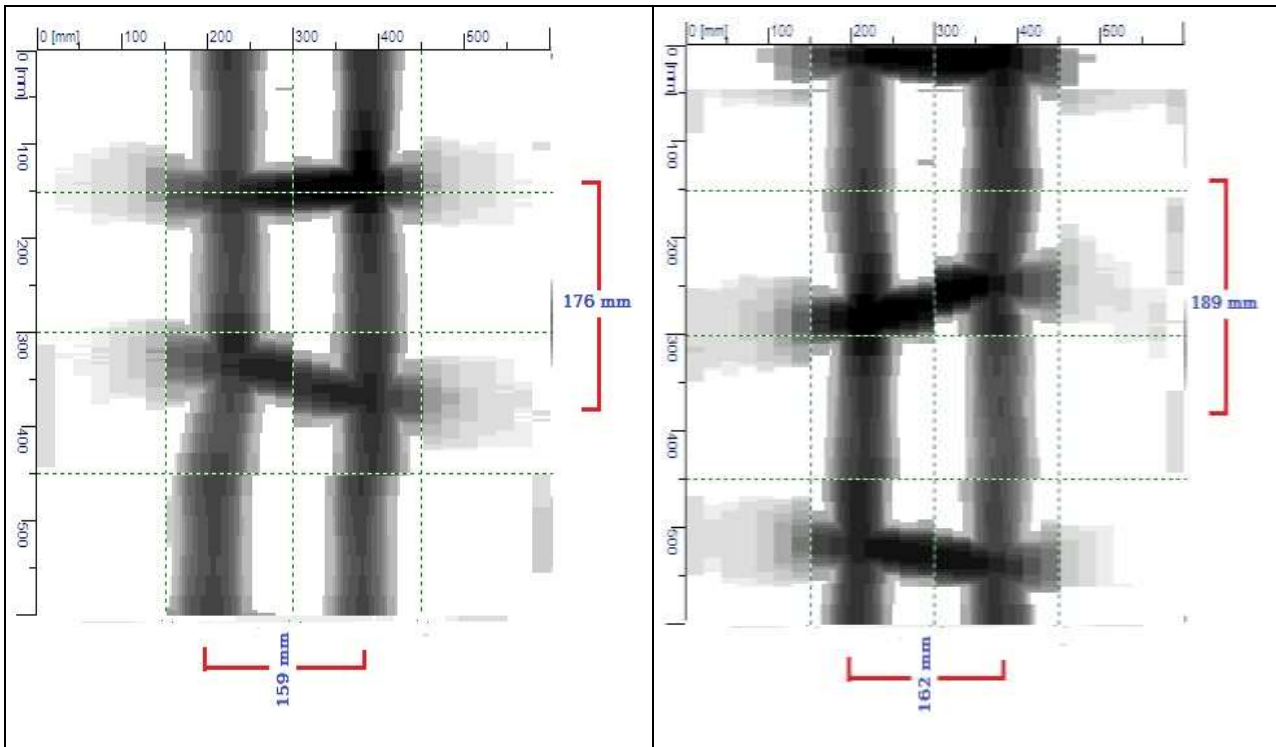
Figure E-14: Image scan of column 2F-B2 (Long Side)

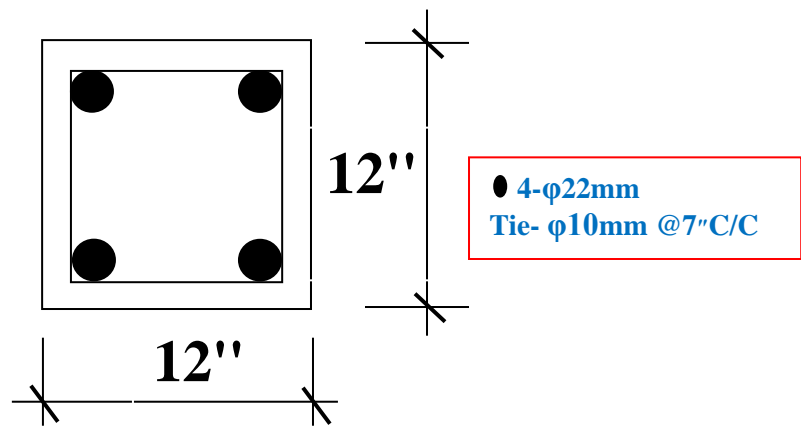
Figure E-16: Cross section of column 2F-B2
