Earthquake Contingency Plan for Ward 4, Sunamganj Municipality: Volume 2

BUET-Japan Institute of Disaster Prevention and Urban Safety (BUET-JIDPUS)
Department of Urban and Regional Planning
Department of Civil Engineering
Bangladesh University of Engineering and Technology (BUET),
Dhaka-1000, Bangladesh.

Earthquake Risk Assessment for Developing Contingency Plans, Training Modules and Awareness Materials for Rangpur City Corporation and Tangail, Rangamati and Sunamganj Pourashavas

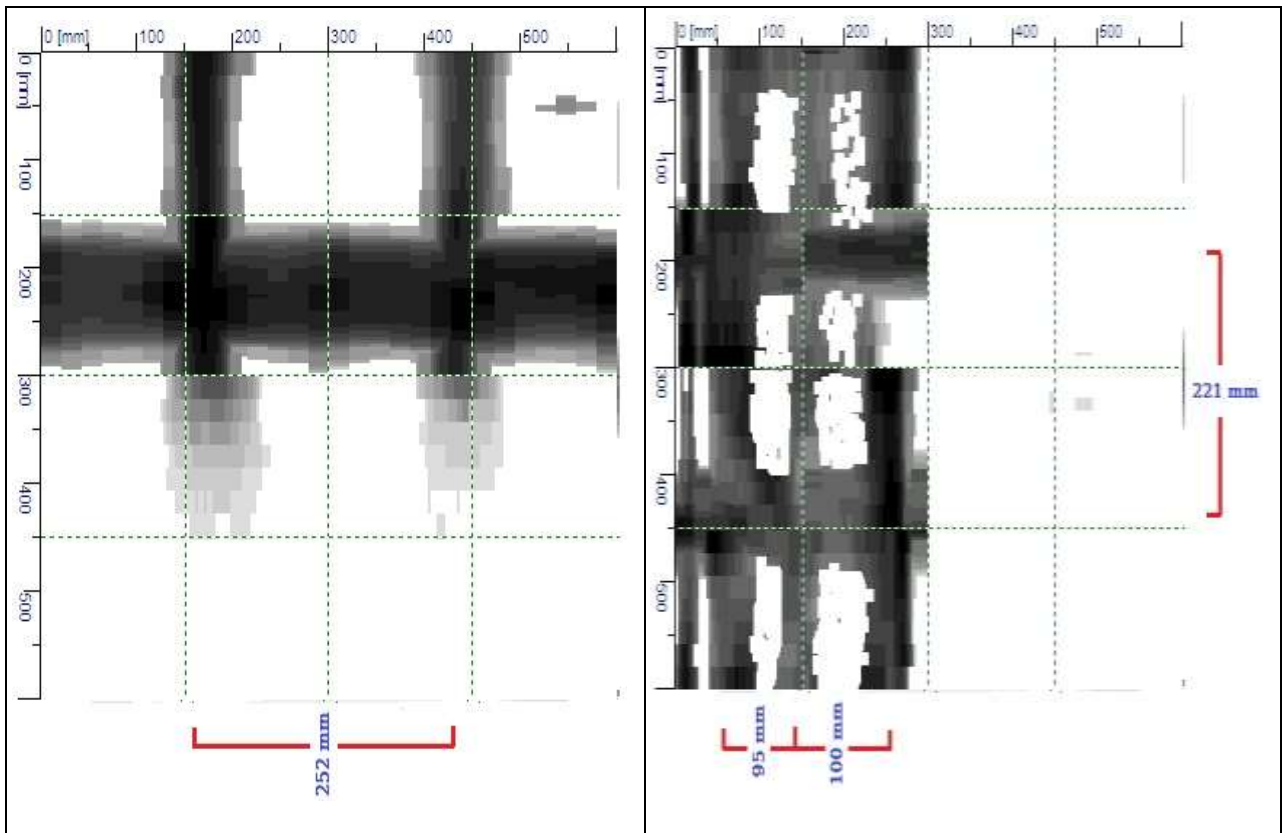
Figure E-17: Image scan of beam 1F-B1 (lateral)

Figure E-18: Image scan of beam 1F-B1 (bottom)

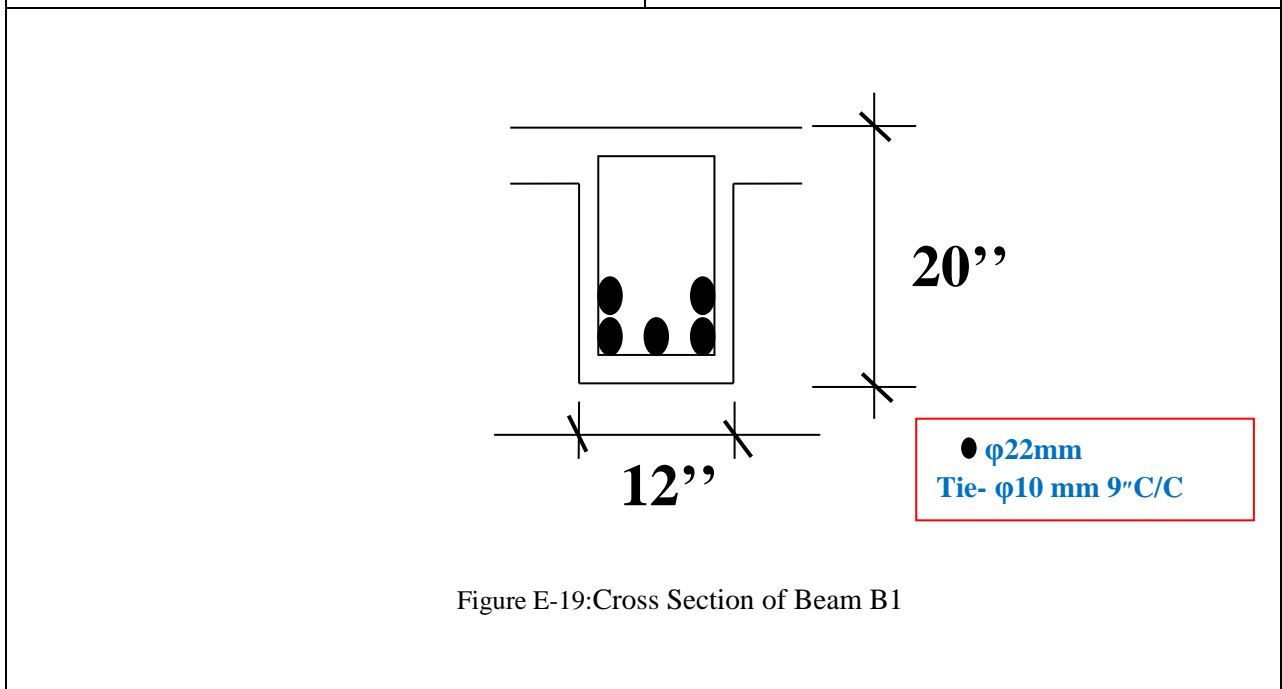
Figure E-19: Cross Section of Beam B1

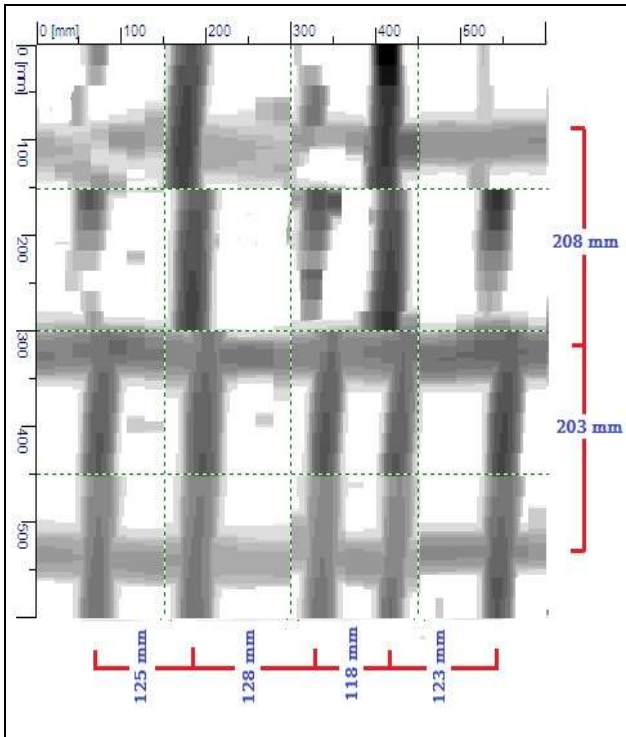
Figure E-20: Image scan of slab 1F-S1

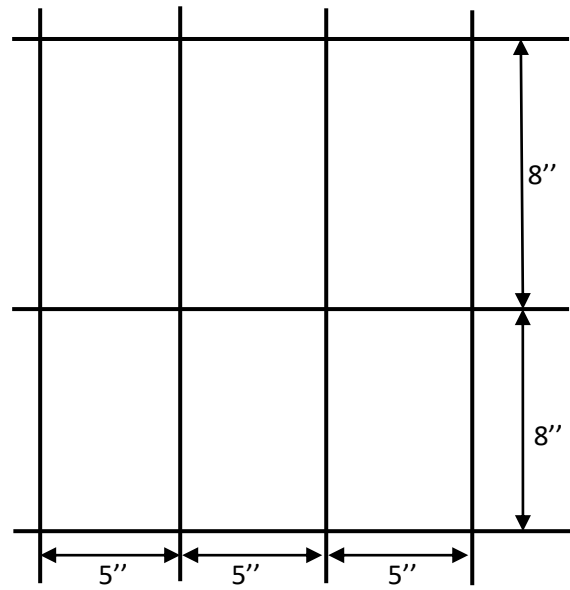
Figure E-21: Cross section of the slab 1F-S1
