National Resilience Programme

Earthquake Contingency Plan for Ward 13, Tangail Municipality: Volume 2

BUET-Japan Institute of Disaster Prevention and Urban Safety (BUET-JIDPUS)
Department of Urban and Regional Planning
Department of Civil Engineering
Bangladesh University of Engineering and Technology (BUET),
Dhaka-1000, Bangladesh.

**Earthquake Risk Assessment for Developing Contingency
Plans, Training Modules and Awareness Materials for
Rangpur City Corporation and
Tangail, Rangamati and Sunamganj Pourashavas**

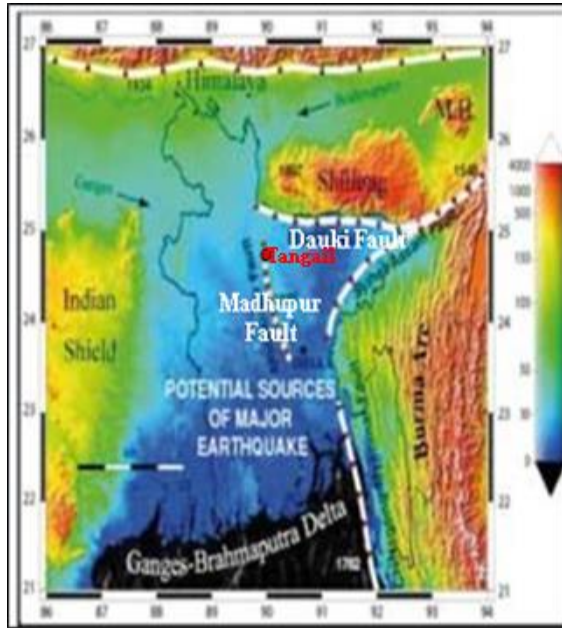
Figure 1.1: Proximity of study area to major fault lines

Tangail is located at the active Madhupur fault and the district is also very close to Dauki fault (Figure 1.2).

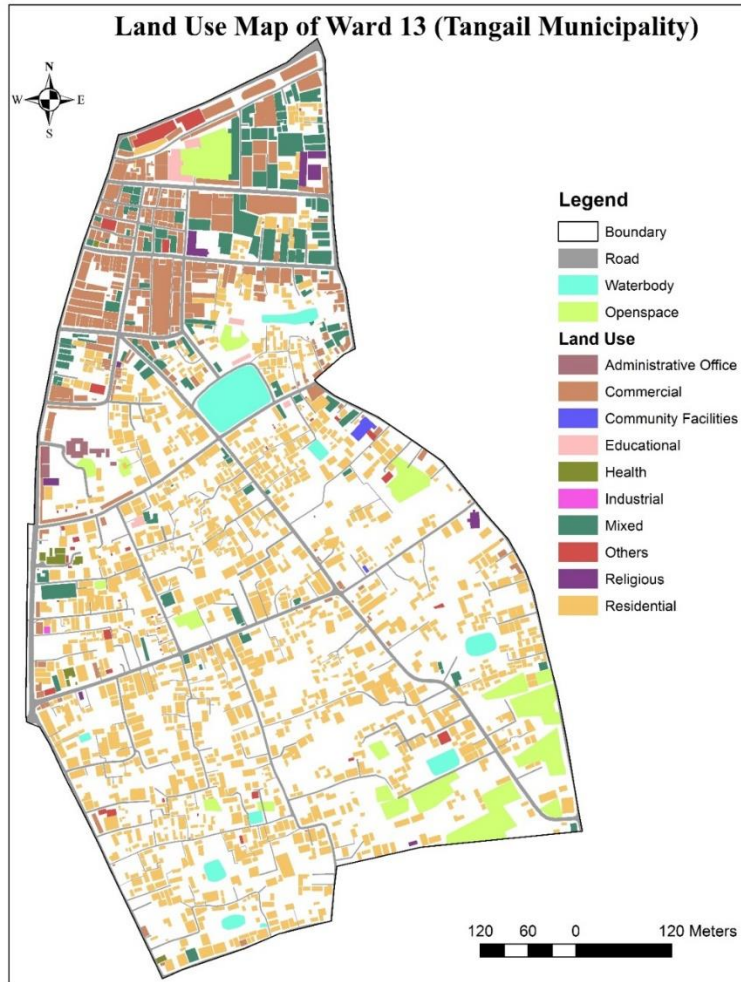
Figure 2.2: Map showing land use of the study area

Figure 2.2 which has been prepared in the present study, reveals that the major land use of Ward no 13 is residential (72.9%). The northern part of Ward 13 is mostly commercial. Structures serving health facility (0.52%) are very negligible to be counted and are located in the south-western part of the Ward. There are equal number of structures of educational institutions (0.31%) and administrative offices (0.31%) in

this Ward. A good percentage of land use is for mixed purpose (7.03%). The road network covers a major portion of land though most of the roads are too narrow to access. A significant number of water body and open space is found in this Ward. There is also space for socio-cultural use in Ward 13.

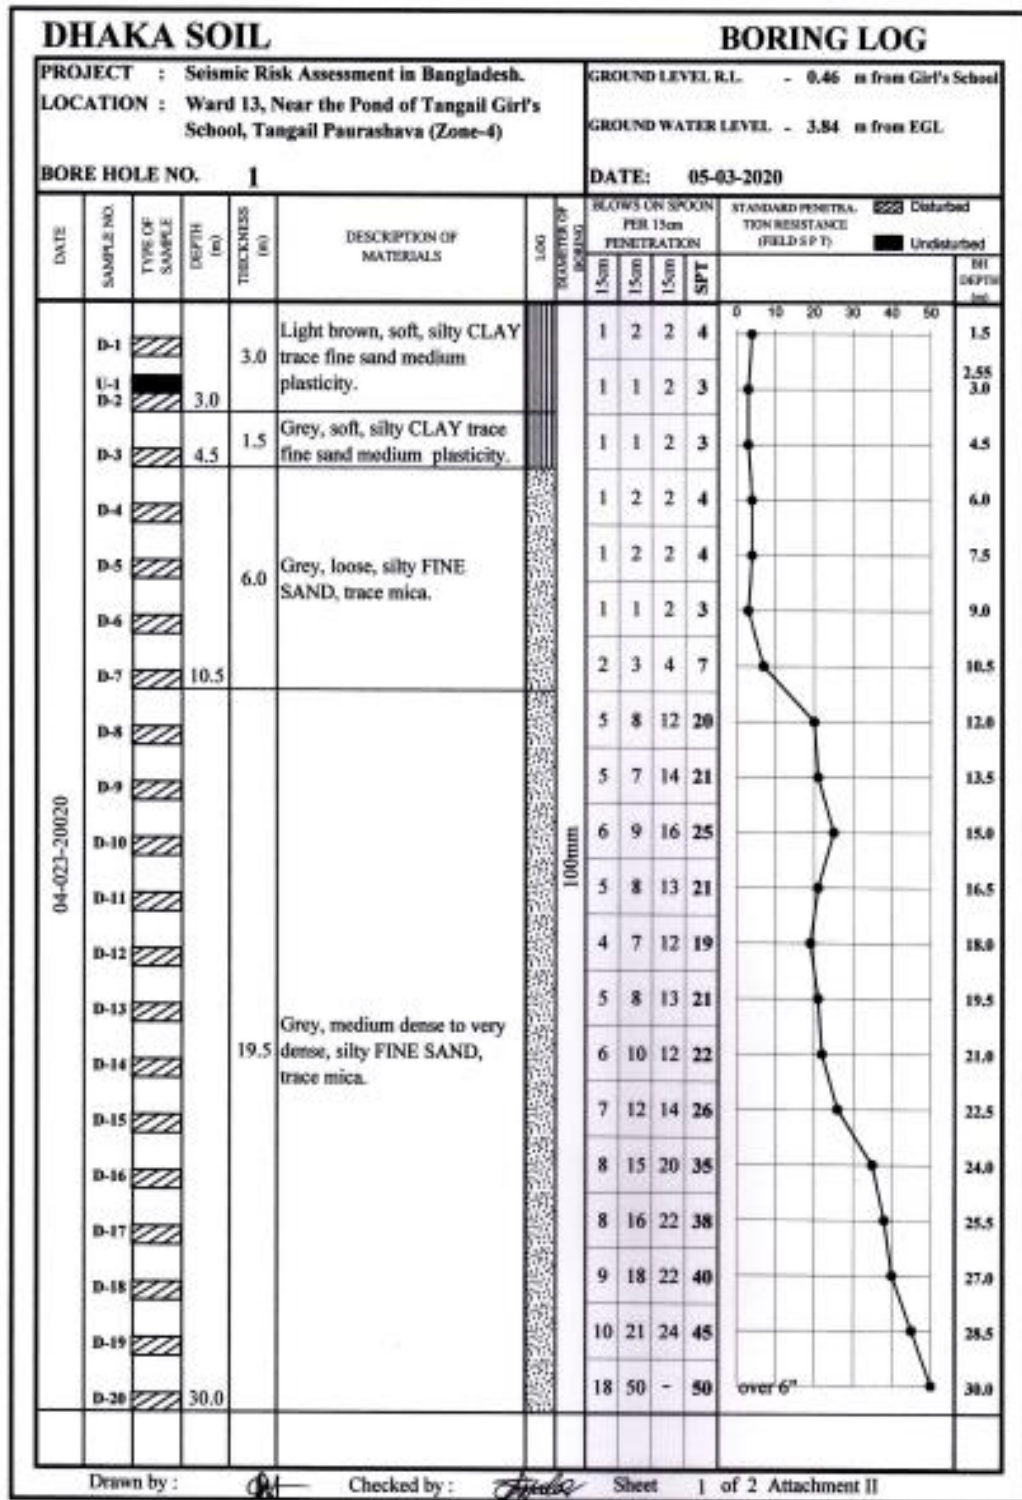
Figure 3.1: SPT data of Bore Hole 1 of Ward 13

The soil profile of bore hole 1 in Figure 3.1 shows four different layers of soil. From the N value, it is observed that up to 10.5m, the readings are less than 10. This means upper layers of soil have lower strength compared to the bottom layers where the readings are approaching 50 as both cohesion and angle of internal friction are positively correlated to SPT-N value (Kumar et al., 2016).. The detailed description of the soil types are shown in Figure 3.1.

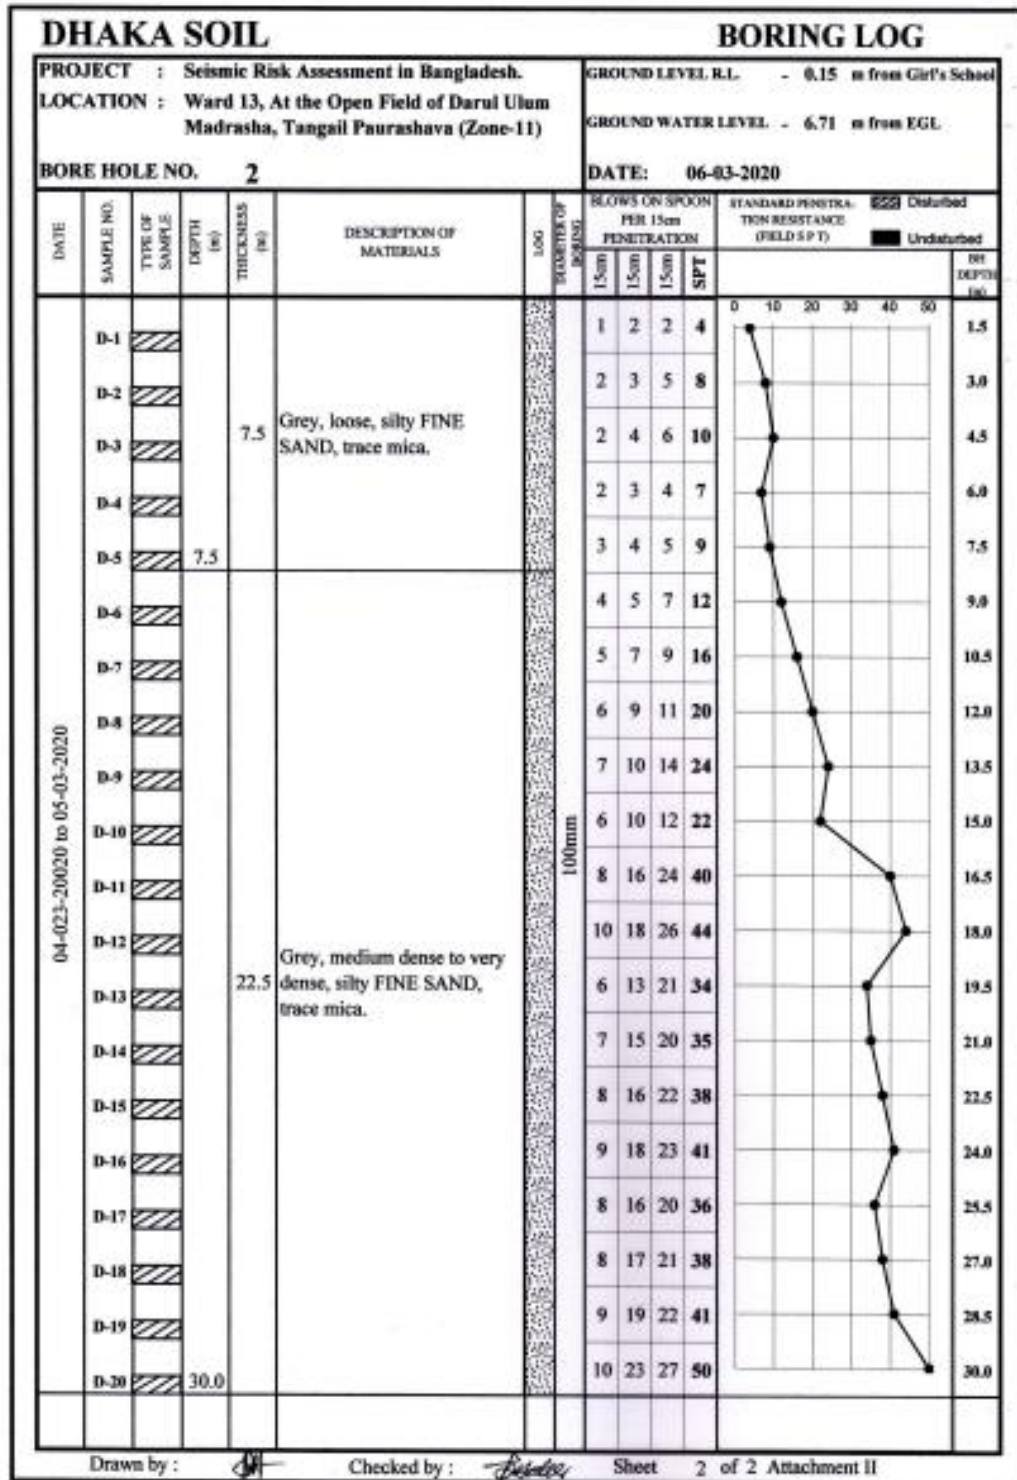
Figure 3.2: SPT data of Bore Hole 2 of Ward 13

On the other hand, the soil profile of bore hole 2 in Figure 3.2 shows two layers of soil. It is observed that up to 7.5m, the N values are less than 10 and the bottom readings are approaching 50. So, the depth of the soil layer with less strength is smaller here than compared to that of bore hole 1.

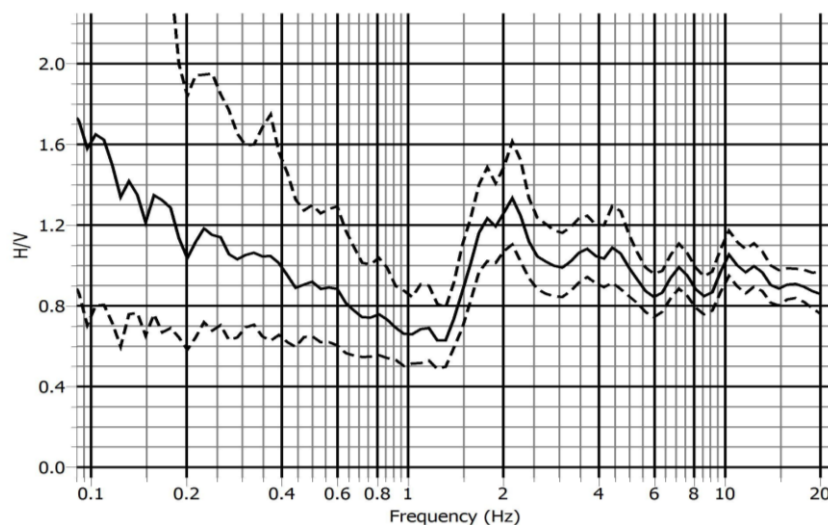
Figure 3.3: Amplitude vs Frequency graph of Ward no. 13 of Tangail Pourashava

By dividing the horizontal component (vibrations recorded in N-S and E-W directions) by the vertical component (vibrations recorded in Up-Down direction) we obtained the amplitude. All the graphs have been smoothed by averaging 20 data points and considering it as a single point in the graph. This was repeated for 25 sections and the geometric average of the amplitude ratios was taken to finally plot the Amplitude ratio vs Frequency (Hz) graph. Figure 3.3 shows the Amplitude ratio vs Frequency graph for Ward 13 of Tangail Pourashava.

From the graph we can observe that the amplitude ratio is maximum at around 2.0 Hz. The frequency at which the amplitude ratio shows a prominent peak is considered to be the predominant/natural frequency of the soil at that location. So, the predominant frequency is around 2.0 Hz. The predominant period is 0.50s. Using empirical equations along with the soil profile obtained from the bore holes, the shear wave velocity of the 30 meter 1-D soil column was found to be around 136.50 m/s (Bore hole-1) and 145.84 m/s (Bore hole-2).

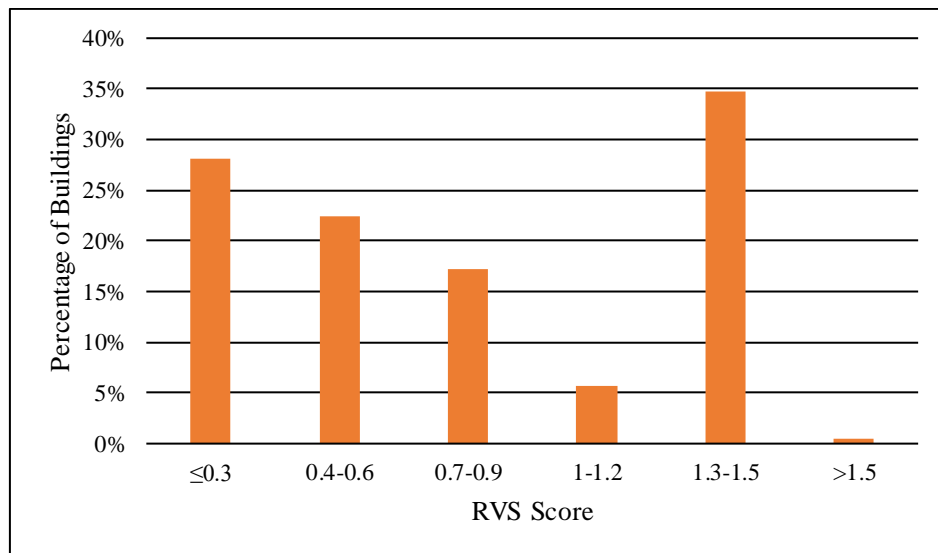
Figure 4.1: Relations between percentage of buildings and RVS Score of Ward no 13

Figure 4.1 represents relations between the percentage of buildings and the RVS score. From the study it was observed that 26% of the buildings has a score less than or equal 0.3, 21% of the buildings has a score between 0.4 to 0.6, 16% of the buildings score in between 0.7 to 0.9, 5% of the buildings has score in between 1 to 1.2, 35% of the surveyed buildings has score in between 1.3-1.5 and finally 1 of the buildings has score greater than 1.5. Thus 36% of surveyed buildings will be safe during earthquakes.

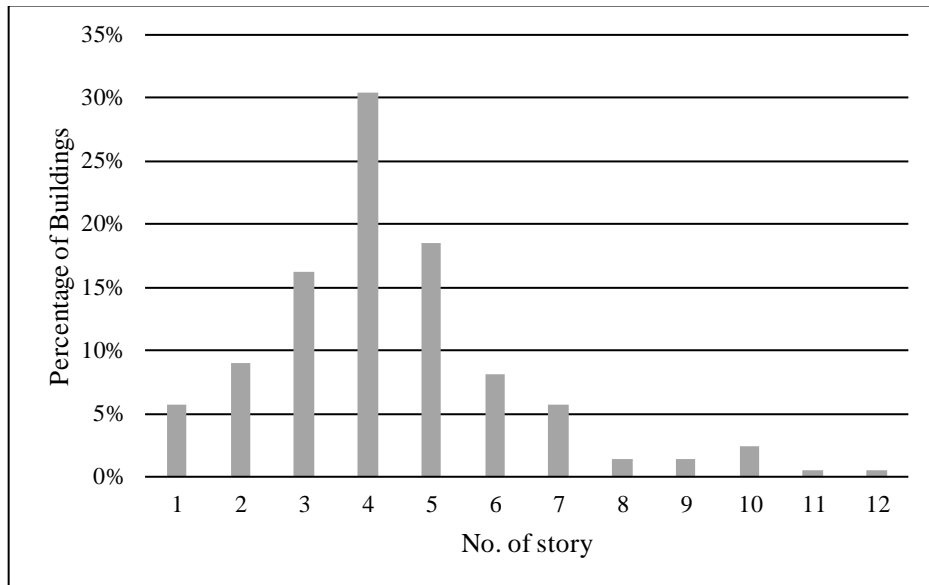
Figure 4.2: Relations between the percentage of buildings and no. of storey of Ward 13

Figure 4.2 shows the relation between the percentage of buildings and number of storey. From this figure, it is clear that 4 storied buildings are predominant in the surveyed area and it is about 30% of the total sample size of ward no. 13. The second dominant type are the buildings with 5 stories and they are 19%. Percentage of 3 storey buildings is 16%. Only 18% of the surveyed buildings fall within the storey range of 6 to 12.

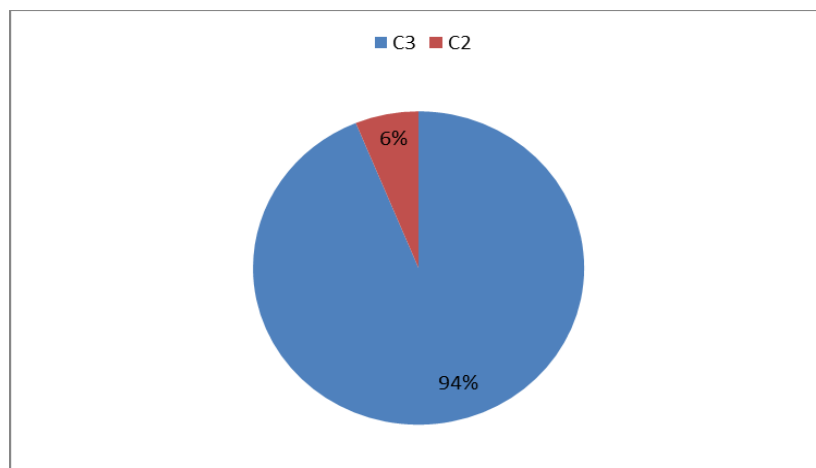
Figure 4.3: Building Classification percentage of Ward 13

It was found that among the 210 surveyed buildings, 197 buildings are Concrete frame with unreinforced masonry infill walls (C3 as per FEMA classification) and only 13 of them are Concrete shear wall buildings (C2 as per FEMA classification). Figure 4.3 shows the percentages of the different building types.

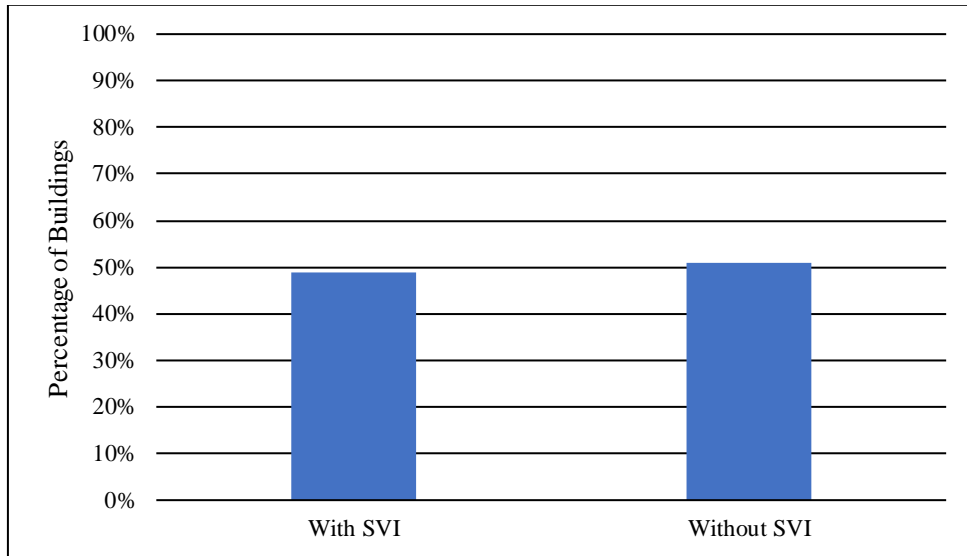
Figure 4.4: Relations between percentage of buildings and Severe Vertical Irregularity

Figure 4.4 represents the relation between percentage of buildings and severe vertical irregularity which include any or a combination of the following: short column, soft story/weak story and out of plane setback. It has been observed that 49% of the buildings which were surveyed have severe vertical irregularity.

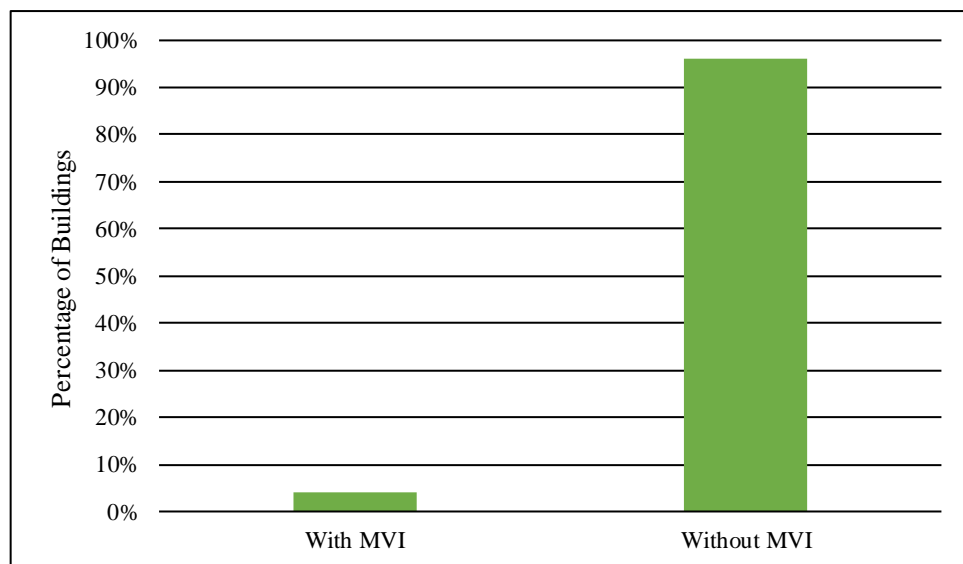
Figure 4.5: Relations between percentage of buildings and Moderate Vertical Irregularity

Figure 4.5 represents the relation between percentage of buildings and moderate vertical irregularity (e.g. in plane setback, sloping site, split level). It is found that only 4% of the buildings have moderate vertical irregularity.

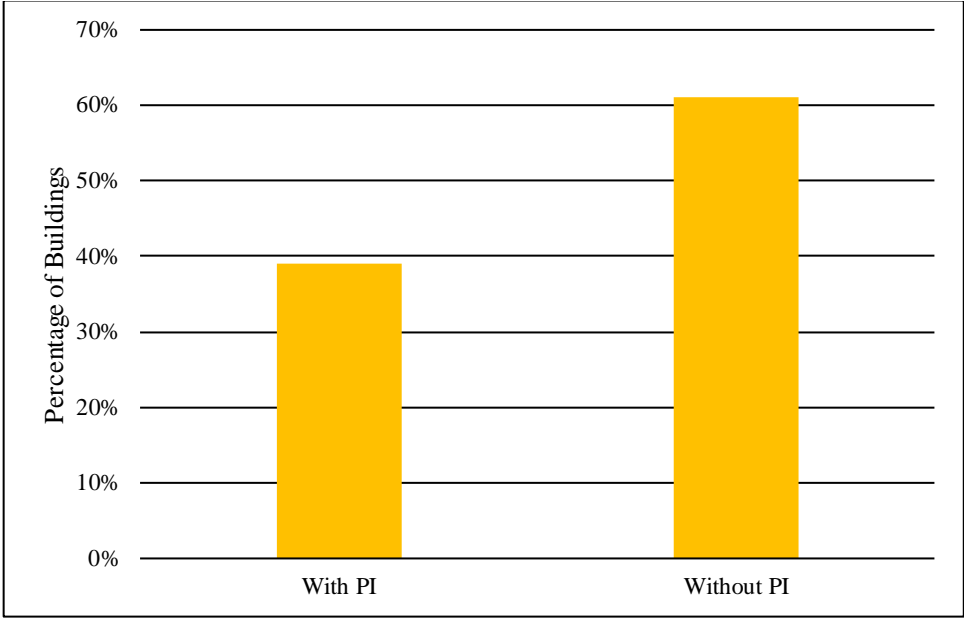
Figure 4.6: Relations between percentage of buildings and Plan Irregularity

Figure 4.6 represents the relation between percentage of buildings and plan irregularity (e.g. torsional irregularity, non-parallel system, reentrant corner, diaphragm opening, out of plane offset). 39% of the buildings have plan irregularity.

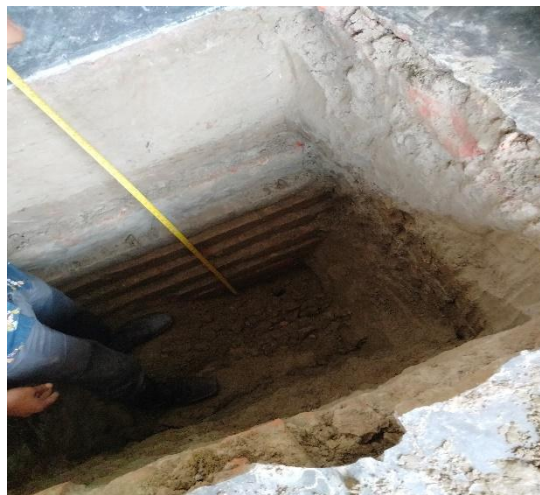
Figure 5.1: Footing Excavation

Foundations of the building were checked by excavating the soil. The size, thickness and depth were measured. Figure 5.1 shows the excavation of footing. Footing details have been attached to the drawing as Appendix C.

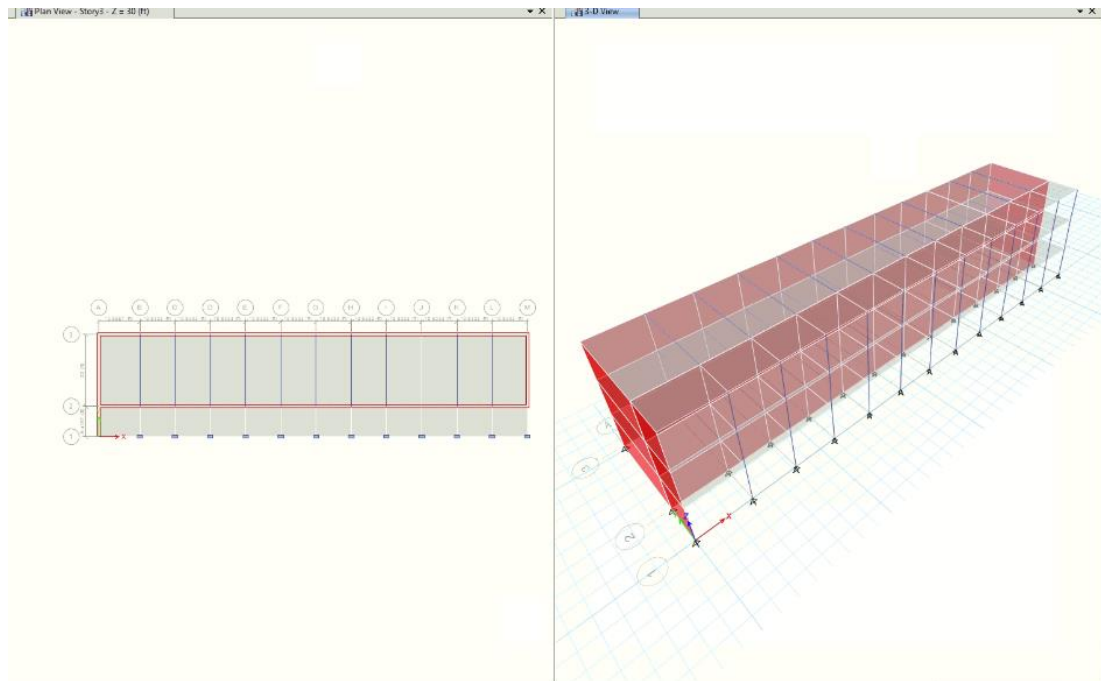
Figure 5.2: Finite element model before analysis in plan view (Left) and elevation view (Right)

It is a three-storied school building. As-built drawings of this building are shown in Appendix C. Figure 5.2 depicts the plan and 3-D view of the finite element model. Figure 5.3 shows the deformed 3-D view of the structure after analysis. From this figure it is also obtained that the beams do not fail under the considered loading combinations.

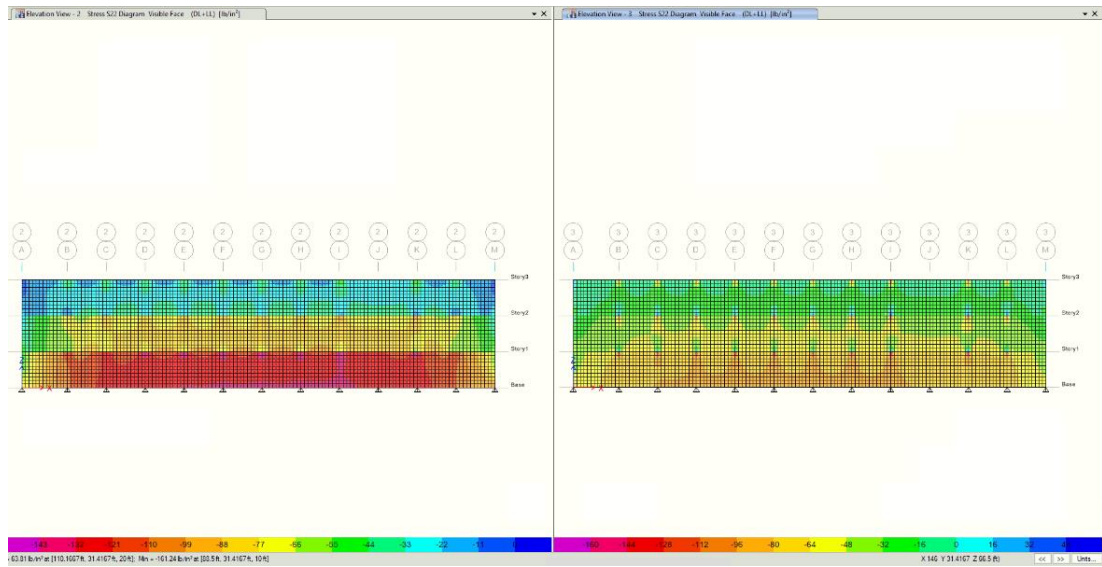
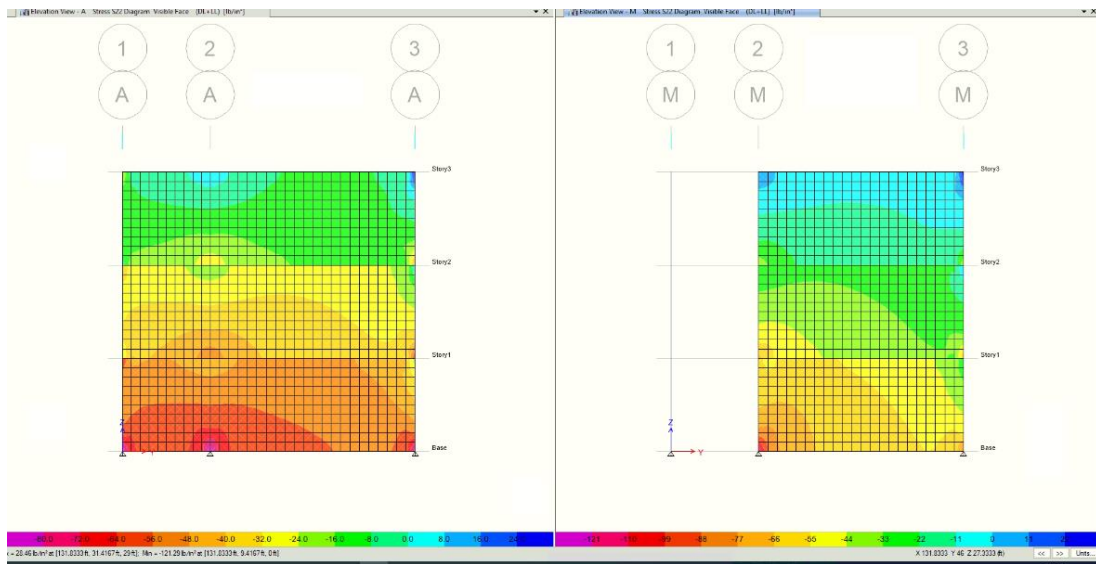
Figure 5.4: Compressive stress (S22) due to combination of dead and live loads at elevation (a) 2, 3 and (b) A, M

Figure 5.4 shows the compressive stress (S22) of load bearing walls due to the combination of dead and live loads at elevations 2, 3 and A, M. Figure 5.5 shows the shear stress (S12) distribution due to combination of dead loads, live loads and earthquake loads along the X direction at elevation 2, 3 and A, M.

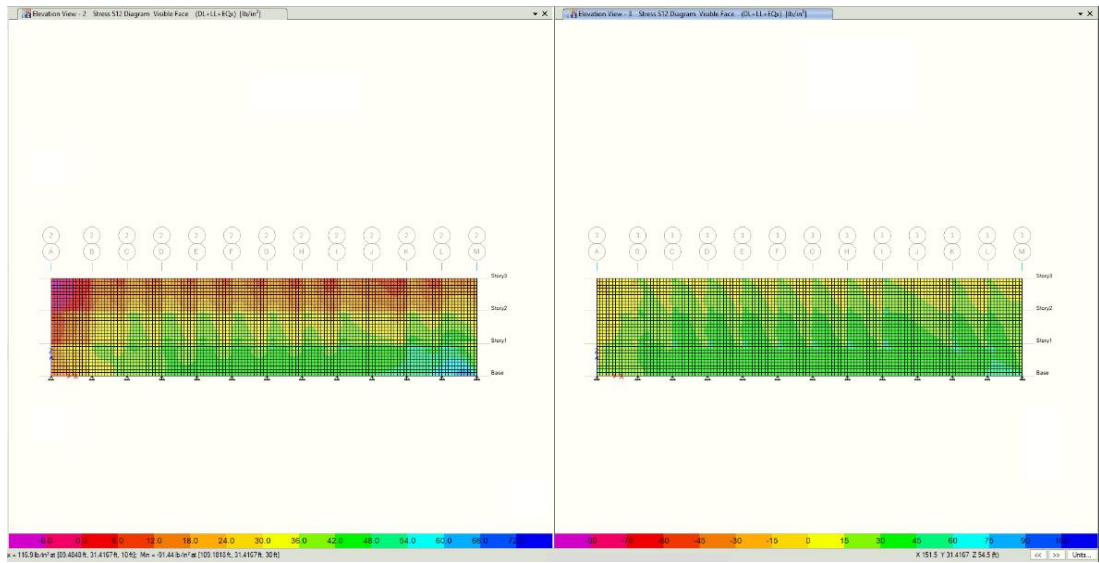
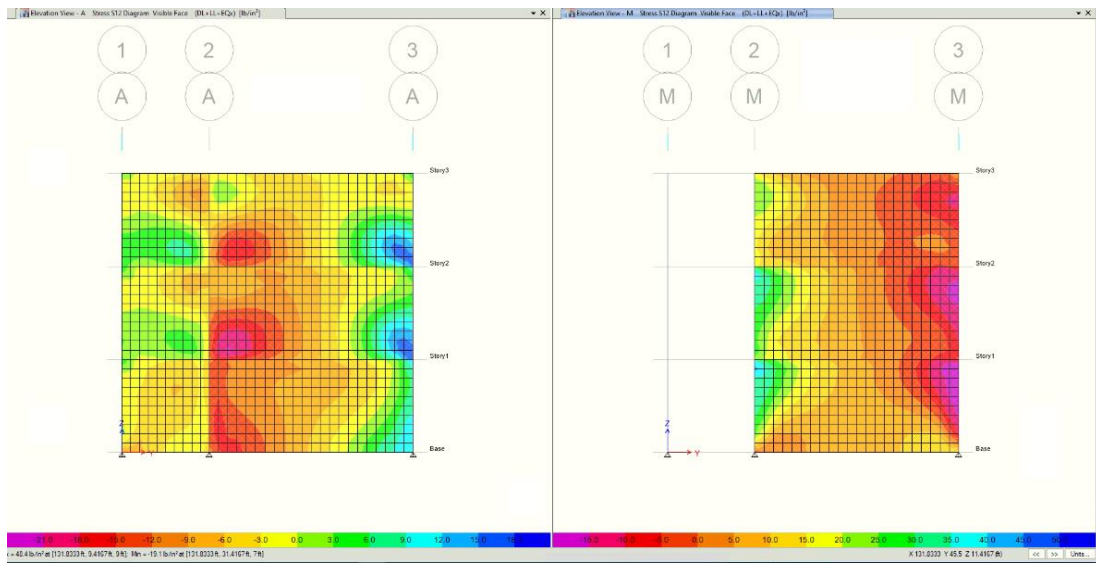
The limit of shear stress of unreinforced masonry was found to be 23 psi (0.16 MPa) from equation 6.7.6 of BNBC 2020,

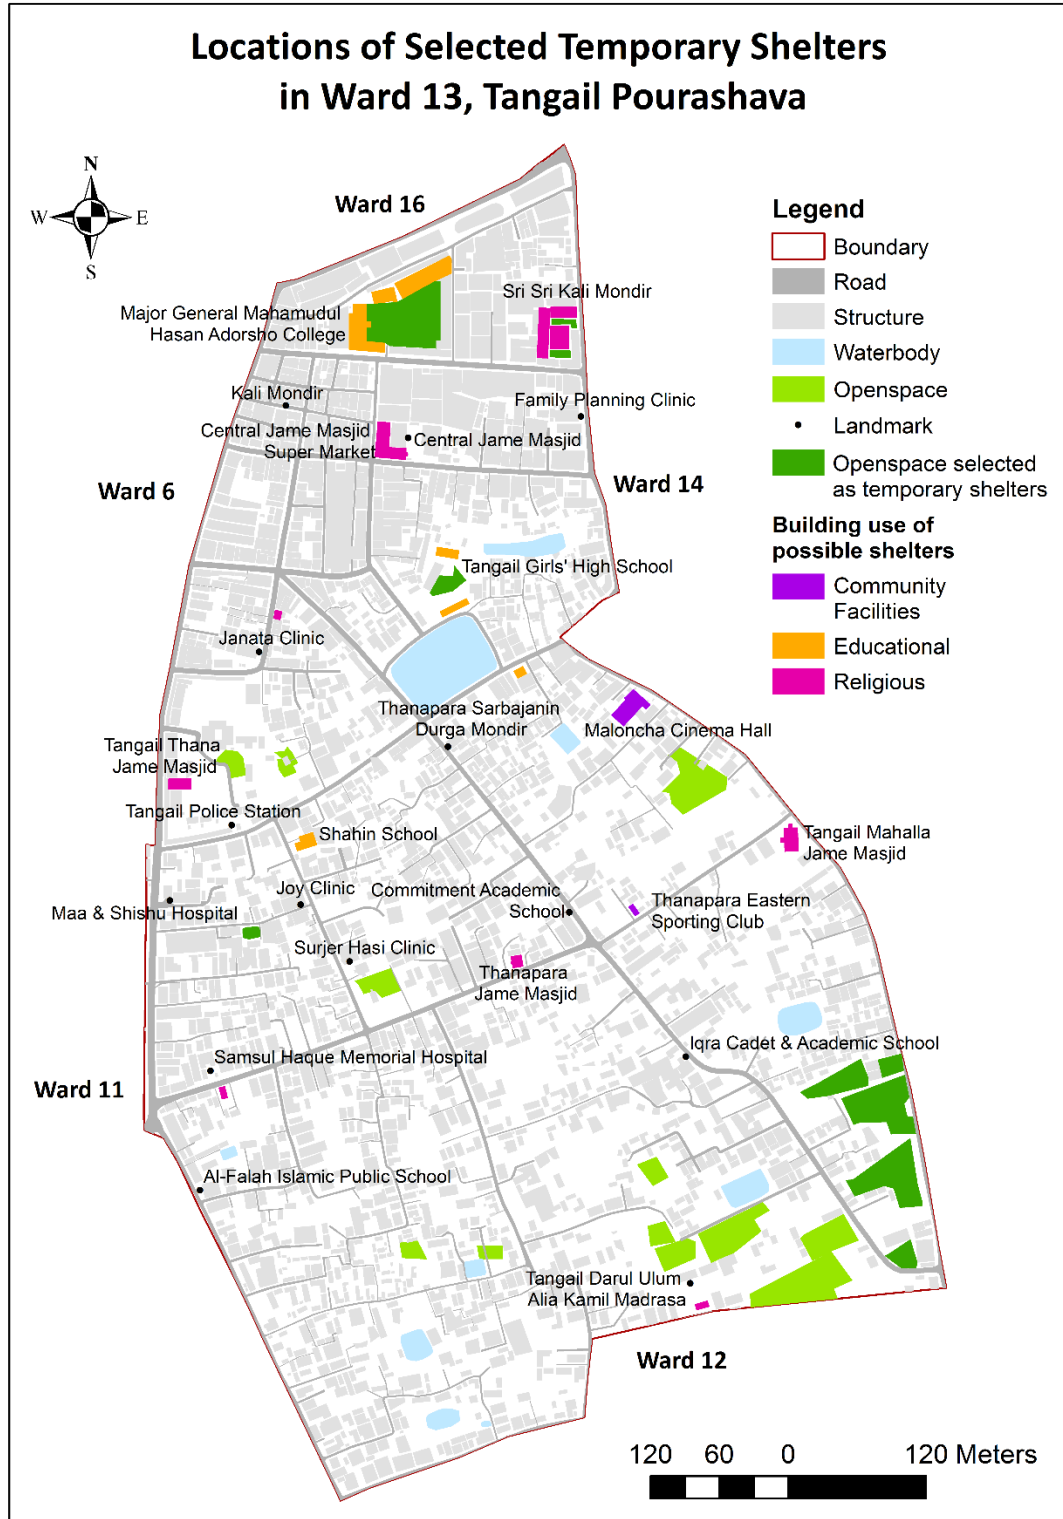
Figure 7.1: Location of possible temporary shelter in the study area

Accordingly, the sites of temporary shelters were identified considering the preference of the residents and using the data extracted from land use map. The locations of temporary shelter were then finalized (Figure 7.1) during the consultation workshop with the local people. Besides the locations proposed using the land use map, the local people proposed one more location as temporary shelter namely 'Thanapara Jame Mahjid' as shown in Figure 7.1. In the case of open space as temporary shelter, they have also proposed the open spaces of 'Sri Sri Kali Mondir' (see Figure 7.1). Although, a number of open spaces proposed primarily from the land use map have been excluded in the final map (Figure 7.1) as local people in the consultation workshop have informed that they are either private property getting filled up or do not have access for public.

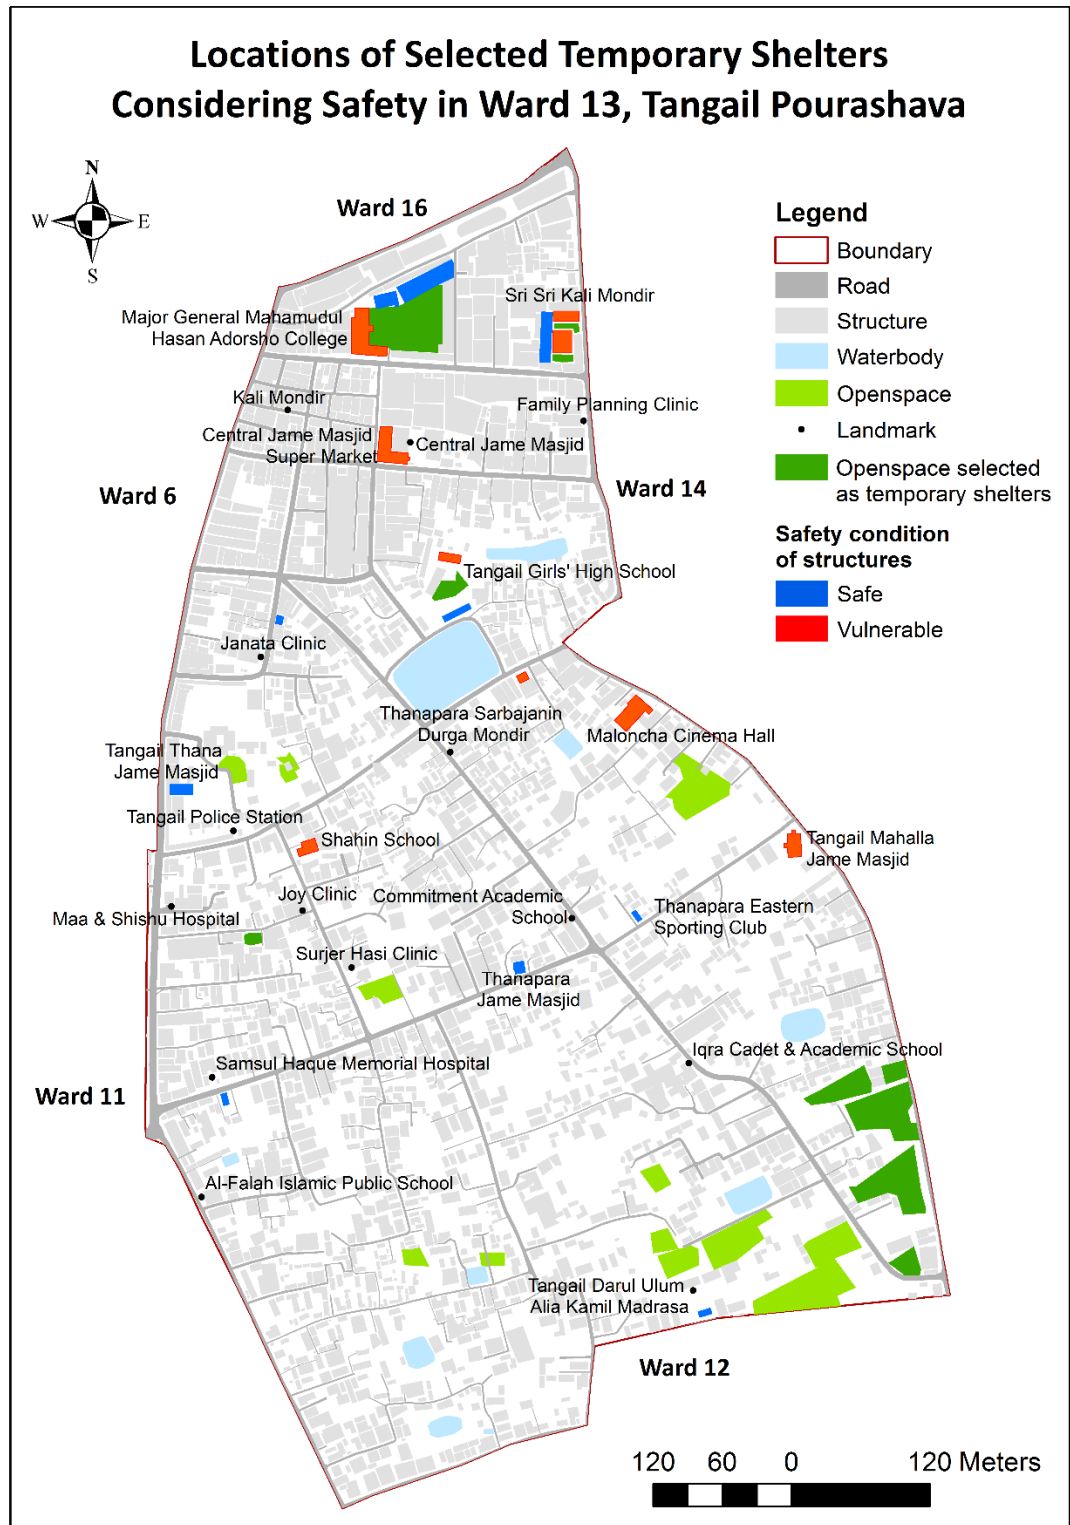
Figure 7.2: Location of possible temporary shelter in the study area considering safety

Among the facility buildings identified to be used for temporary shelter, some are structurally vulnerable (with RVS score less than 1.2) which cannot be utilized as

temporary shelter. Figure 7.2 shows the locations of possible temporary shelters in the study area considering safety including the open spaces, safe public buildings and unsafe public buildings. Table 7.1 shows the supply scenario of the possible temporary shelters in the study area including supply as a whole, capacity of safe facilities and capacity of unsafe facilities. From Figure 7.2 and Table 7.1 it can be observed that most of the public buildings with higher capacity in the study area are unsafe. From the demand-supply comparison, it has been found that the supply of temporary shelter in safe public building is insufficient to accommodate the people requiring shelter. So, open spaces have to be used as temporary shelters following an earthquake. Table 7.1 also shows how much more can be added if unsafe facility buildings are retrofitted. If the unsafe buildings are retrofitted they would be able to accommodate 3570 people.

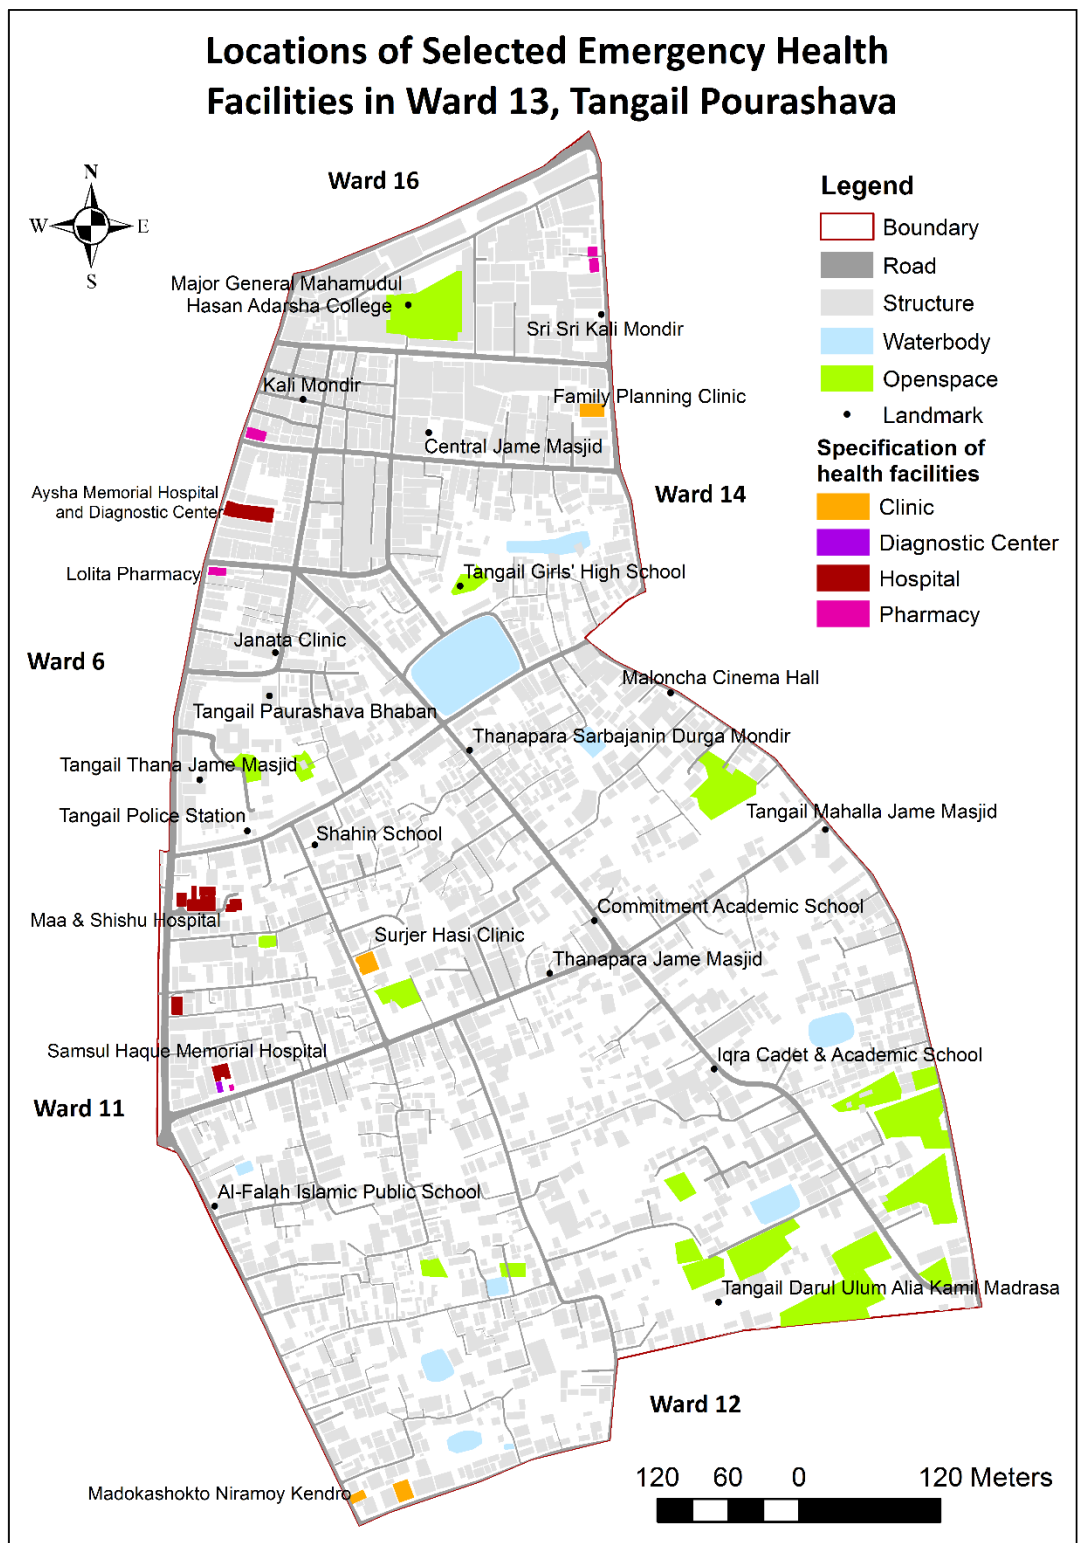
Figure 7.3: Location of possible emergency health facilities in the study area

The emergency health facilities were identified as per the requirement mentioned in Chapter 2, Volume-1. Figure 7.3 shows locations of possible emergency health facilities in the study which includes hospital, diagnostic center and clinics and pharmacies might be used for giving first aid treatment for injured people of severity 1. These facilities actually are concentrated in a certain location. These locations were then finalized during the consultation workshop with the local people. Besides the locations proposed using the land use map, the local people proposed five more location namely ‘Ayesha Memorial Hospital and Diagnostic Center’, ‘Lolita Pharmacy’, ‘Medinova Hospital’, ‘Surjer Hasi Clinic’, and ‘Family Planning Clinic’ as shown in Figure 7.3.

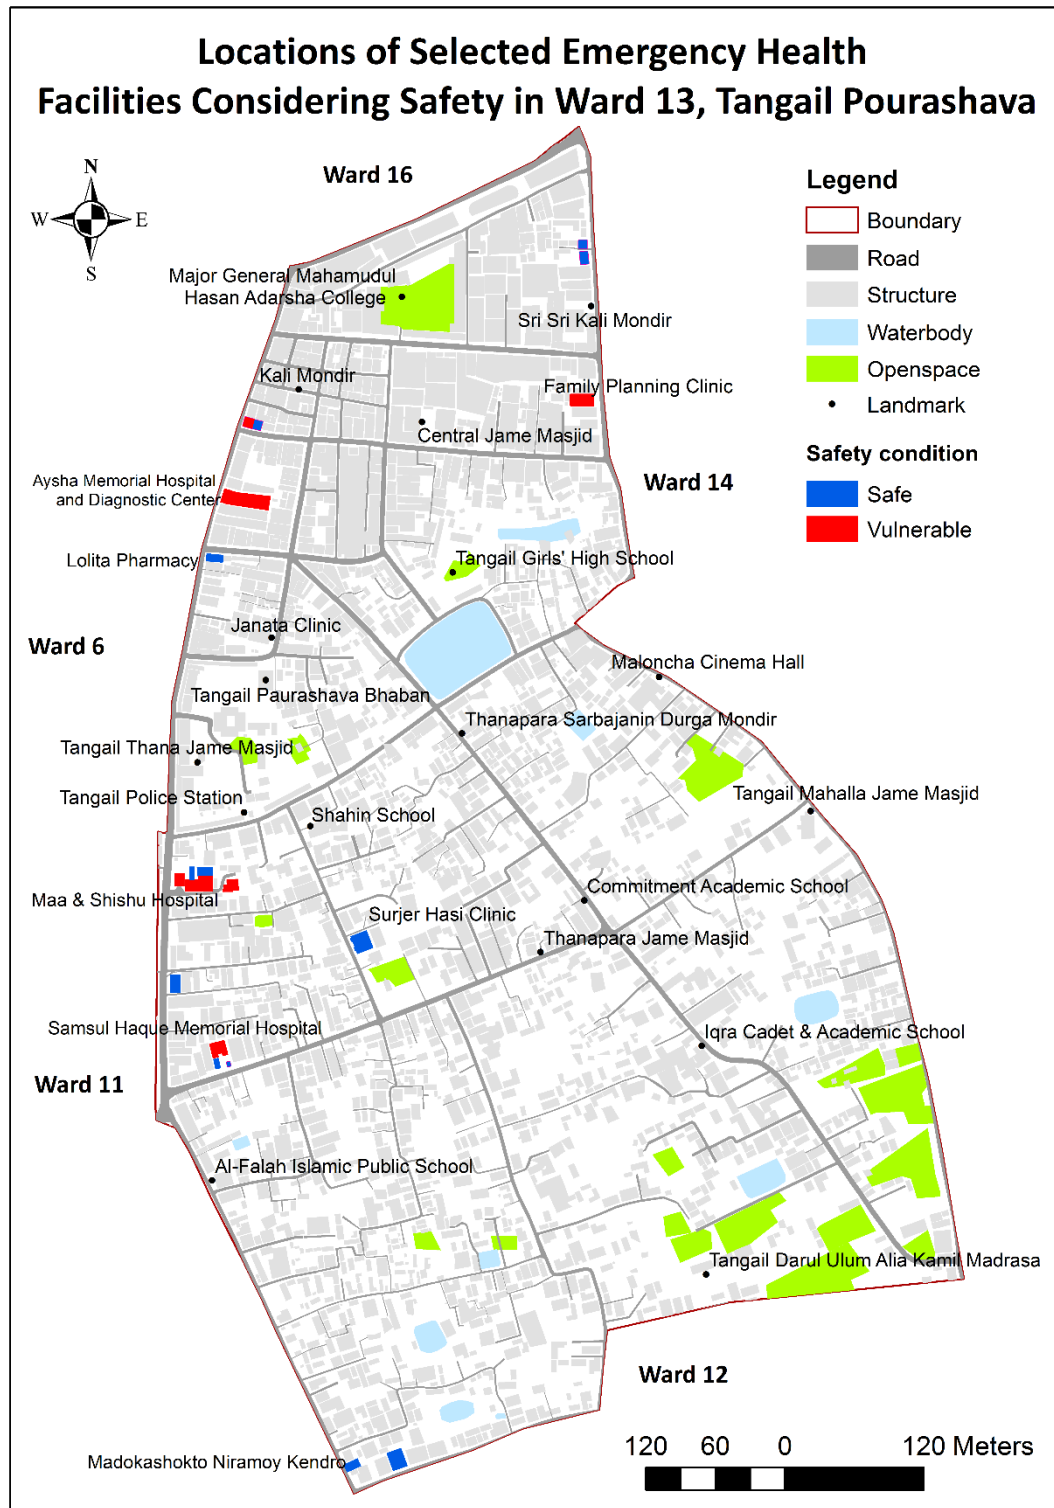
Figure 7.4: Location of possible emergency health facilities in the study area considering safety

not meet the demand, then selected unsafe health facility buildings might be retrofitted to equalize the supply and demand. Figure 7.4 shows the emergency health facility buildings according to the structural safety of the facility building.

Considering the assumptions described in methodology chapter (Chapter 2 of Volume 1), the capacity of each of the emergency health facilities were determined which has been shown in Table 7.3. It also shows number of emergency health facilities and their area and the number of persons they could treat considering the space requirement per person (2 square meters) for both safe and unsafe facility buildings. It has been found from Table 7.3 that that 374 people can be given treatment in the structurally safe emergency health facilities. If the unsafe building could be retrofitted 737 people more could have been given health service at the time of emergency.

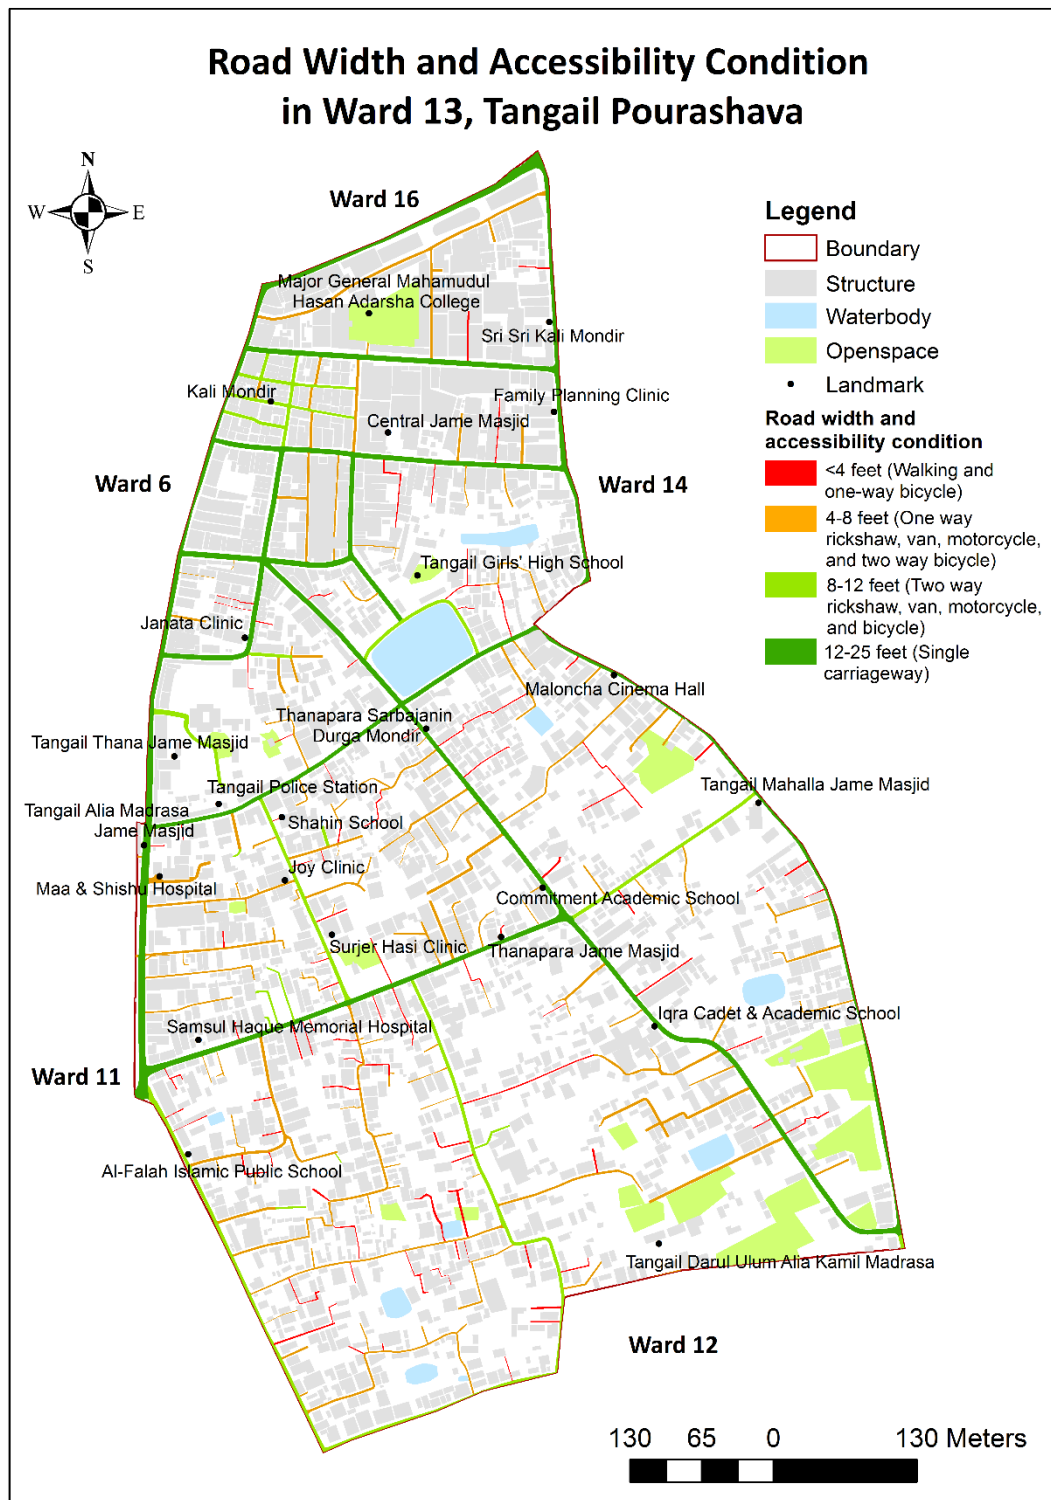
Figure 7.5: Road width and accessibility condition

Figure 7.5 shows the existing accessibility condition within Ward 13 of Tangail Pourashava which was validated during the workshop. This ward is surrounded by roads in almost all sides of the ward boundary. Especially, the northern, eastern and western sides of ward boundary are merged with single carriageway accessible by the motor vehicles. The northern boundary side road is named Victoria Road and the western boundary side road is known as District Sadar Road. Among the three selected wards of Tangail, ward 13 seems to be in better accessibility condition, as many internal roads are single carriageway with a road width of 12 to 25 feet. But in overall scenario, the internal road network of ward 13 is not that kind of good in terms of road width. Most of the roads belong to the category of '<4 feet' and '4-8 feet' which are accessible by pedestrians and one-way bicycle; and one-way non-motorized traffic (rickshaw or van), one-way motorcycle and two-way bicycle respectively.
