National Resilience Programme

Earthquake Contingency Plan for Ward 13, Tangail Municipality: Volume 2

BUET-Japan Institute of Disaster Prevention and Urban Safety (BUET-JIDPUS)
Department of Urban and Regional Planning
Department of Civil Engineering
Bangladesh University of Engineering and Technology (BUET),
Dhaka-1000, Bangladesh.

**Earthquake Risk Assessment for Developing Contingency
Plans, Training Modules and Awareness Materials for
Rangpur City Corporation and
Tangail, Rangamati and Sunamganj Pourashavas**

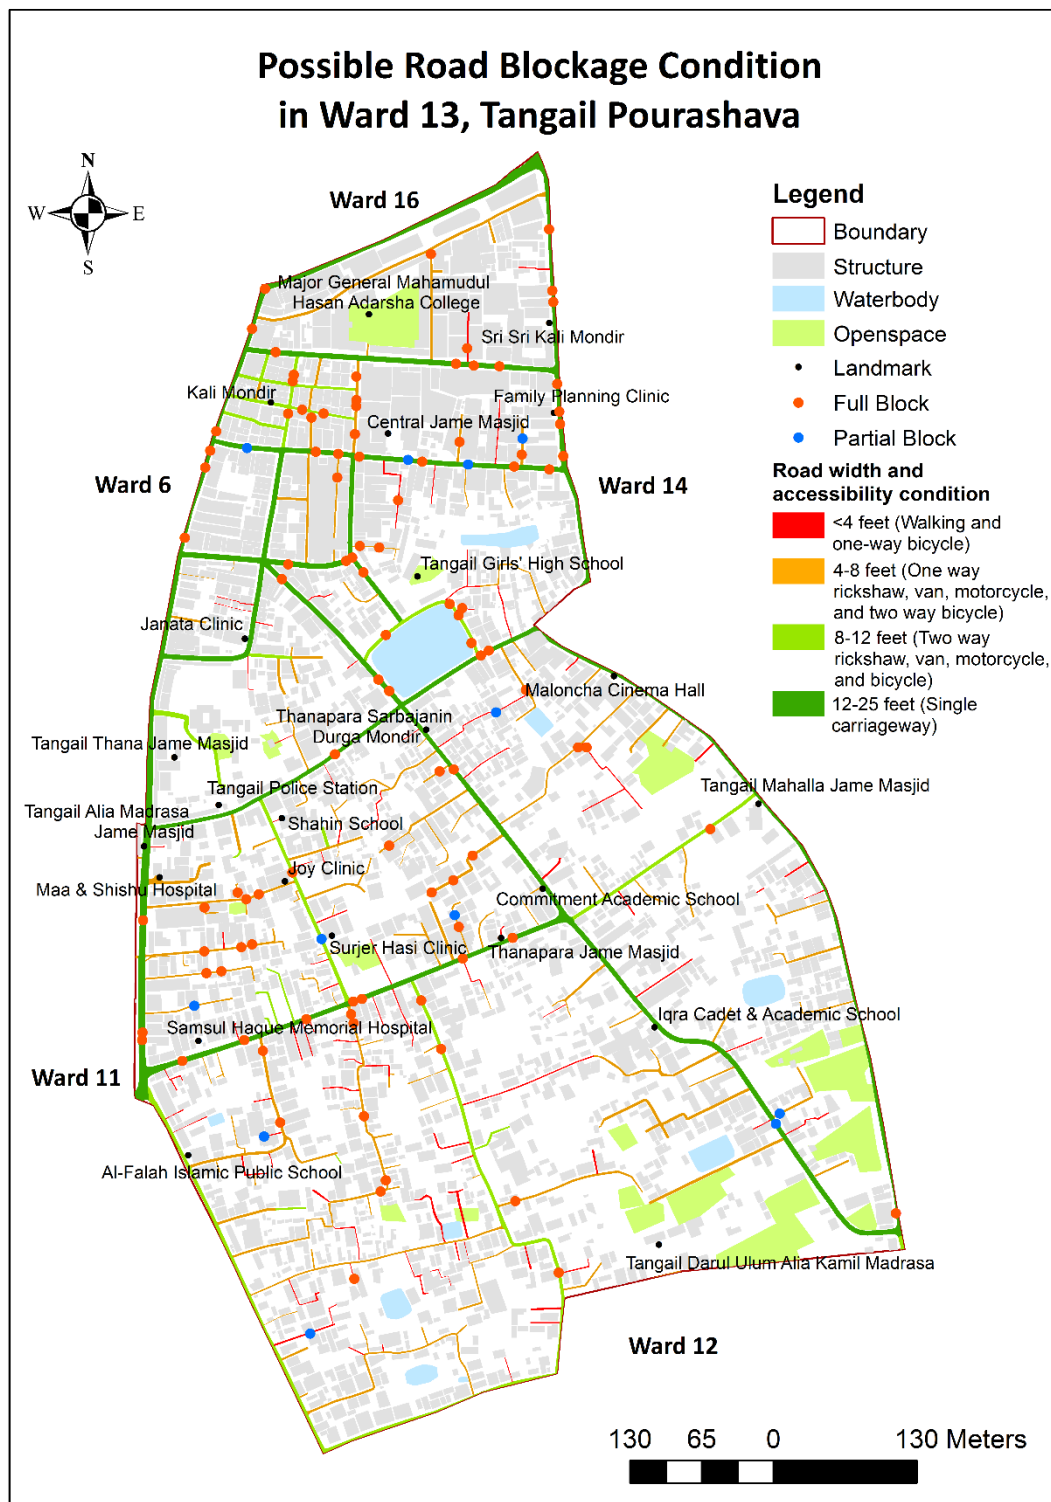
Figure 7.6: Road blockage condition

It can be assumed that rescuing from residential building and access to temporary shelter and emergency health facility will be quite challenging because most of the access roads of the residential buildings will be fully blocked. These blockages of roads are crucial as they will trap other roads which will be unable to use for any kind of movements and which will possibly prohibit entrance of any large emergency vehicle or rescuing equipment in the northern and middle portion of the ward. Figure 7.7 provides the evacuation route map which will be usable for the evacuees to move to designated locations after an earthquake.

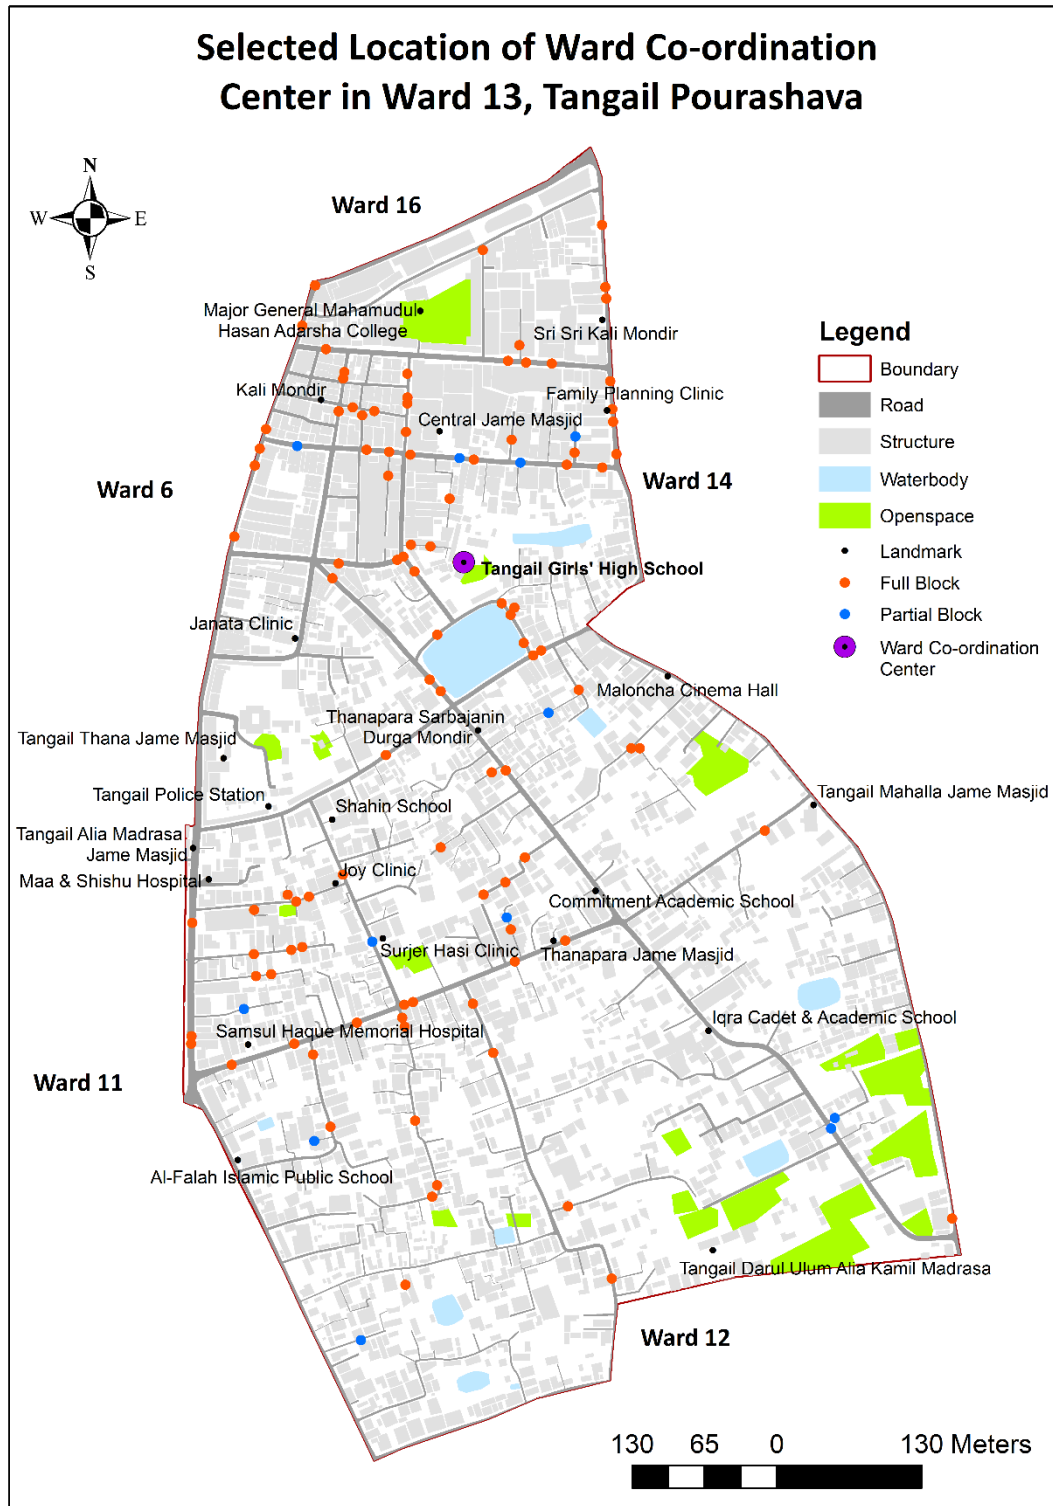
Figure 7.8: Location of selected Ward Co-ordination Center

As mentioned in the methodology, the selection criteria considered in this study for Ward Co-ordination Center are: the facility should be in a government building, should be structurally safe, and should be centrally located (Chapter-2, Volume 1). Primarily, the building of Major General Mahmudul Hasan Adarsha College was proposed for the establishment of WCC using the land use data. Although, it is a privately owned institutions and also not in the central location. During the consultation workshop, the local people have proposed another location for WCC which is more central as shown in Figure 7.8. It is a newly constructed building of “Tangail Girls High School” for which information regarding structural safety was not available. So, using this building as WCC needs necessary structural vulnerability assessment and retrofitting if necessary.

Adjacent road width of the building is more than 12 feet, a single carriageway, which not only connects this ward with others also most of the major roads of the ward can be accessed by this road. Therefore, it can be said that, this building of “Tangail Girls High School” can be an optimal position for WCC after ensuring structural safety considering its accessibility and centrality.

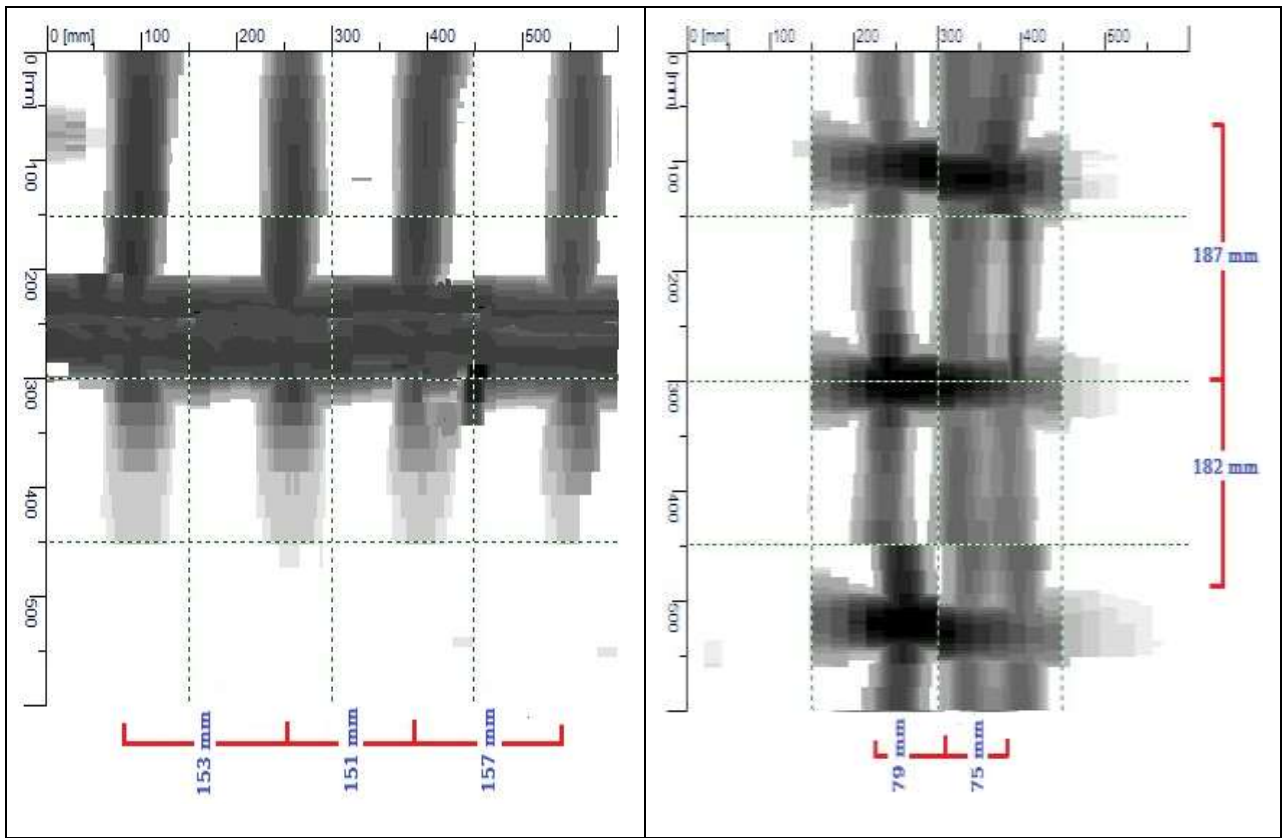
Figure E-01: Image scan of beam 1F-B2 (lateral)

Figure E-02: Image scan of beam 1F-B2 (bottom)
