Earthquake Contingency Plan for Ward 14, Tangail Municipality: Volume 2

**National
Resilience
Programme**

**Earthquake Risk Assessment for Developing Contingency
Plans, Training Modules and Awareness Materials for
Rangpur City Corporation and
Tangail, Rangamati and Sunamganj Pourashavas**

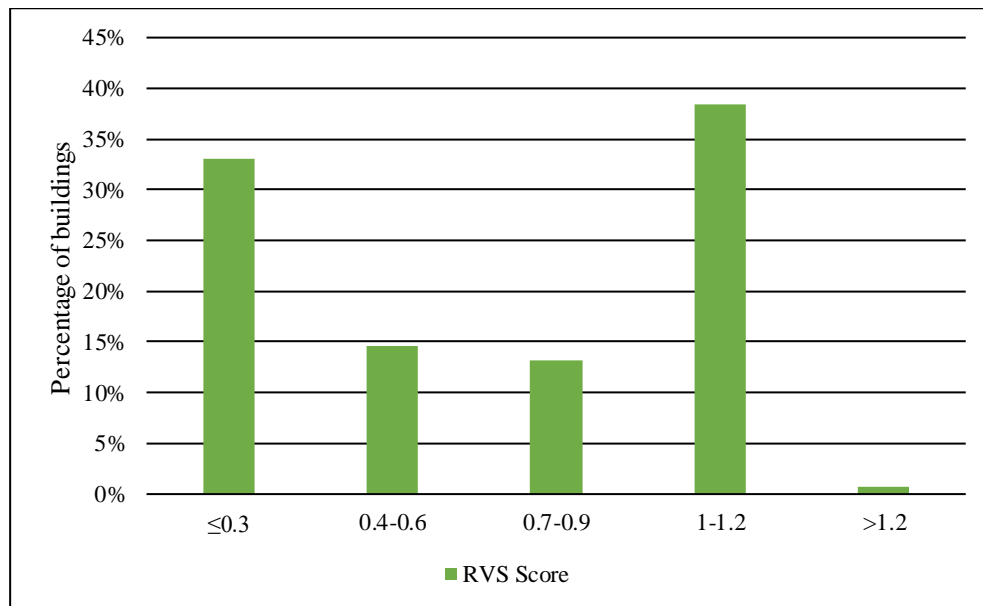
Figure 4.1 (b): Relations between percentage of buildings and RVS score of ward no 14 for high seismicity

Figure 4.1 (b) shows that 33% of buildings score less than or equal 0.3. 15% score in between 0.4-0.6. 13% buildings were within the range of 0.7-0.9, 38% scored between 1.0-1.2 and finally 1% of the buildings scored higher than 1.2. Thus, considering a cutoff of 1.2 for higher seismicity, 1% building will be marked as safe during earthquakes of higher magnitude.

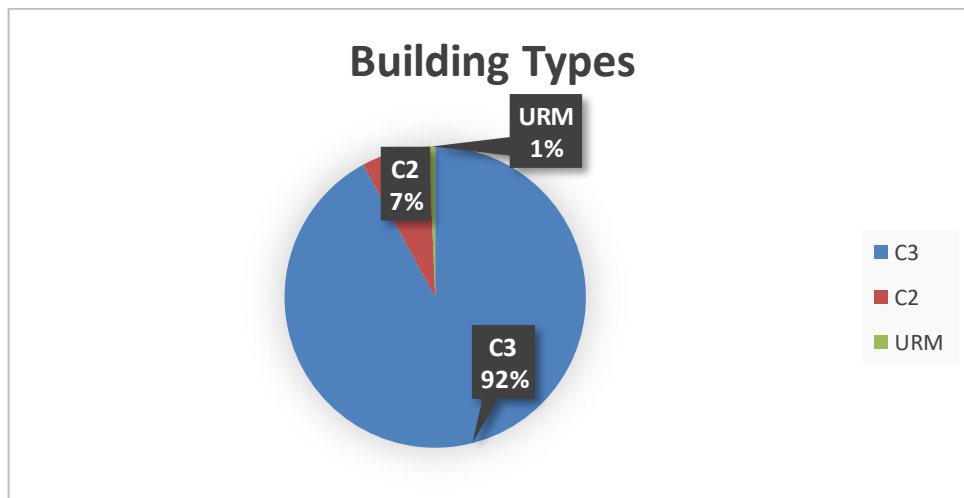
Figure 4.3: Building Classification percentage of Ward 14

It was found that among the 151 surveyed buildings, 139 are Concrete frame with unreinforced masonry infill walls (C3 as per FEMA classification). 1 of the buildings are Unreinforced masonry (URM) and 11 are Concrete shear wall buildings (C2). Figure 4.3 shows the percentages of the different building types.

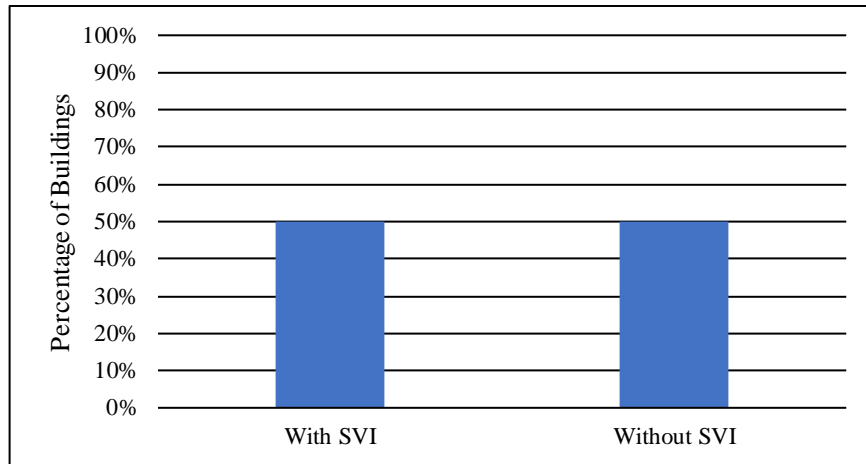
Figure 4.4: Relations between percentage of buildings and Severe Vertical Irregularity

Figure 4.4 represents the relation between percentage of buildings and severe vertical irregularity which include any or a combination of the following: short column, soft story/weak story and out of plane setback. It has been observed that 50% of the buildings that were surveyed have severe vertical irregularity.

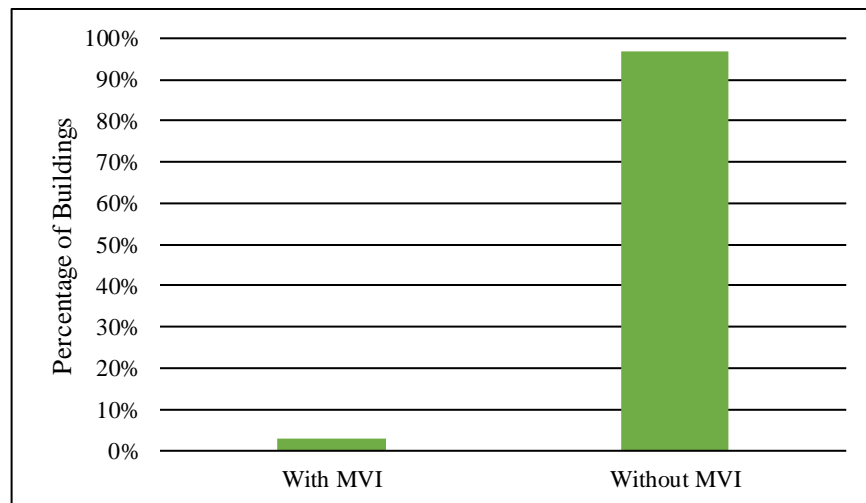
Figure 4.5: Relations between percentage of buildings and Moderate Vertical Irregularity

Figure 4.5 represents the relation between percentage of buildings and moderate vertical irregularity (e.g. in plane setback, sloping site, split level). It is found that only 3% of the buildings have moderate vertical irregularity.

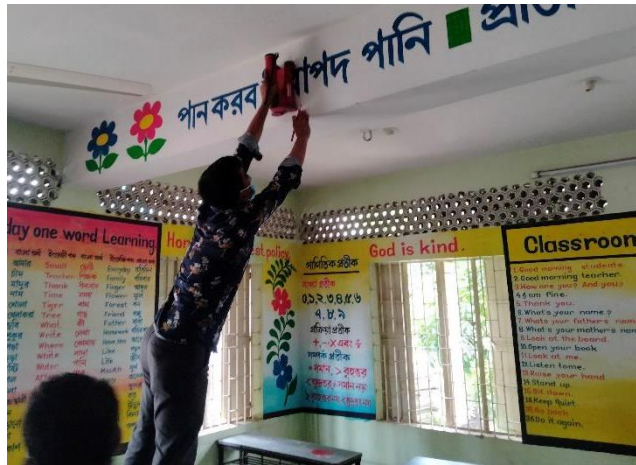
Figure 5.1: Ferro-scanning of a beam

Ferro-scan tests of the building have been done to know the number and size of reinforcement in column, slab and beam. All scanned images of the Ferro-scan results are attached in Appendix C. Figure 5.1 shows ferro-scanning of a beam.

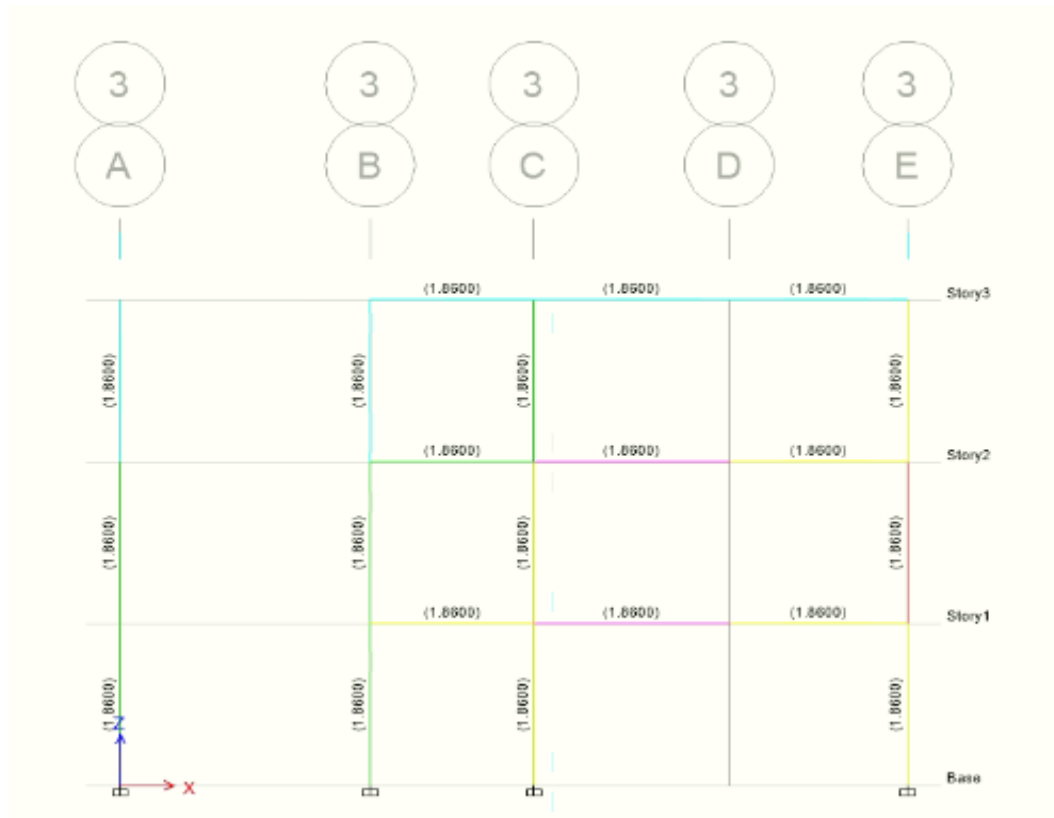
Figure 5.4 identifies the overstressed columns (shown in “Red”) along Frame 2-ABCDE and 3-ABCDE in elevation view. Hence, the red marked columns need to be retrofitted to use this structure as a temporary shelter in future.
